**NUMBER:** 08-082-19

UAV and UCV Radio Enhancements

This bulletin involves inspecting and if required, updating the radio software level to 28.3

2019 (WK) Jeep Grand Cherokee

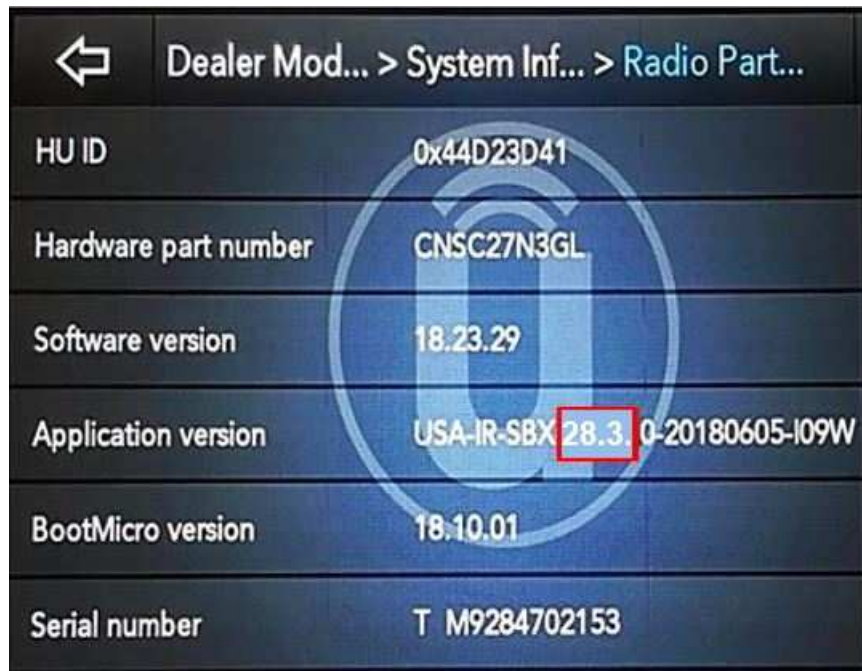
Fig. 1  
Radio Software Level Screen

1. Verify the radio software version. Radio must be in Dealer Mode to verify. To put the radio in Dealer Mode, follow these steps:
  - a. Press and hold both lower corners of the display screen, until the Dealer Mode screen appears (approximately seven seconds). Release buttons.
  - b. Select "Radio Part Information". The software level will be listed next to "Application Version".
2. Is the radio software level "Application Version" currently at or higher than 28.3 (Fig. 1) ?
  - YES >>> The radio software is already up to date. Normal diagnostic should be performed.
  - NO >>> The radio software needs to be updated. Back out of Dealer Mode and proceed to [Step 1](#) of the Repair Procedure.
