NUMBER: 08-083-19

Flash: Hands Free Module (HFM) Software Enhancements

2012 - 2019	(JC)	Dodge Journey
2012 - 2014	(LD)	Dodge Charger
2012 - 2014	(LX)	Chrysler 300

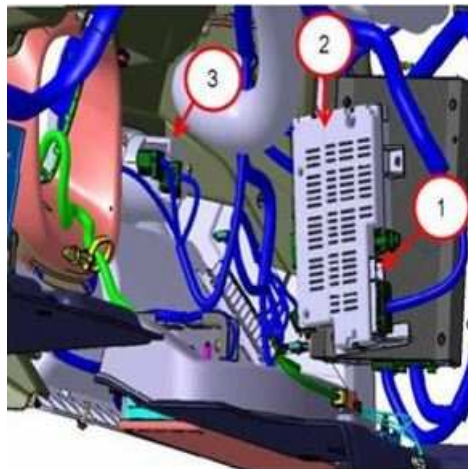
Fig. 7
LD and LX HFM Locations

For LX and LD vehicles, the HFM module is located above the driver side kick panel. Plug the orange cable into your PC and into the HFM at the connector marked “1” in (Fig. 7) .

- 1 - USB Connector Cavity
 - 2 - Hands Free Module
 - 3 - Headlamp Switch
-

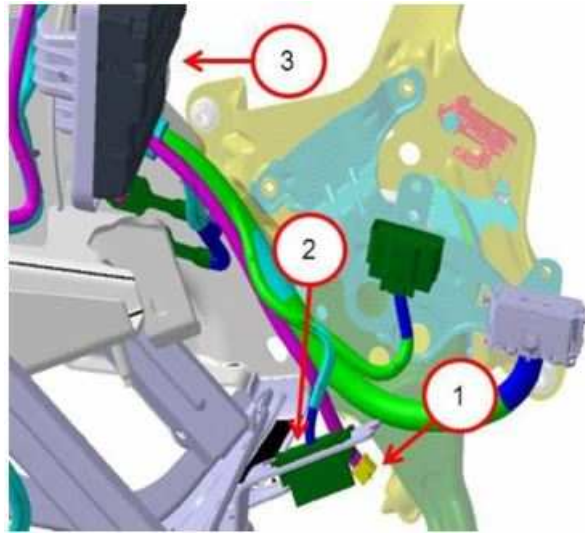
Fig. 8
JC HFM Connections

For JC vehicles, a Delphi 4-way USB connector is located on the driver side, next to the diagnostic connector. Plug the purple cable into your PC and into the connector marked “1” in (Fig. 8) .

- 1 - Delphi 4-Way connector (connect wiTECH USB Cable here)
- 2 - Diagnostics Connector
- 3 - Hands Free Module

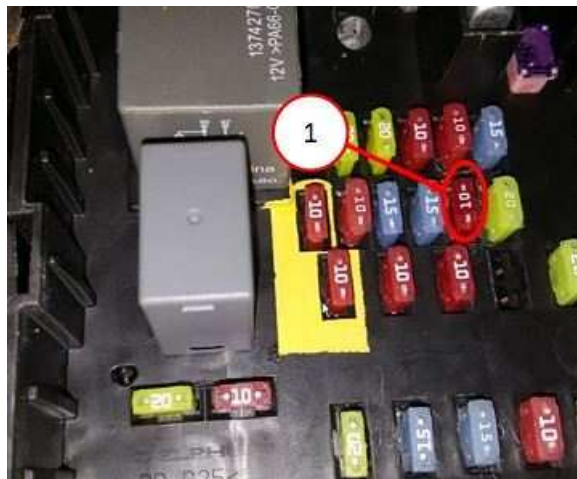
Fig. 10
JC Fuse Panel

- Locate the fuse panel in preparation to remove the HFM fuse. For JC vehicles, locate fuse #131 on the fuse panel found under the Instrument Panel (IP) on the passenger side (Fig. 10) .

1 - Fuse #131

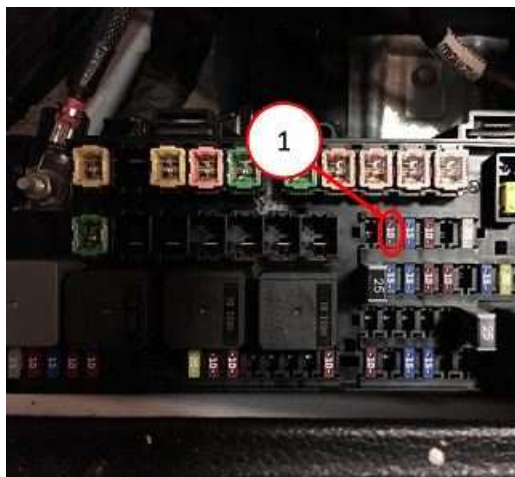
Fig. 11
LX and LD Fuse Panel

- For LD and LX vehicles, locate fuse #23 on the fuse panel found in the trunk under the floor panel on the passenger side (Fig. 11) .

1 - Fuse #23
