NUMBER: 23-019-19 REV. A

RamBox Applique Separation/Delamination

**2019	(DS)	RAM 1500 Pickup **
2019	(DJ)	RAM 2500 Pickup
2019	(D2)	RAM 3500 Pickup

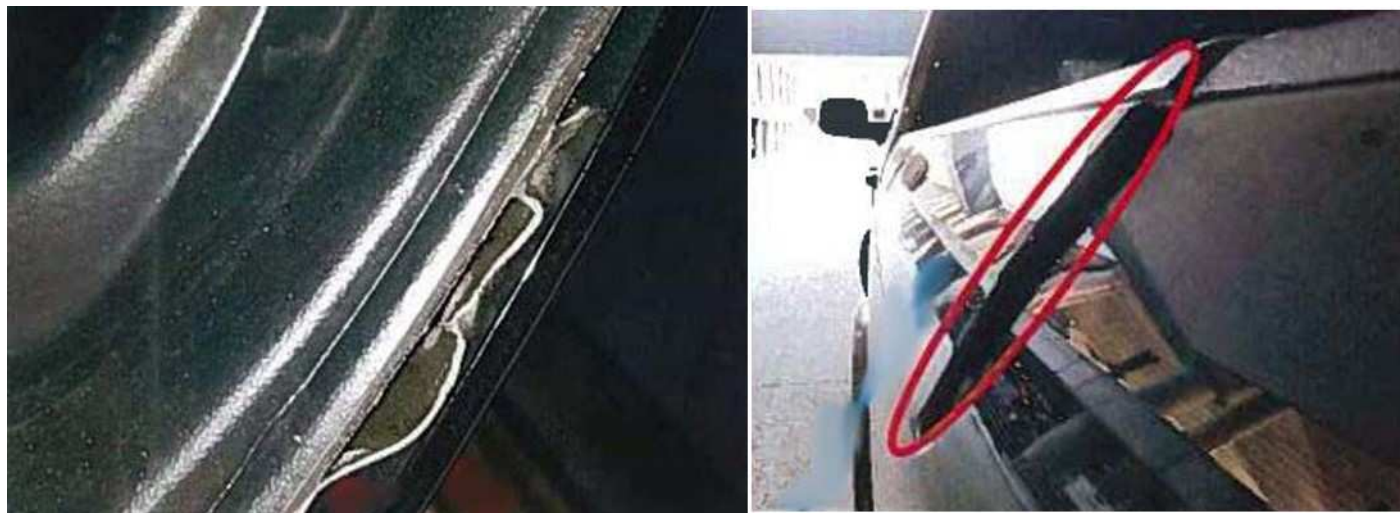
Fig. 1

- One or both of the RamBox appliques are separating/delaminating from the RamBox doors.

Examples of RamBox Separation or Delamination

1. Remove the applique from the RamBox door. Refer to the detailed service procedures available in DealerCONNECT/Service Library under: Service Info>23 - Body/Exterior/Ram Box/Removal.

CAUTION! Ensure the red liner side of the tape is applied to the applique. Failure to do so may result in the applique not adhering to the RamBox door properly.

2. Install the applique to the RamBox door. Refer to the detailed service procedures available in DealerCONNECT/Service Library under: Service Info>23 - Body/Exterior/Ram Box/Installation.
