NUMBER: 02-005-19 REV. A

GROUP: 02 - Front Suspension

Knock or Clunk Type Noise In Front Left Suspension

2019 (KL) Jeep Cherokee

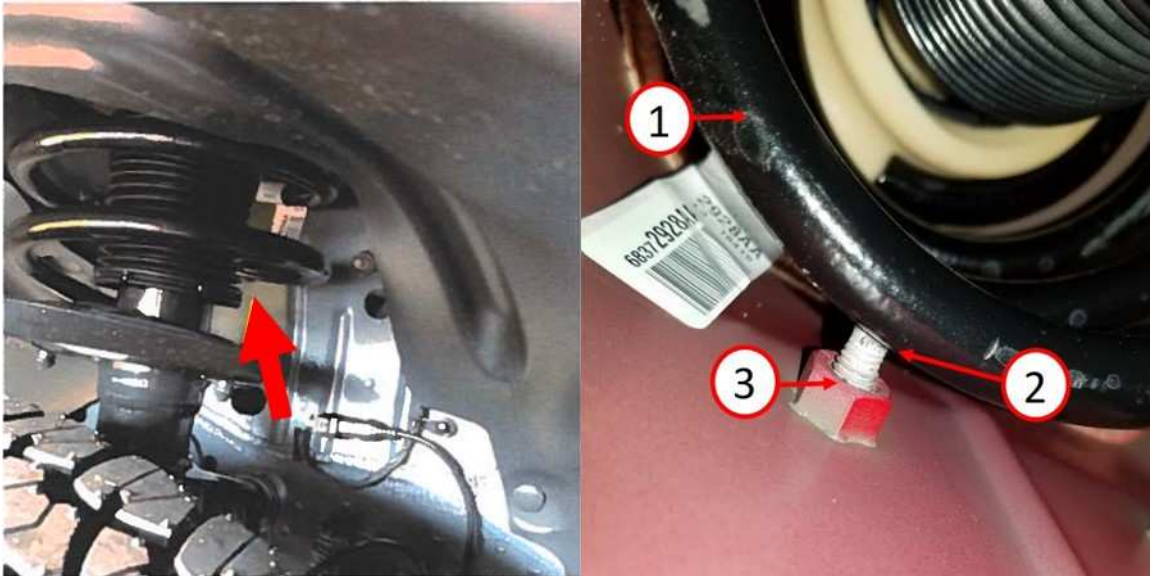
Fig. 1
Bolt Location

1. Measure the clearance between left front spring and bolt (Fig. 1) .

- 1 - Spring
- 2 - Area To Perform Measurement
- 3 - Bolt (Located on inner wheel well)

2. Is the bolt to spring clearance less than 9mm?

- YES>>> Proceed to [Step 1](#) of the Repair Procedure.
- NO>>> Vehicle has the proper spring clearance. This bulletin has been completed, use inspect LOP (02-27-01-9A) to close the active RRT.

1. Remove the Left Front Strut Assembly. Refer to the detailed service procedures available in DealerCONNECT> Service Library under: Service Info 02 - Front Suspension / Front / Strut, Suspension, Assembly / Removal.

2. Disassemble the strut assembly and remove the spring. Refer to the detailed service procedures available in DealerCONNECT> Service Library under: Service Info 02 - Front Suspension / Front / Strut, Suspension, Assembly / Disassembly.

3. Install the new coil spring into the strut assembly. Refer to the detailed service procedures available in DealerCONNECT> Service Library under: Service Info 02 - Front Suspension / Front / Strut, Suspension, Assembly / Assembly.

4. Install the strut assembly. Refer to the detailed service procedures available in DealerCONNECT> Service Library under: Service Info 02 - Front Suspension / Front / Strut, Suspension, Assembly / Installation.

5. Verify if the toe alignment is within specs after the strut/spring is reinstalled. Refer to the detailed service procedures available in DealerCONNECT> Service Library under: Service Info 02 - Front Suspension / Wheel Alignment / Standard Procedure / Toe.
