HPSGEN3

Detached Connector

Problem Description

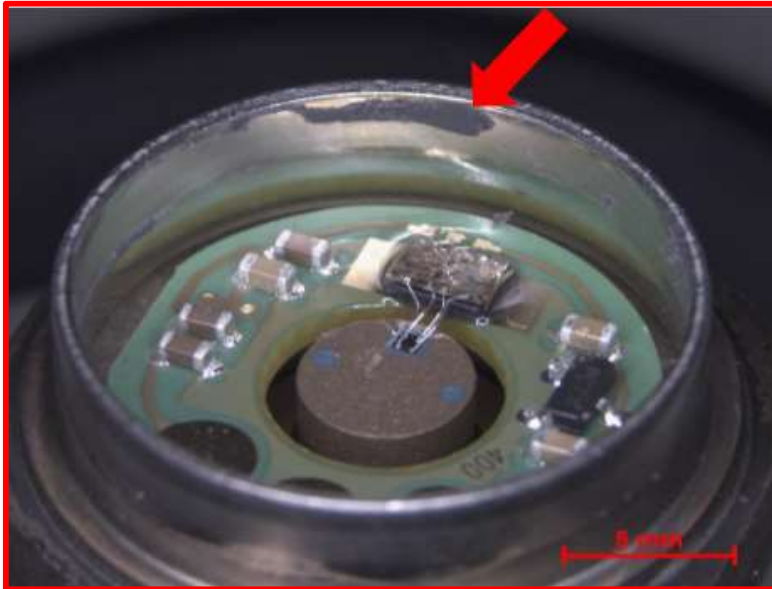
- > Small remains of glue inside metal ring
- > No visible glue residues on the outside of the ring

NOK - Small remains of glue on the whole ring

100% capable automatic 100N test before delivery out of Trutnov
Introduction of Overmold connector as Final corrective action due date
cw40.

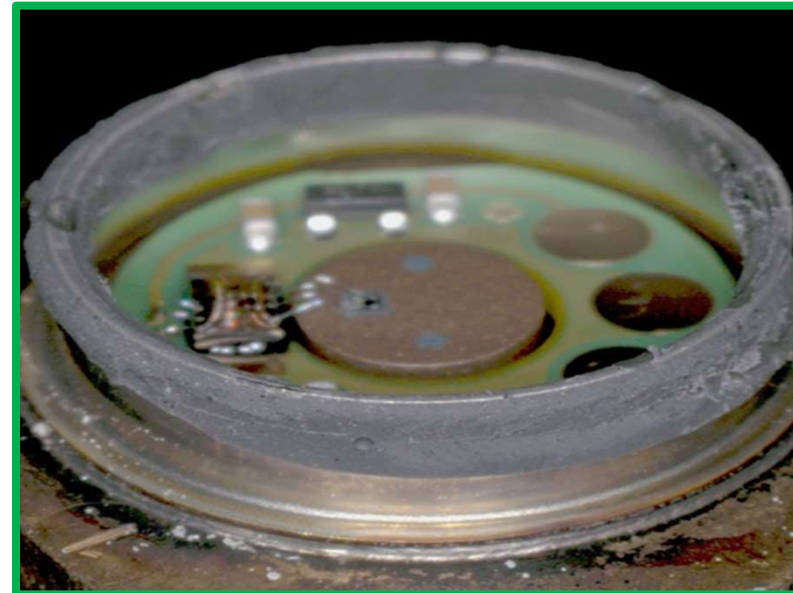
OK part
Standart condition of glue in TRU
