## HPSGEN3

Detached Connector

# Problem Description

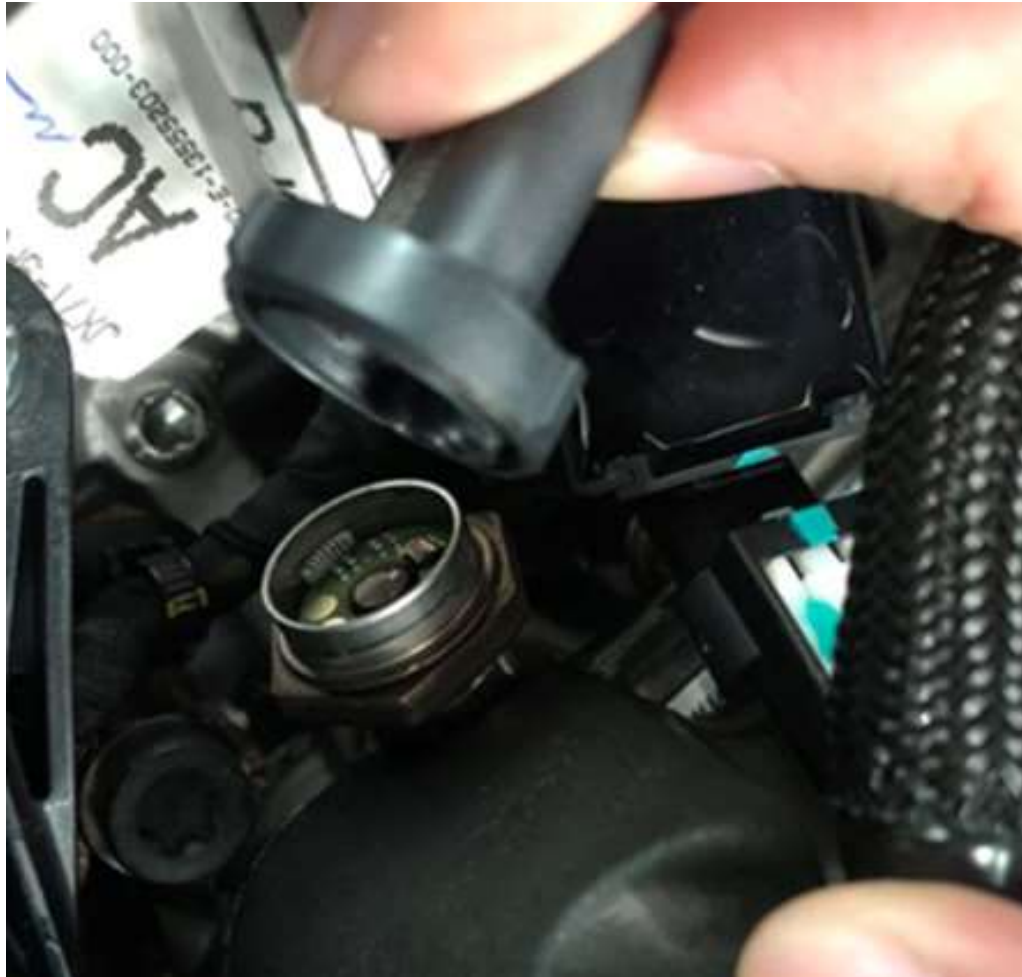
## Problem visualization

- › 28th of June 2019, Continental determined about detached connector on GDI06
- › Part was found during End Of Line test
- › Serial number of the part and production date in Trutnov is G61817730D
  - › Part was produced in Trutnov 26th of June 2018
  - › Fuel Rail Assembly in NPN was done 29th September 2018
- › Second group of sensors found in external warehouse with detached connector

100% capable automatic 100N test before delivery out of Trutnov  
Introduction of Overmold connector as Final corrective action due date  
cw40.

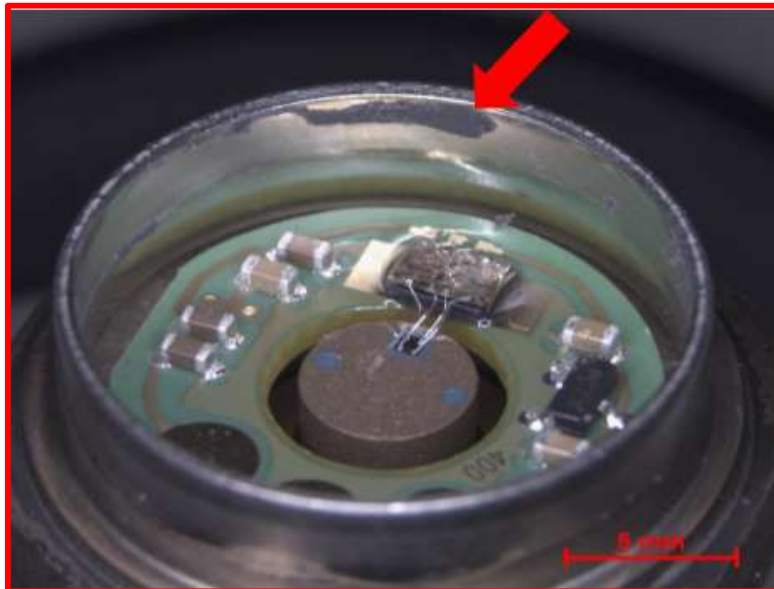
- > Small remains of glue inside metal ring
- > No visible glue residues on the outside of the ring

NOK - Small remains of glue on the whole ring

A fluid (or vapour) has attacked the glued joint and caused failure.

The bond between glue and steel ring is primarily a chemical bond at the passivation layer on the metal surface. It can be destroyed chemically by certain fluids if they get into the joint. This scenario is proven. The glue material is not harmed; only the atomic bonding between the glue material and the steel's passivation-layer material.

Finally there will be an entire dis-bond of the glue leaving a clean ring (which we see here).

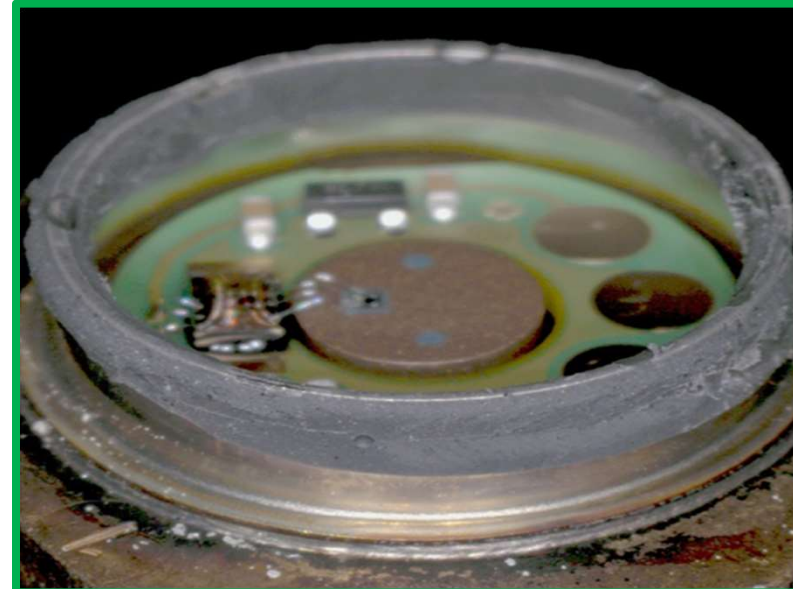
OK part  
Standart condition of glue in TRU
