Service Bulletin

Bulletin No.: 19-NA-195

Subject: Intermittent OnStar Inoperative, DTC B101D-39, Red LED and Clock Date/Time Inaccurate

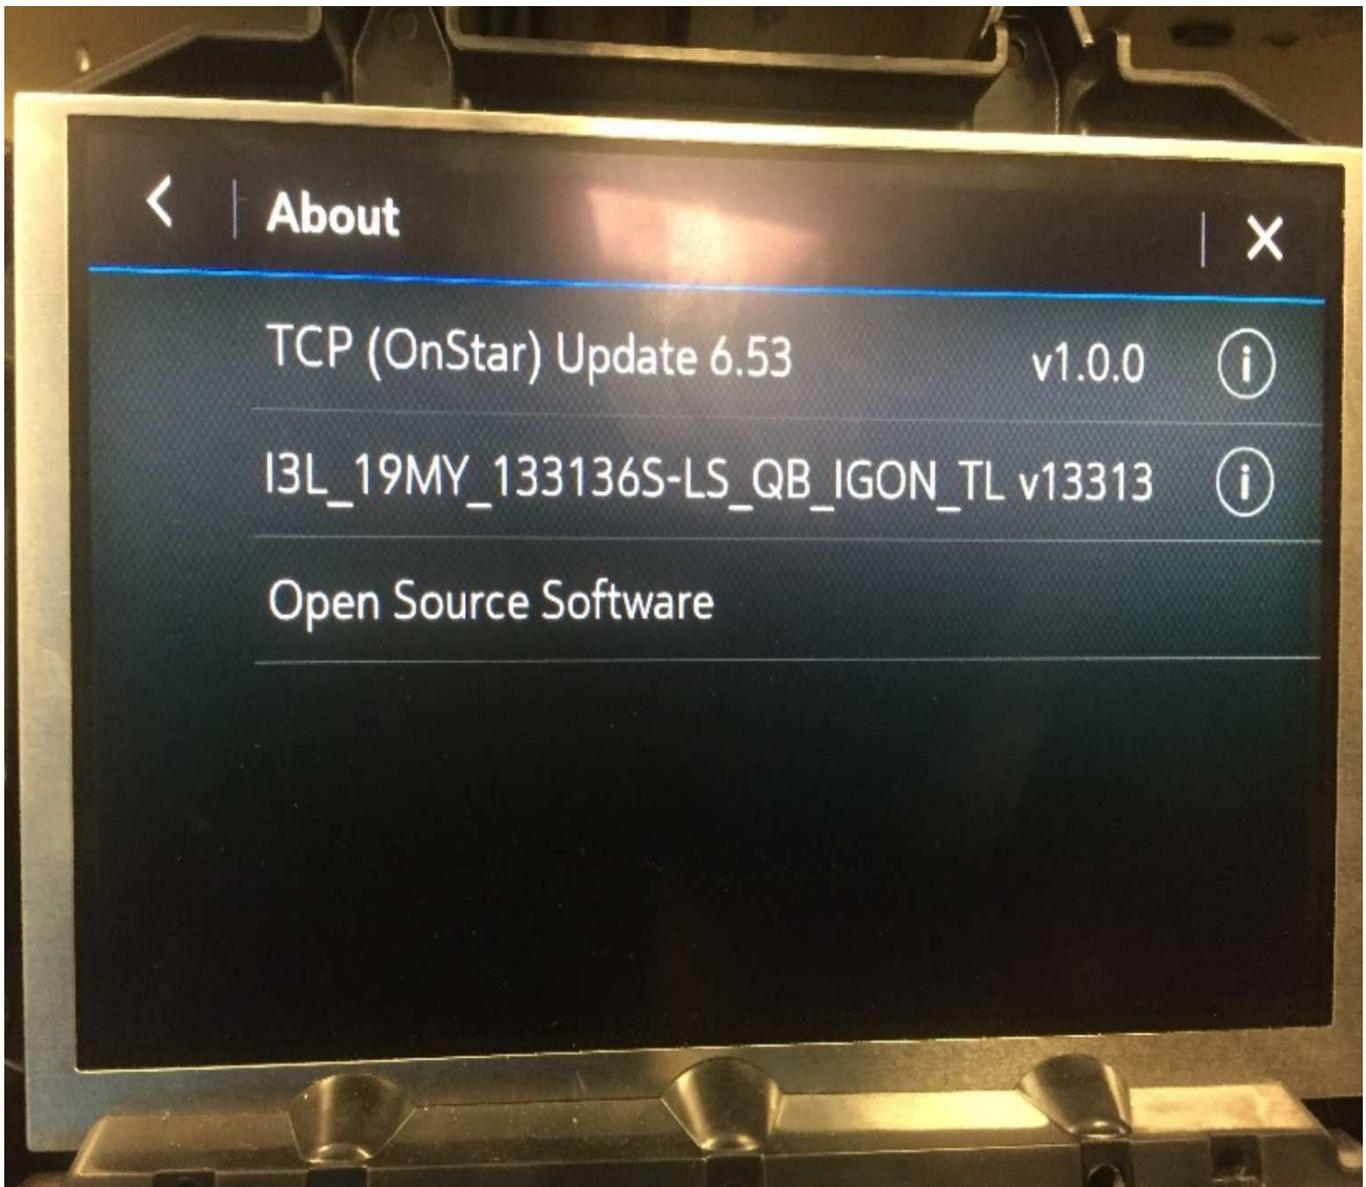
IOR-equipped vehicles:

- Enter the radio menu on the radio display. Select Home > Settings > About.
- On IOR-equipped vehicles, this will bring you to the About menu page to view Update History.
- On IOS, IOU, or IOT-equipped vehicles, scroll to Build Number and select the lowercase "i" next to Build Number to view Update History.
