# Service Bulletin

Bulletin No.: 19-NA-206

**Subject:** Intermittent Shift to Park Message Displayed While Vehicle in Park

**This Bulletin replaces 18-NA-297. Please discard 18-NA-297.**

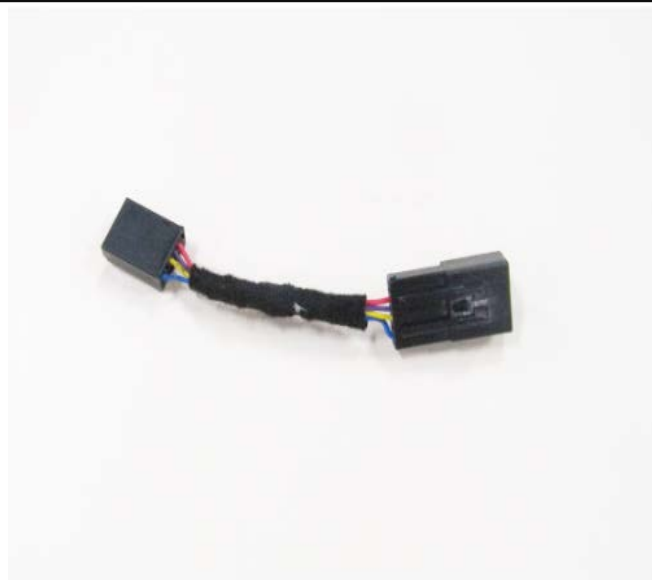
5386336

<b>Involved Region or Country</b>	North America, Europe, Russia, Middle East, Israel, South America, Japan, South Korea, China, Thailand, Australia, New Zealand, Africa
<b>Condition</b>	Some customers may comment on seeing an intermittent Shift to Park message when the vehicle has been shifted into Park, and the ignition has been turned to the Off position.
<b>Cause</b>	The cause of the condition may be that the park switch in the transmission control (shifter) assembly is not pulling the BCM signal low to electronically show that the vehicle is in the Park position.

Verify the condition and following the steps in the Service Procedure below, install an In-line Shifter Wire Harness Jumper between the shifter base connector and the console harness connector.

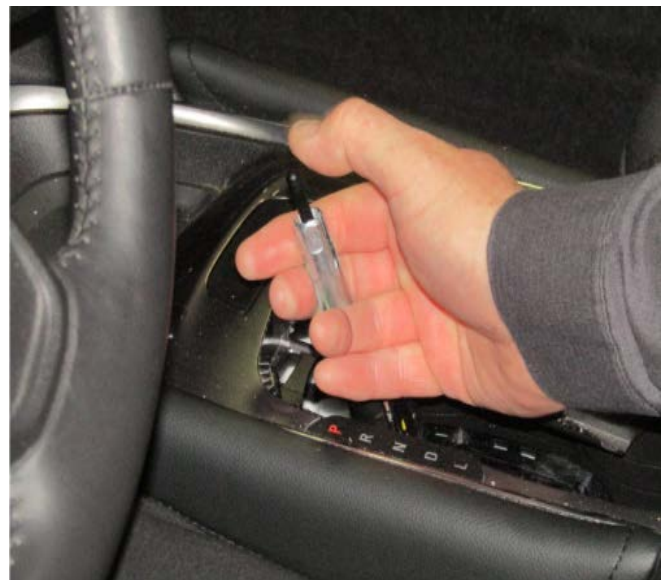
5386341

**Important:** Cleaning the Park Switch electrical contacts is a very critical part of the repair procedure. Ensure these steps are not overlooked.

3. Clean the Park Switch electrical contacts by doing the following steps:

- 3.1. Depress the actuation rod fully with your thumb or a trim stick.
- 3.2. Release the actuation rod by sliding your thumb or the trim stick off the rod, allowing the rod to "snap" back to the full up position.
- 3.3. Repeat 50 times.
4. Start the vehicle and verify that the Shift to Park message is NOT displayed:
  - If the Shift to Park message IS still displayed, stop here and replace the shift control assembly. Refer to the appropriate *Transmission Control Replacement* in SI.
  - If the Shift to Park message IS NOT displayed, proceed ahead to step # 5.
