Service Bulletin

Bulletin No.: 19-NA-211

Subject: Loss of Propulsion or No Start with Malfunction Indicator Lamp (MIL) Illuminated and DTC P0A45 or P1B04 Set

Brand:	Model:	Model Year:		VIN:		Engine:	Transmission:
		from	to	from	to		
Chevrolet	Malibu E2	2016	2018	—		1.8L — RPO LKN	5ET50 — RPO MKE
	Volt D2	2016	2018			1.5L — RPO L3A	5ET50 — RPO MKV

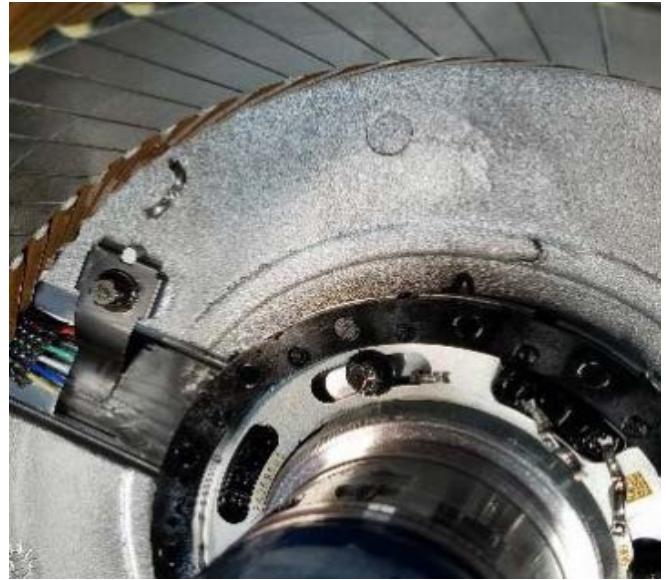
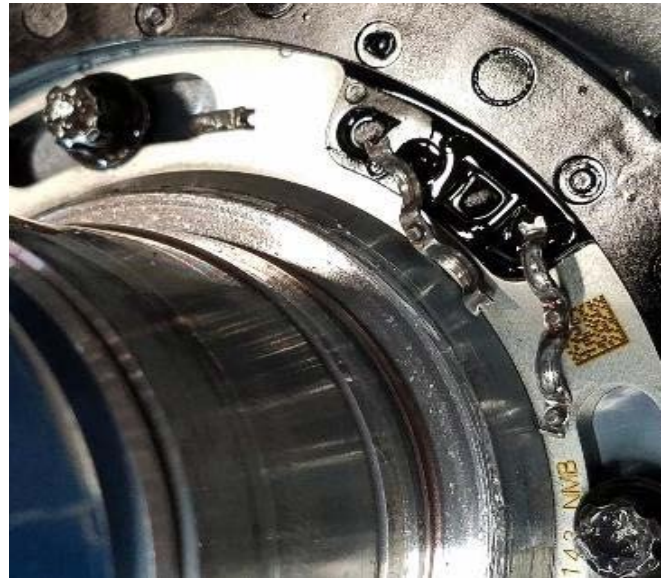
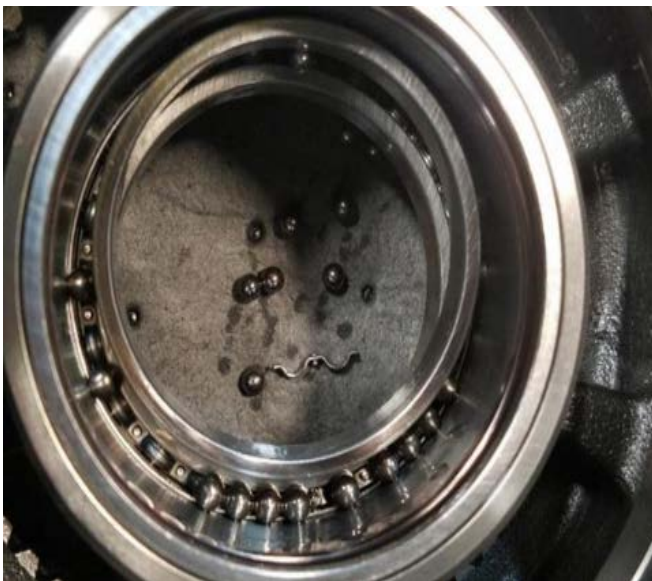
8. Inspect for Drive Motor 2nd Position rotor bearing cage failure/damage.
 - ⇒ If the Drive Motor 2nd Position Rotor Bearing has failed, locate and remove **all** of the pieces of the failed bearing throughout the entire transmission case. Any leftover debris can cause another loss of propulsion event by causing a short circuit in either of the motors. Refer to **Transmission Case Cleaning and Inspection** in SI.
Go to Step 9.
 - ⇒ If the Drive Motor 2nd Position Rotor Bearing has not failed, Go to Drive Motor Position Sensor Circuits in this Bulletin.

9. Replace the following components for the Drive Motor 2nd Position: Rotor, Stator, and Motor Position Sensor Stator. Refer to *Drive Motor Assemble - 2nd Position* in SI.
10. Install the Drive Motor 2nd Position. Refer to *Drive Motor Installation - 2nd Position* in SI.
11. Install the transmission. Refer to *Transmission Replacement* in SI.
12. Enable the high voltage system. Refer to *High Voltage Enabling* in SI.
13. Perform the Diagnostic Repair Verification. Refer to *Diagnostic Repair Verification* in SI.

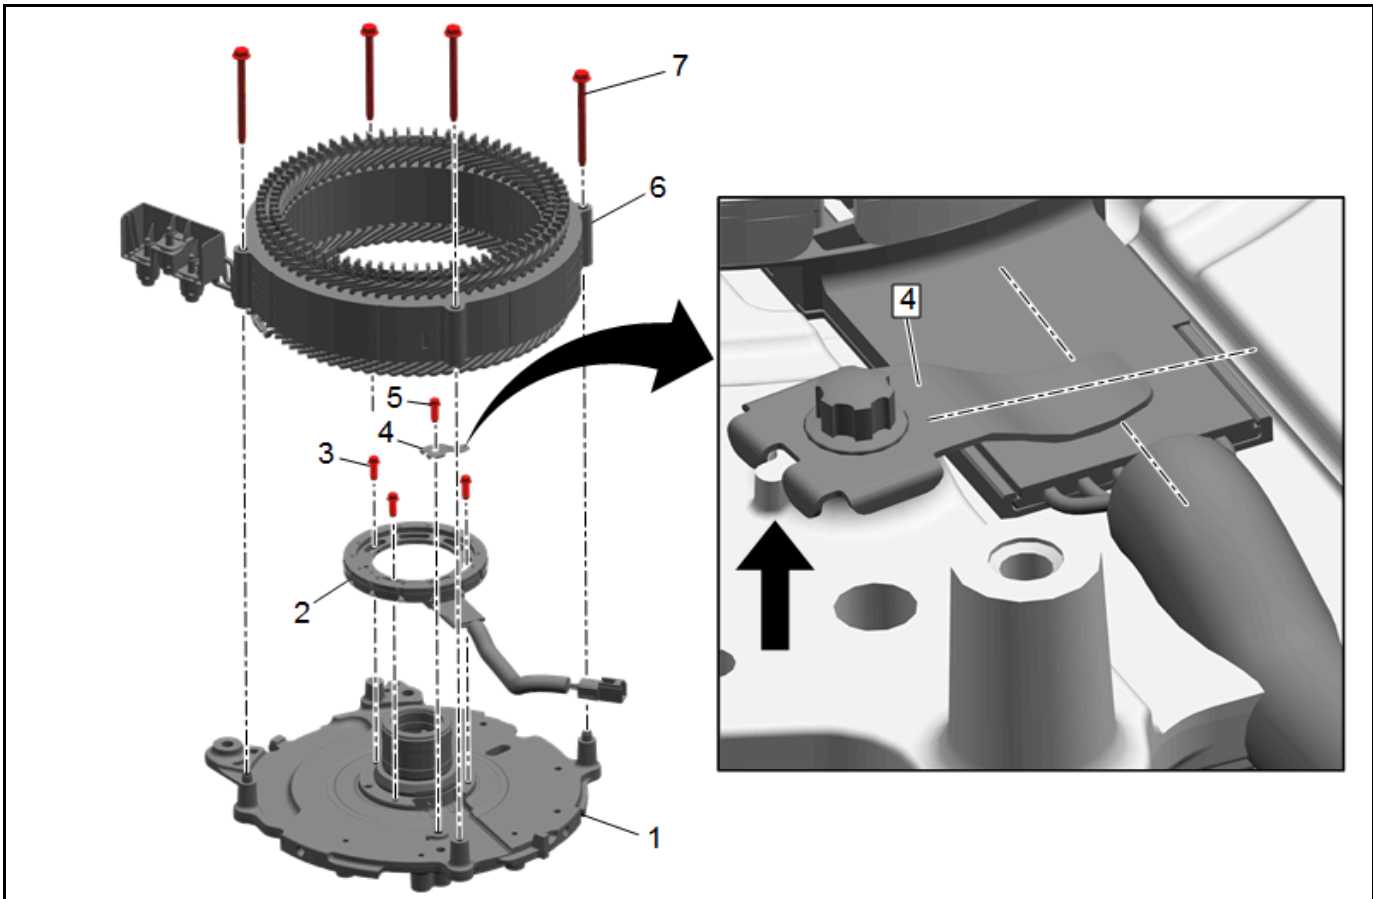
4051633

Important: When installing the new Drive Motor 2 Position Sensor, the black clip must be oriented 90 degrees to the sensor body as shown in the image above. Failure to do so could cause a DTC P0A46 Drive Motor 2 Position Sensor Performance to Set, with a loss of propulsion.

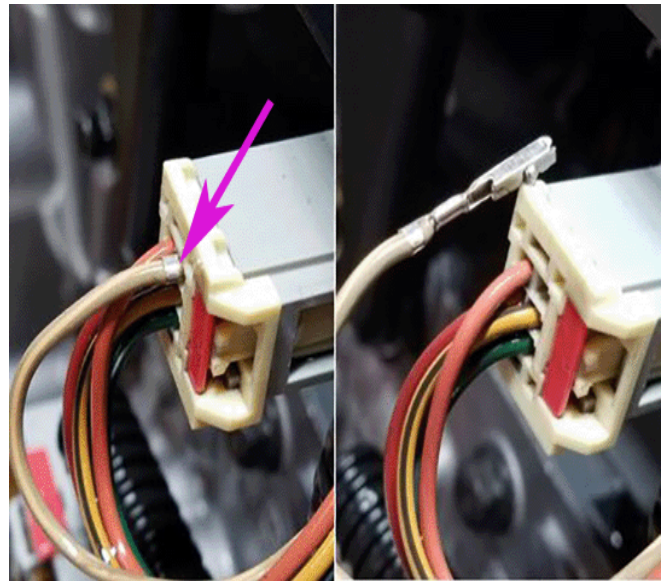
5051615

The motor control module monitors the angular position, speed and direction of the drive motor rotor based upon the signals of the resolver-type position sensor. The drive motor position sensor circuits operate at very low current. These circuits are susceptible to moisture intrusion, backed out terminal(s) (shown), poor terminal connections or damage, poor crimps and corrosion. The harness **cannot be repaired** for any of these conditions, it **must be replaced**.

1. Verify the date code on the replacement harness is **after** 04/07/2018 **prior** to installation.
2. Replace the transmission wiring harness with Part Number 24285318 HARNESS, A/TRNS WRG SHF POSN SWITCH. Refer to **Automatic Transmission Wiring Harness Replacement** in SI.
3. Perform the Diagnostic Repair Verification. Refer to **Diagnostic Repair Verification** in SI.
