Service Bulletin

Bulletin No.: 17-NA-114

Subject: Oil Leak from Turbocharger Inlet or Outlet Duct

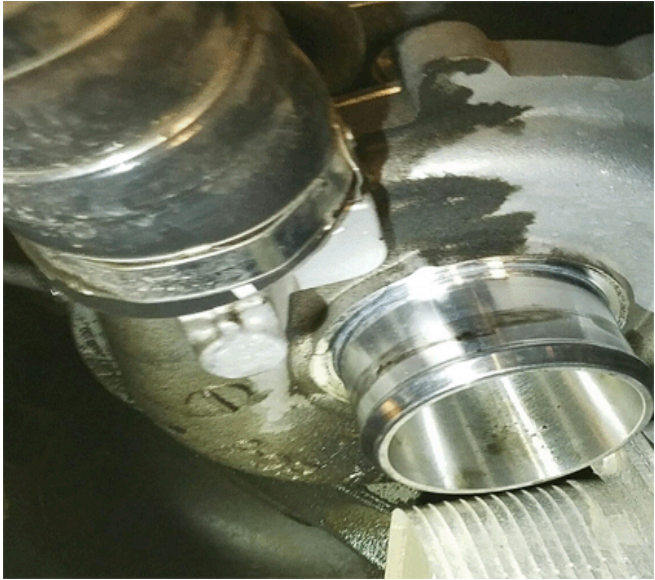
4754826

<p style="text-align: right;">4754827</p> <p>Some customers may comment on an oil leak originating from either the inlet or outlet duct of the turbocharger.</p>
Cause	This may be due to the charge air cooler pipe clamp not being tightened properly.
Correction	If you encounter a vehicle with the above concern, do not replace the turbocharger for this condition, instead tighten the charge air cooler pipe clamp.

Refer to *Charge Air Cooler Inlet/Outlet Duct Replacement* in SI for the procedure to gain access to the clamps needed to be tightened.
