Service Bulletin

Bulletin No.: 17-NA-166

Date: September, 2019

Subject: Rough Idle in Drive

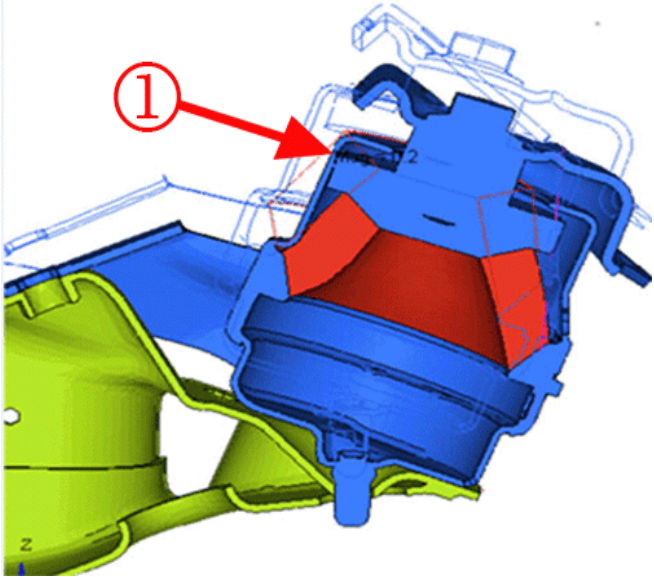
<p style="text-align: right;">4787059</p> <p>This concern may be caused by ground out (1) within one or both engine mounts.</p>
<p>Correction</p>	<p>Important: Familiarize yourself with this entire bulletin before proceeding to ensure you are diagnosing and focusing on the correct issue by frequency measured with Pico scope.</p> <p>Perform PICO analysis, refer to the Service Procedure section below.</p> <p>⇒ If the rough idle / vibration concern frequency is E1.5 in the horizontal / lateral direction with Pico sensor mounted in seat track as indicated below – continue with steps to install updated design engine mounts and settle both engine and trans mounts to reduce amplitude (mg) / eliminate ground out within the engine mounts for vehicles built prior to engine mount breakpoint. For vehicles built after breakpoint, follow Shimming Procedure for Engine Mount Vibration/Grounding after Mount Replacement.</p> <p>Important: The updated engine mounts are designed to reduce internal ground out, primarily E1.5. These mounts along with engine and trans mount settling will typically reduce amplitude at the seat track to 2 mg or less.</p> <p>Note: The 6.2L engine has a characteristic E1 which can be felt and may be described as a lopey idle. V-8 engine firing frequency produces E4 which will typically be very low frequency at the seat track. Do not confuse 6.2L E1 characteristic (not caused by mount ground-out), with E1.5 normal idle characteristics being transmitted into the truck via ground-out through the engine mounts.</p>

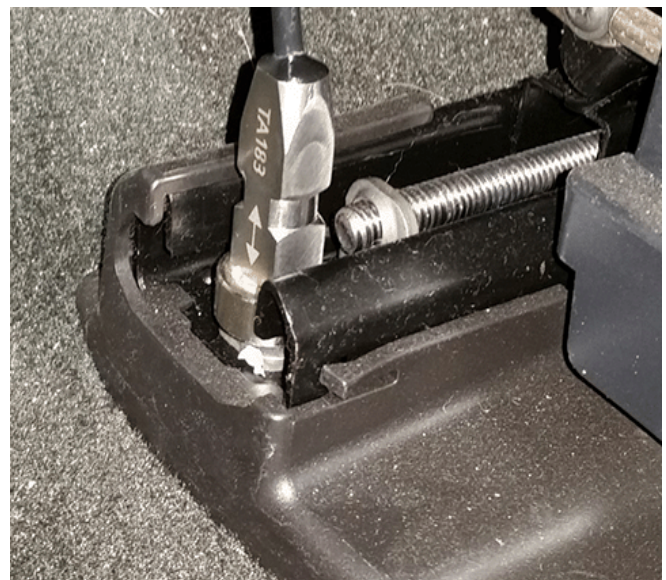
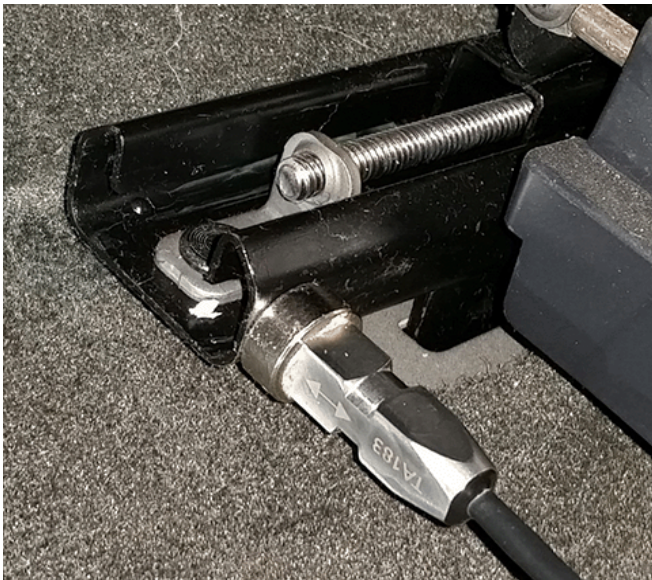
4532456

Measure the vibration disturbance using the vibration analyzer, CH-51450-A (Pico Oscilloscope), to qualify whether the issue frequency is E1.5 as opposed to E1 or E4.

Note: If using a single-axis pico sensor, mount and test both vertically and horizontally – E1.5 rough idle vibration will usually be horizontal / lateral at the seat track.

(TA183 single axis pico sensor shown / TA143 is tri-axis sensor)

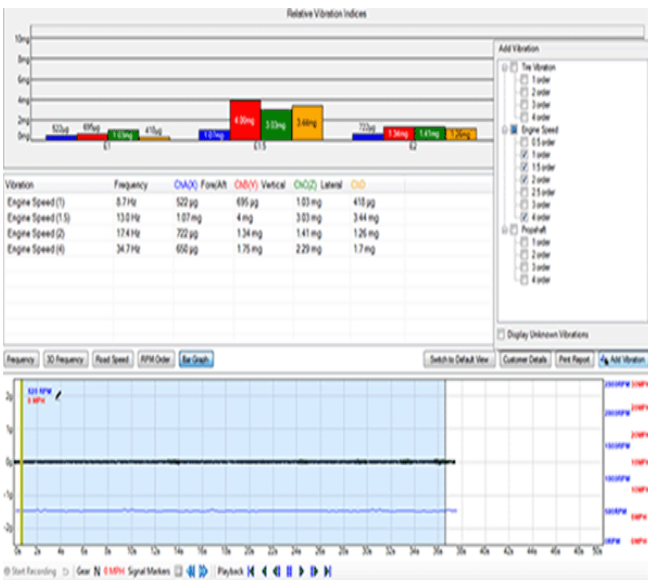
4534309

Add E1.5 to the displayed data and turn Off T and P related data (under Add Vibration in Pico) since issue occurs with vehicle stationary.

Note: Amplitude (mg) readings from a single-axis pico sensor will be approximately 10% lower than with a tri-axis sensor. For example, a reading of 4 mg using a tri-axis sensor, would likely measure as about 3.6 mg on a single-axis sensor.
