# Service Bulletin

Bulletin No.: 18-NA-186

**Subject: Loss of Propulsion or No Start with Malfunction Indicator Lamp Illuminated DTC P0A3F or P1B03 Set**

Brand:	Model:	Model Year:		VIN:		Engine:	Transmission:
		from	to	from	to		
Chevrolet	Malibu E2	2016	2018	—		1.8L — RPO LKN	5ET50 — RPO MKE
	Volt D2	2016	2018			1.5L — RPO L3A	5ET50 — RPO MKV

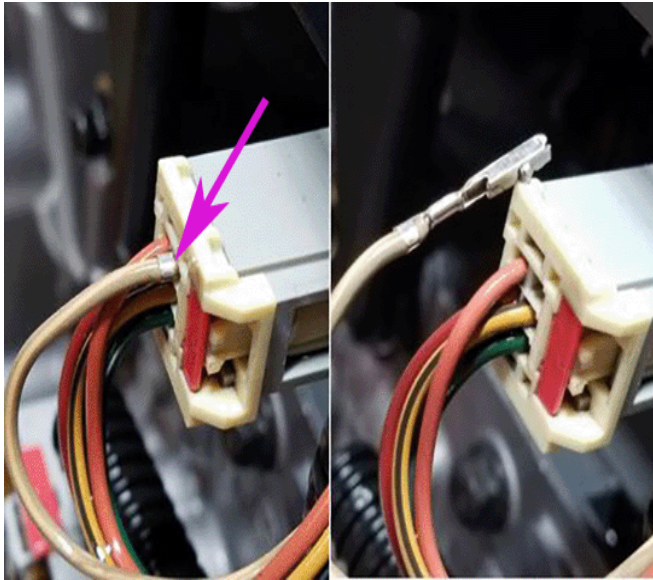
5051615

The motor control module monitors the angular position, speed and direction of the drive motor rotor based upon the signals of the resolver-type position sensor. The drive motor position sensor circuits operate at very low current. These circuits are susceptible to moisture intrusion, backed out terminal(s) (shown), poor terminal connections or damage, poor crimps and corrosion. The harness **cannot be repaired** for any of these conditions, it **must be replaced**
