Service Bulletin

Bulletin No.: 19-NA-215

Subject: Service Engine Soon (SES) Lamp Illuminated, DTC U1345 Set.

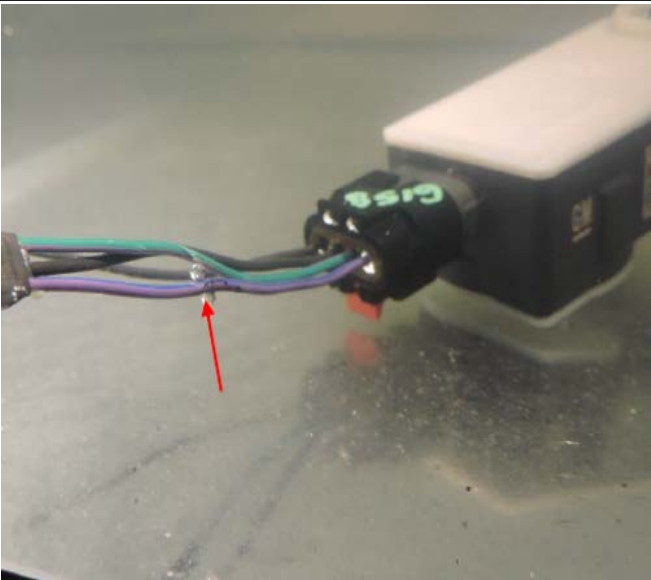
5405347

Involved Region or Country	North America, N.A. Export Regions
Additional Options (RPOs)	
Condition	Some customers may comment on the Service Engine Soon (SES) lamp illuminated. Technician may find DTC U1345 – Engine Control Module LIN Bus 1 (or Bus 21), set.
Cause	The cause of the condition may be water intrusion at the upper or lower connectors of the Active Grille Air Shutter.

<p>5405349</p> <p>Note: Examples of harness damage are shown in the graphics above.</p> <p>Inspect the Active Grille Air Shutter harnesses for cuts or nicks near the connectors.</p> <ul style="list-style-type: none"> • If NO damage is evident, refer to further diagnostics, in SI. • If damage is evident, replace the forward lamp wiring harness connector with the connector kit listed in the Parts table below. Refer to <i>Connector Repairs</i>, in SI.
