# Service Bulletin

Bulletin No.: 19-NA-216

**Subject:** Noise, Vibration, and/or Harshness Issues/Clunk Noise Heard During Coast Down Event

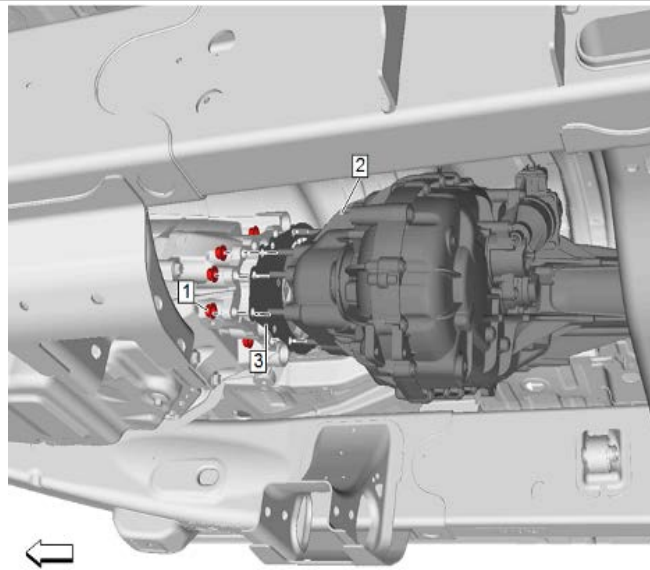
5411622

- If the noise is NOT from the transfer case (2), refer to SI for further diagnostics.
- If the noise has been verified to be from the transfer case, refer to the Service Procedure below.

Perform road test:

1. Drive vehicle up to 40 mph (64 km/h) on a smooth, flat road.
2. Allow vehicle to decelerate by coasting in drive to below 10 mph (16 km/h) (do not use the brakes).
3. Listen and feel for bumps or clunks from the underbody.

⇒ Repeat steps 1-3 at least 8 times.
