# Service Bulletin

Bulletin No.: 19-NA-222

**Subject:** Upper B-Pillar Rattle Noise

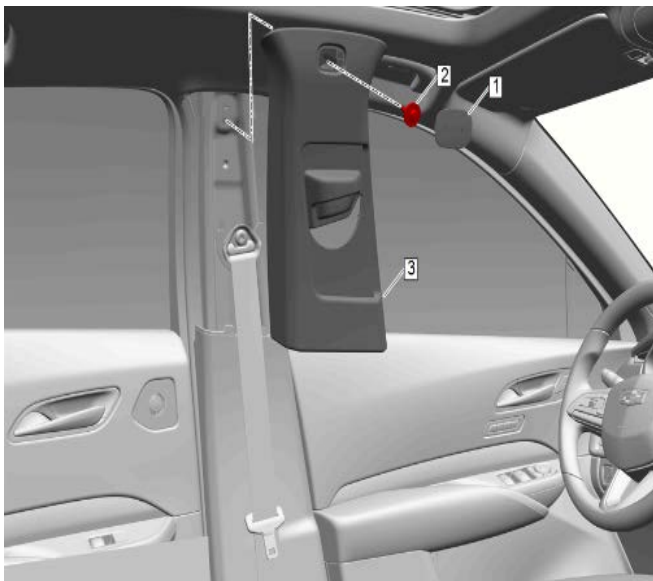
5411087

<b>Involved Region or Country</b>	North America, Middle East, Palestine, Europe, Russia
<b>Condition</b>	Some customers may comment on hearing a slight B-Pillar rattle noise on the driver and/or passenger side of the vehicle.
<b>Cause</b>	The cause of the condition may be an unintended design variance which may allow too much clearance between the center pillar upper trim panel and the seatbelt retractor D-ring and belt.
<b>Correction</b>	Verify if one, or both, B-Pillar(s) are affected and follow the steps in the Service Procedure below to eliminate the condition.

1. Remove the center pillar upper trim panel (3) on the affected side. Refer to *Center Pillar Upper Trim Panel Replacement* in SI.

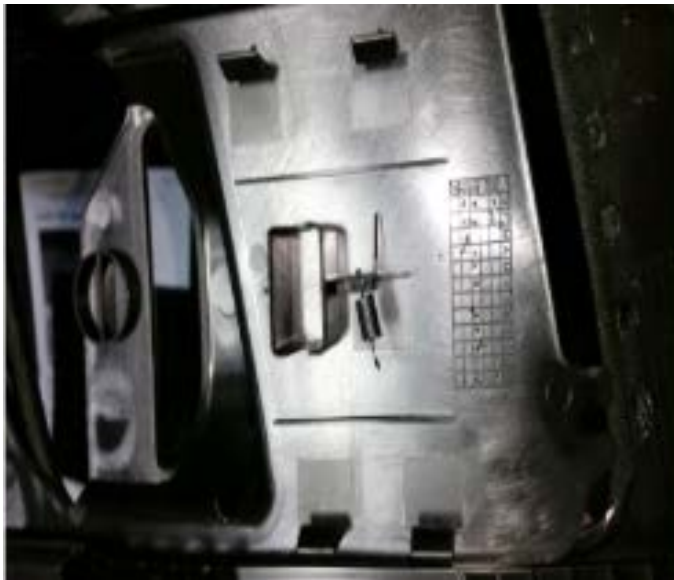
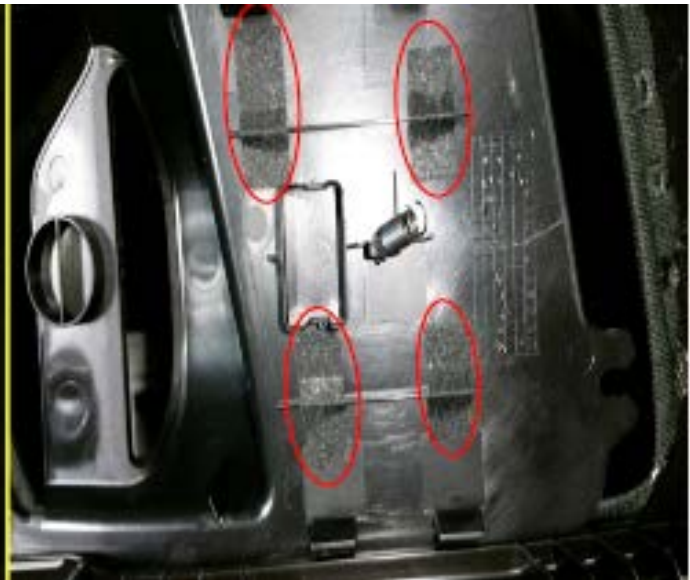
5411089

**Note:** The trim panel may need more than one tape piece applied per location. Use your best judgement as to what final thickness of tape will help alleviate the clearance issue.

2. Once the panel is removed, add Kent Automotive BRS Tape P/N KT13486, or equivalent, to the four areas shown in the graphic above.
