Service Bulletin

Bulletin No.: 19-NA-225

Subject: Stalling, ESC Disabled Message/ESC Light/Traction Control Light Displayed on Driver Information Center (DIC), Malfunction Indicator Lamp (MIL) Illuminated - DTC C0035, C0040, C0045, C0055 and/or C0511 Set

Brand:	Model:	Model Year:		VIN:		Engine:	Transmission:
		from	to	from	to		
Chevrolet	Malibu	2019	2020			1.5L (LFV)	CVT250 Automatic (MRG)

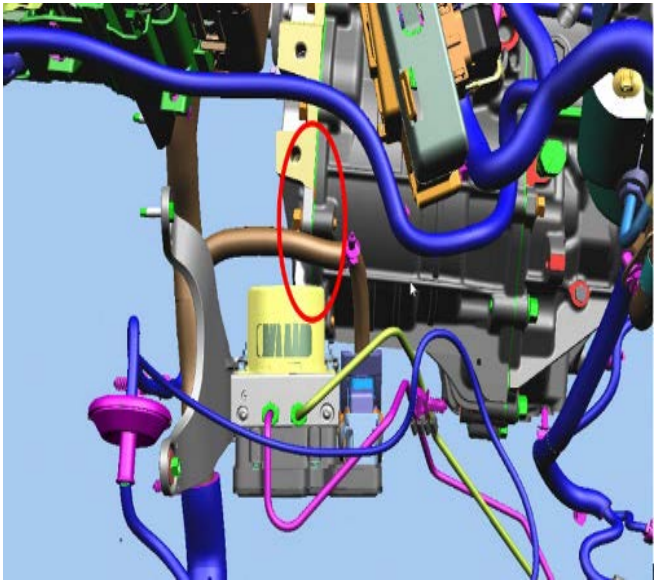
<p>Cause</p>

<p style="text-align: right;">5412559</p> <p>This condition may be caused by the engine harness chaffing against the top front of the transmission, below the electronic brake control module (EBCM).</p>
<p>Correction</p>	<p>If the above condition has been validated, inspection of the engine wiring harness must be done.</p> <ol style="list-style-type: none"> 1. With a suitable light, inspect the wiring harness point of contact at the transmission. <p>⇒ Refer to <i>Wire to Wire Repair</i> in SI.</p> <ol style="list-style-type: none"> 2. Using Woven Polyester Electrical Tape (PET), tape all the contact points of the harness ensuring that the tape is applied in a double layer. 3. Reposition the harness away from the transmission housing.
