Subject: Engineering Information – Oil Leaking From Oil Pan

Brand:	Model:	Model Year:		VIN:		Engine:	Transmission:
		from	to	from	to		
Chevrolet	Silverado 1500 (New Model)	2019	2019	-	-	Equipped with 2.7L Engine (RPO L3B)	-
	Silverado 1500	2020	2020				
GMC	Sierra 1500 (New Model)	2019	2019				
	Sierra 1500	2020	2020

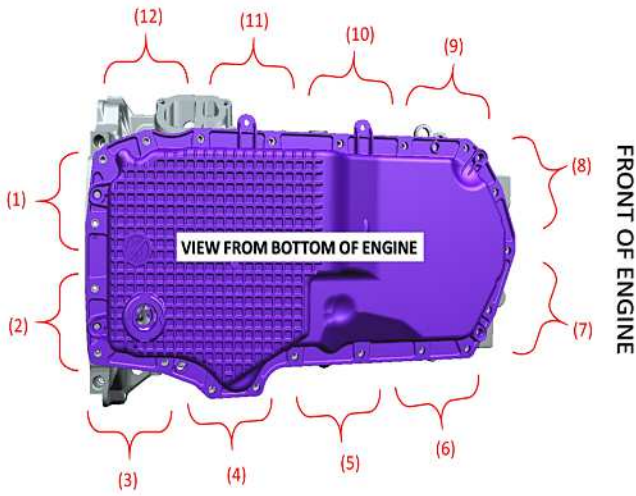
1. Visually inspect oil pan to identify traces of residual oil collection, and trace the leak path to the highest point (check if this is the oil pan to LCE joint).
2. If leak seems to be from oil pan to LCE joint, wipe excess oil and add engine dye.
3. Put additional miles on vehicle, and re-inspect with a black light to confirm that source of leak is in fact the oil pan to LCE joint.
4. If dye is detected, take clear snapshots of leak location / path at the oil pan to LCE joint.

5. Make an assessment on which leak “zone” 1–12, as shown in the picture above, that the oil is originating from.
