Title	Under Review AMT-F Oil In Control Housing Or TECU-- Need specifics on the cleaner. Need to add "bench test before reinstallation"
-------	---

**** SOLUTION ******Cause**

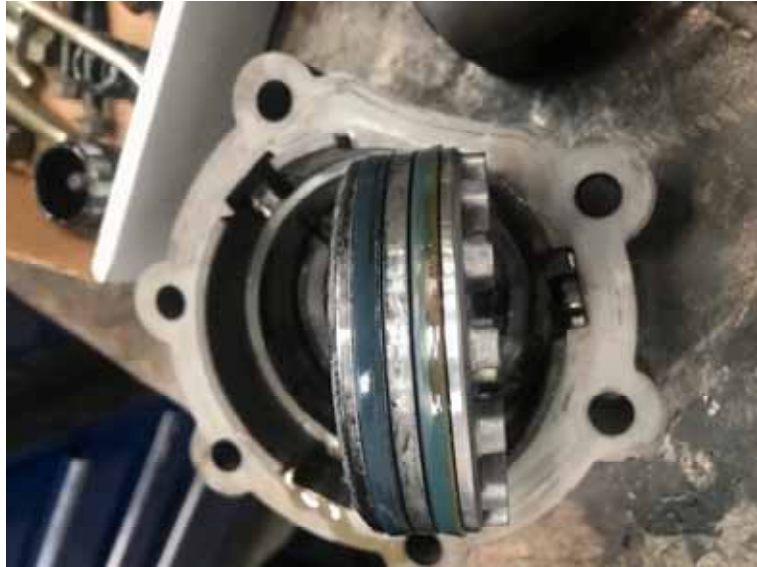
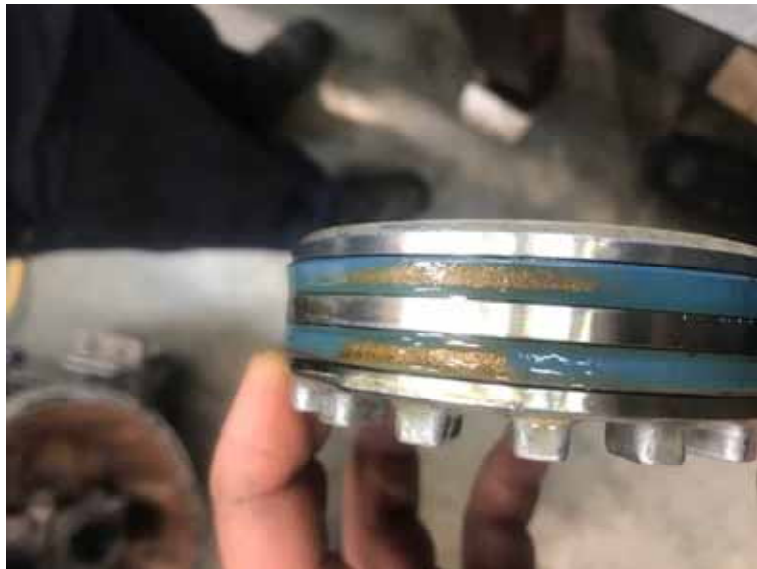
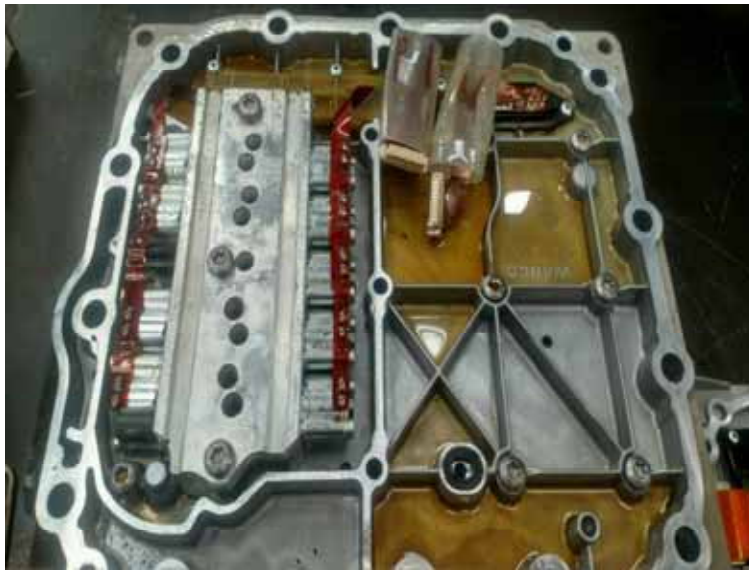
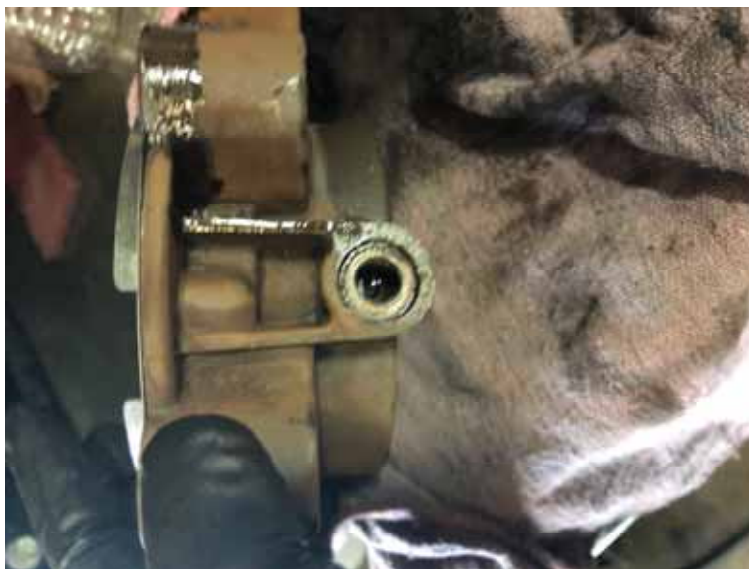
In several instances there has been oil found in the control housing of the transmission during fault investigations. The oil may or may not be a cause of the customer complaint. There may also be excessive oil residue or leakage from the vents on the left side of the gearbox.

Clean the oil from the inside of the control housing and from the TECU with a circuit board cleaning spray and blow it dry with compressed air. Unplug the connectors from the circuit board and clean the oil from inside the connections and blow dry. Clean all the air passages for the countershaft brake and reassemble the unit.
