Title	Diagnostic Trouble Code (DTC) P215A-64, Fault Code SPN 84 FMI 19; Speedometer Drop-Out, Speedometer Inoperative
-------	-----------------------------------------------------------------------------------------------------------------

Mack Models

Volvo Models

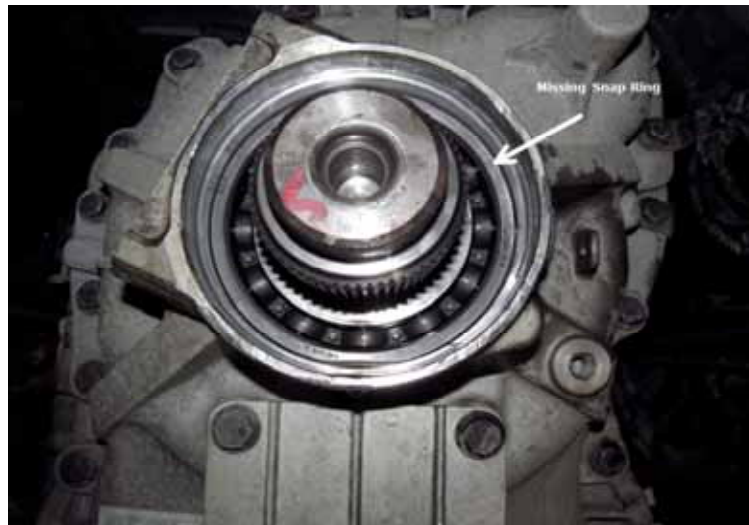
Vehicles may experience an inoperative speedometer, or a speedometer that jumps or drops out. It has been determined that this condition may be caused by a missing or dislodged output shaft bearing snap ring, which results in a damaged transmission speed sensor.

You need to remove the companion flange and inspect for a missing or dislodged output shaft bearing snap ring. If the snap ring is missing there are 4 different thickness snap rings available. You will need to get them all and use trial and error method to find the one that fits the tightest while fully seated. If the snap ring is still there but has come out of the groove you will need to reposition the shaft/bearing forward in the transmission, inspect for damage to the groove, if ok, re-install the snap ring and insure it is fully seated in the groove.

Follow instructions for R&R the output shaft seal, 4349-03-02-03 Sealing Ring, Rear Output Shaft, Replacement. Reposition the output shaft bearing forward in the auxiliary housing. If the snap ring is still there but has come out of the groove you will need to inspect for damage to the groove, if ok, re-install the snap ring and insure it is fully seated in the groove. If it is missing IMPACT shows 4 different thickness rings you will need to get. The correct thickness snap ring is the one that provides the tightest fit for the bearing.

- 1652802, THK 3.70
- 1652803, THK 3.80
- 1652804, THK 3.90
- 914556, THK 4.00

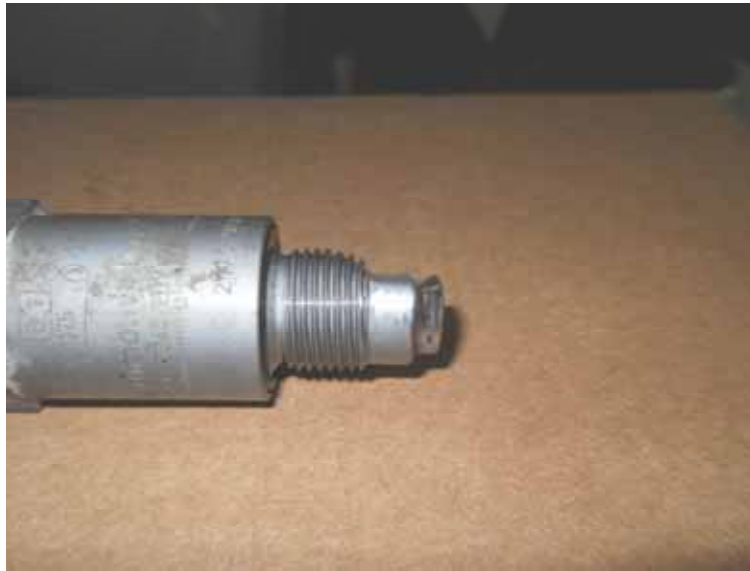
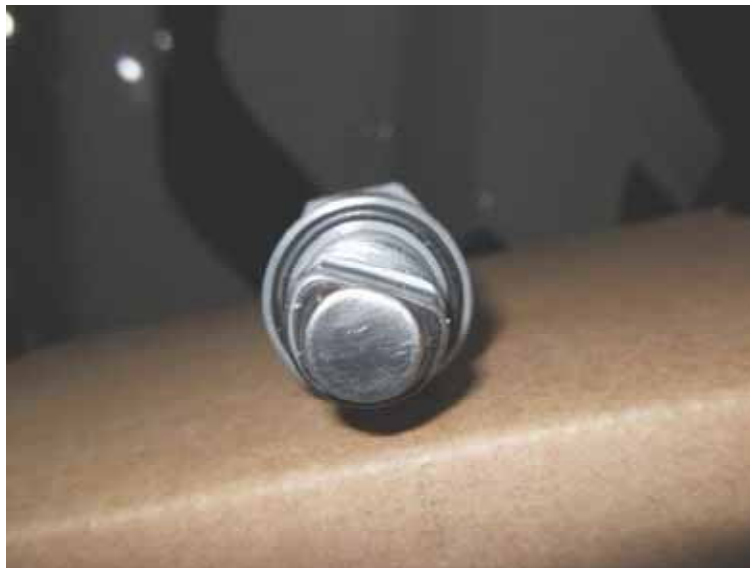
During replacement of the sensor for SPN 84 FMI 19, if the technician finds the sensor damaged in this manner (see below) the snap ring for the tail shaft bearing is missing or not seated. This repair can be done in the field.

- There are 4 different thickness snap rings:
 - 1652802, THK 3.70
 - 1652803, THK 3.80
 - 1652804, THK 3.90
 - 914556, THK 4.00

- Follow instructions for R&R the output shaft seal, 4349-03-02-03 Sealing Ring, Rear Output Shaft, Replacement.
- Reposition the tail shaft bearing forward in the auxiliary housing.
- To find the correct size snap ring start with the thickest and use the largest one that fully seats in the groove.

- Reassemble
