Solution K73241583

Title	Mack Chassis - Anthem (AN) Models - Headlight Diagnostics And Replacement; Instructions For Non-Functioning Headlight Or Turn Signal In Headlight Housing
-------	---

Mack Model	AN - Anthem
-------------------	-------------

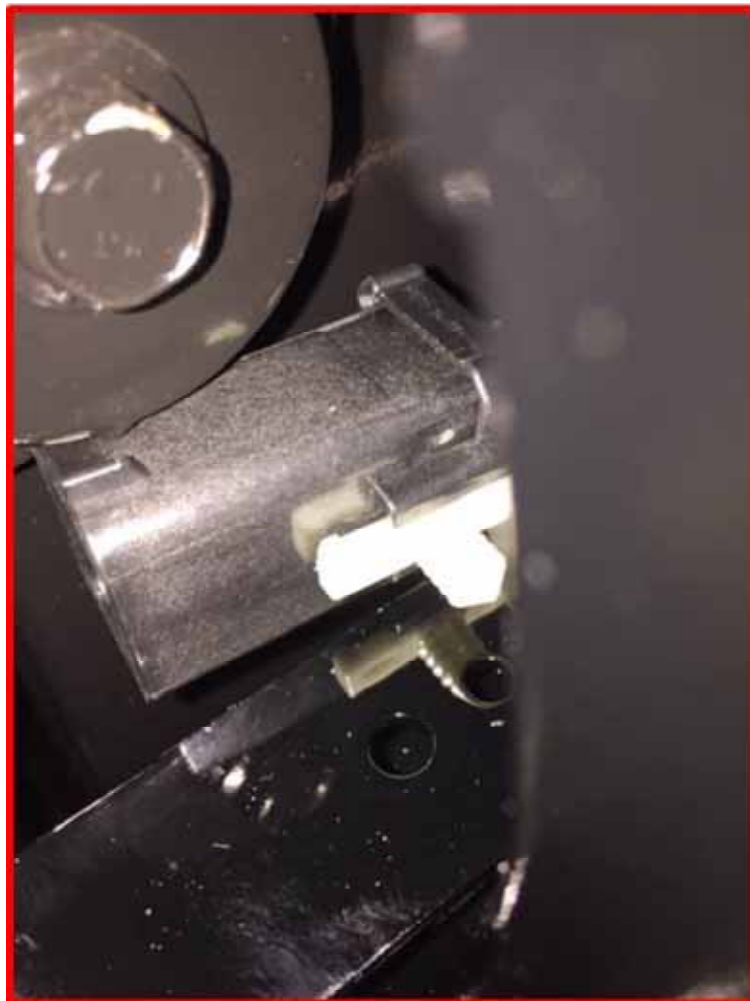
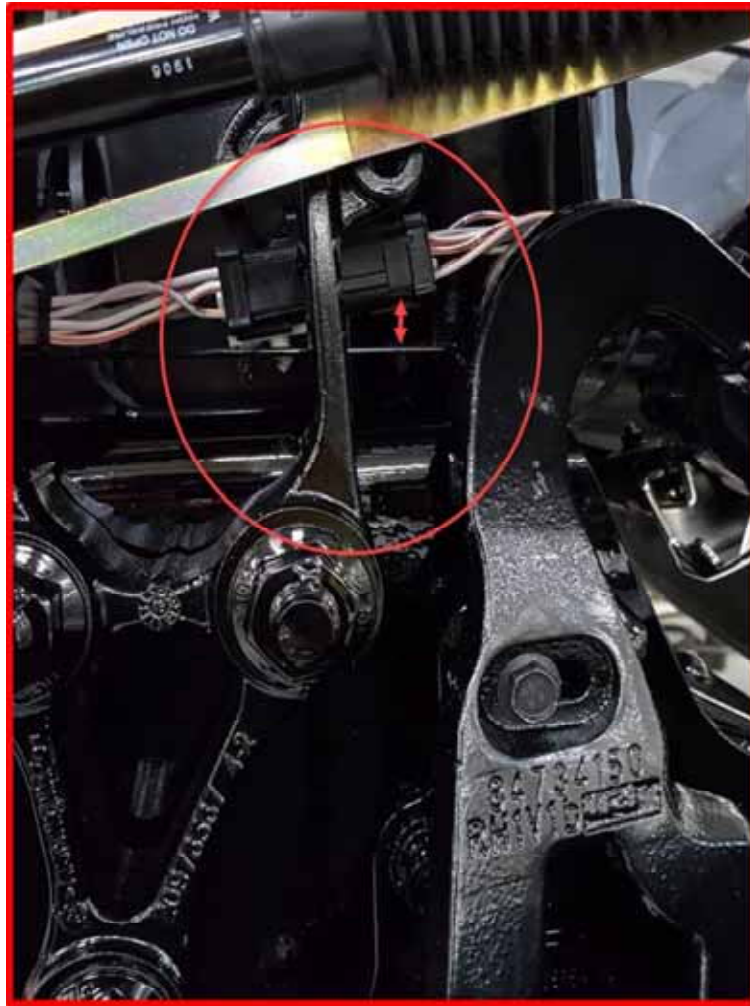
Check if the connectors shown below are aligned correctly and securely pushed into the bracket. Wiring fatigue may result in a headlight, marker light, or fog light not working due to an open or short circuit.

If the connectors are out of place:

1. Clip the harness securely to the hood bracket and the chassis bracket to pull harness away from the charge air cooler (CAC).
2. Use cable ties to secure the harness in the positions shown below.

If the wiring harness is found to be damaged: Repair the harness using pigtail(s) part number [23662347](#) (chassis side) and/or part number [23662349](#) (hood side).

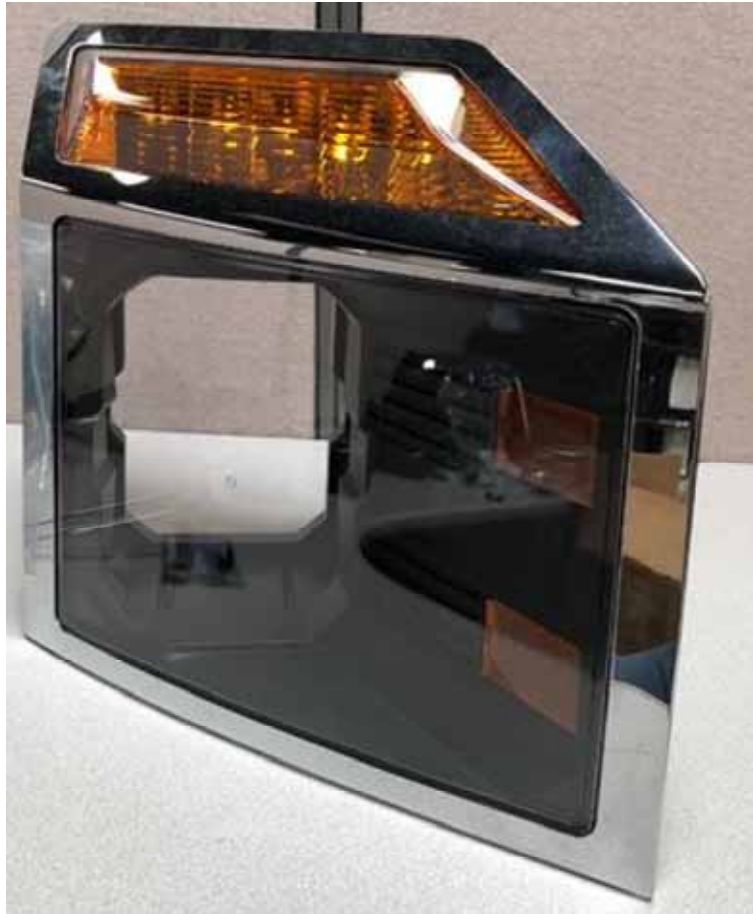
Amber/Turn Signal Not Working

If the amber/turn signal is not working the complete headlight housing will need to be replaced. The failure has been found to be the headlight housing itself. Due to the

housing/lens geometry, the turn signal can not be sold as a replacement part (unable to install after lens is glued to housing).

NOTE: The headlight module should NOT be replaced if the turn signal is not working.

Refer to [Impact](#) for the current headlight assembly part number.

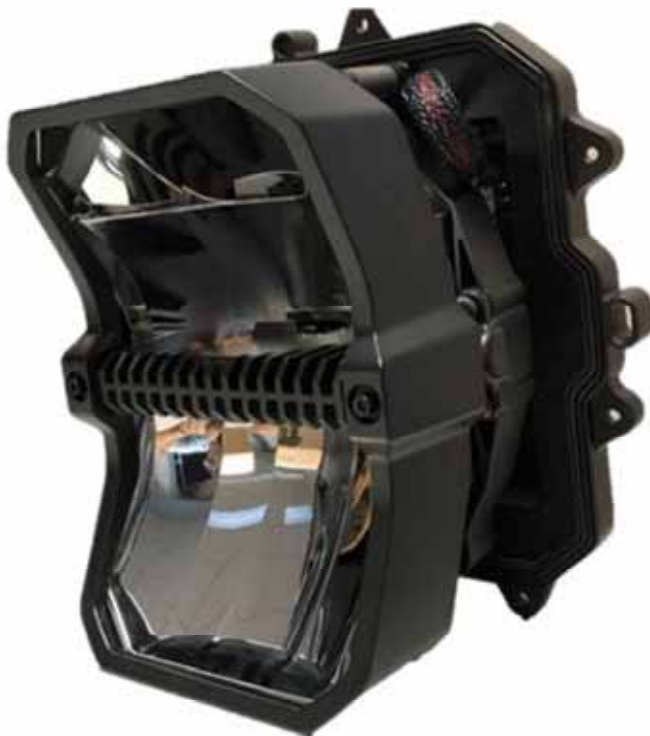
Headlight Not Working

If the headlight is not working, only the headlight module will need to be replaced. The headlight module is the only serviceable part for the Mack Anthem headlamp.

Part Number for the Headlight Module:

- Right and Left- [84735466](#)

For removal and installation instructions refer to [3521-03-02-01 Headlamp Assembly, Replacement](#) located in [Impact](#).
