Technical Service Bulletin

91 MIB2+: Software Update Instructions

91 19 01 2056558/1 October 16, 2019.

Model(s)	Year	VIN Range	Vehicle-Specific Equipment
A6, A7, A8, Q7, Q8, Q3, and Audi e-tron quattro	2019 - 2020	All	With MIB2+

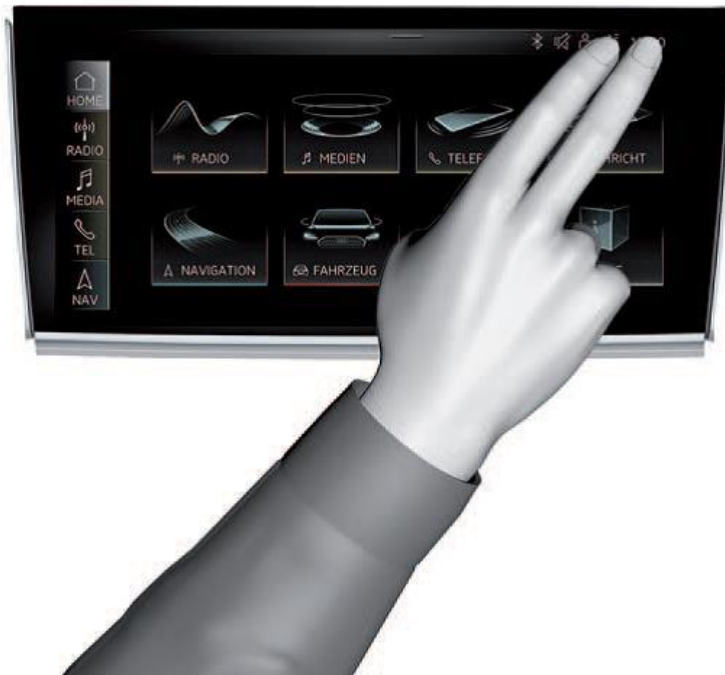
Figure 1. Gesture to enter the red engineering menu.

1. Enter the red engineering menu by touching the screen with two fingers in the top right corner (Figure 1).
