Technical Service Bulletin

92 Washer system sprays automatically and uses an excessive amount of fluid

92 19 22 2053997/2 October 9, 2019. Supersedes Technical Service Bulletin Group 92 number 19-18 dated February 26, 2019 for reasons listed below.

Model(s)	Year	VIN Range	Vehicle-Specific Equipment
A6, A7, A8, Q8, and Audi e-tron quattro	2019 - 2020	All	With laserscanner

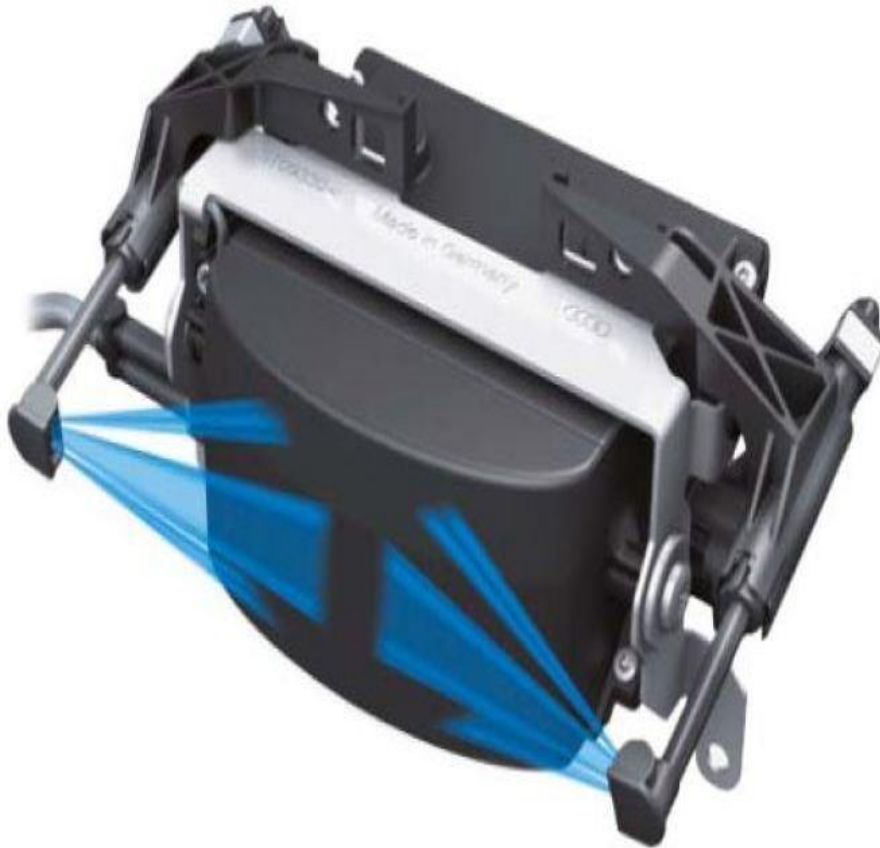
If the laserscanner recognizes dirt on its screen, a message is sent to the onboard supply control module, J519 (address word 0009). Then it instructs the windshield washer pump, J1100 to clean the laserscanner. The laserscanner is only cleaned while driving (Figure 1).

Figure 1. Laserscanner cleaning system.

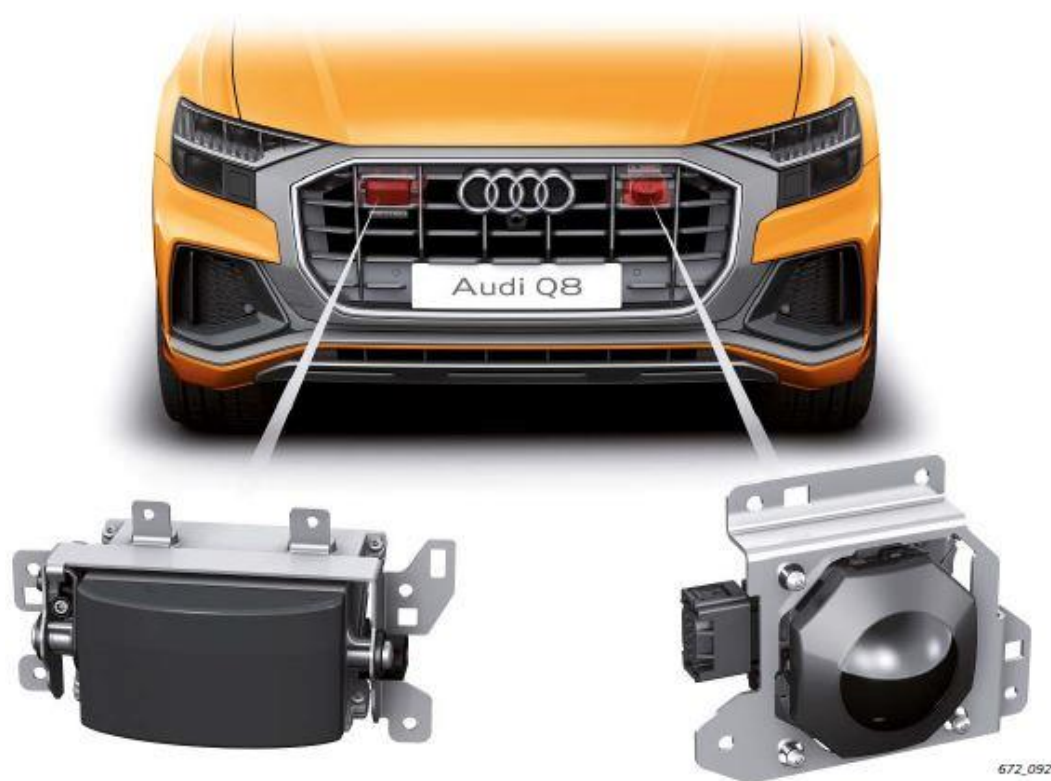
On the A6, A7, and Q8 vehicles the laser scanner is located in the right upper single frame area (Figure 2).

Figure 2. Laserscanner locations (A6, A7, and Q8).
