Technical Service Bulletin	Transaction No:	2015173/27
46-19-02 - Brake Disc, Vibration / Pulsation (U.S. Only)		Release date:	10/17/2019

When applying the brakes at highway speeds the following symptoms may occur:

- Brake Pedal pulsation
- Vibration felt in Vehicle Body
- Steering Wheel shakes

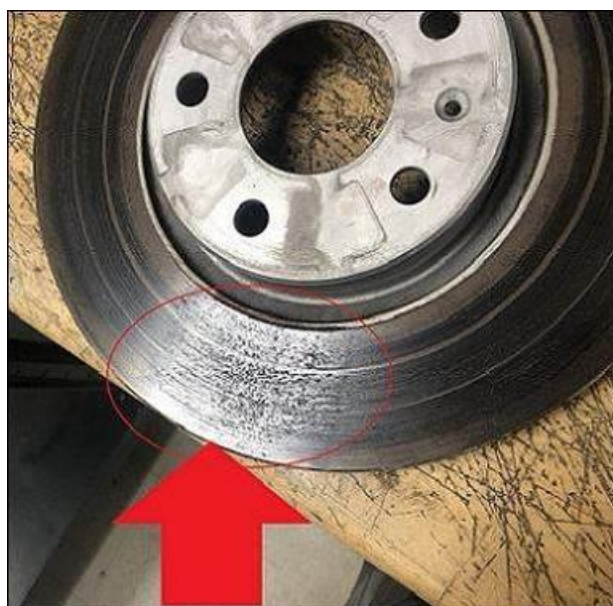
Please see the example pictures below of damage NOT covered under warranty.

Figure 1: Brake pad imprint.

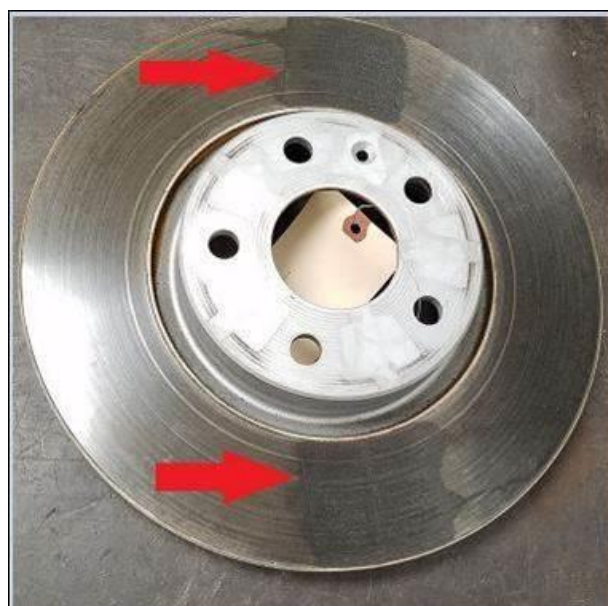
Figure 2: Brake pad imprint.

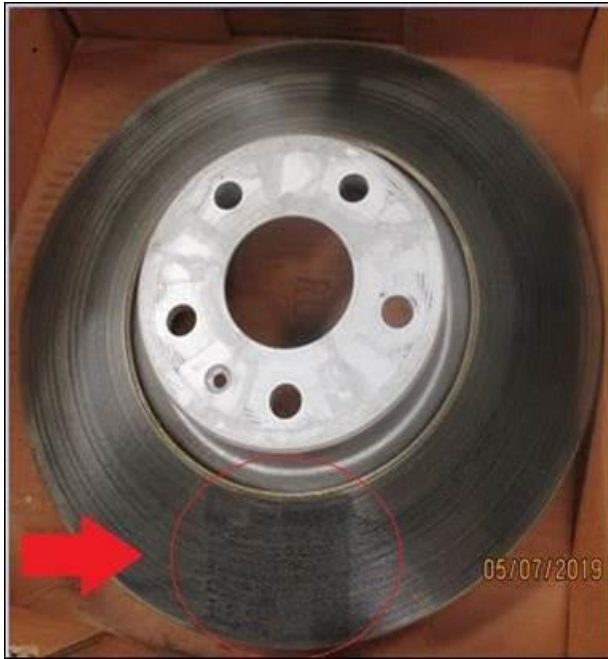
Figure 3: Brake pad imprint.

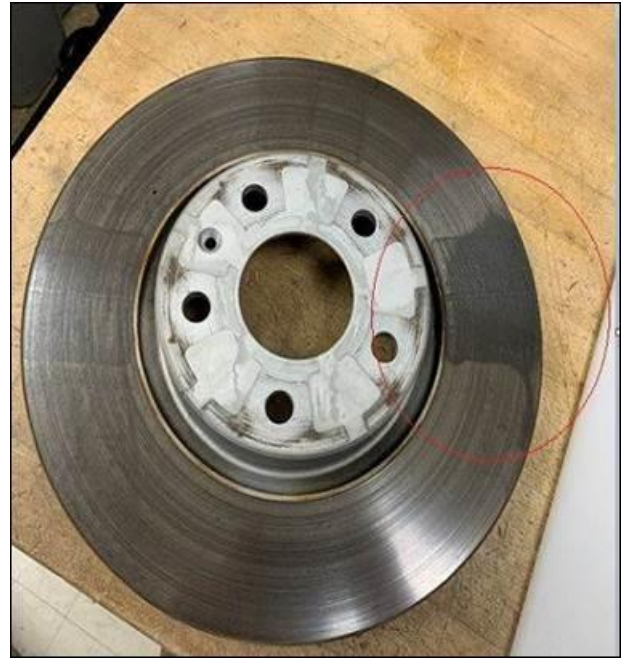
Figure 4: Brake pad imprint.

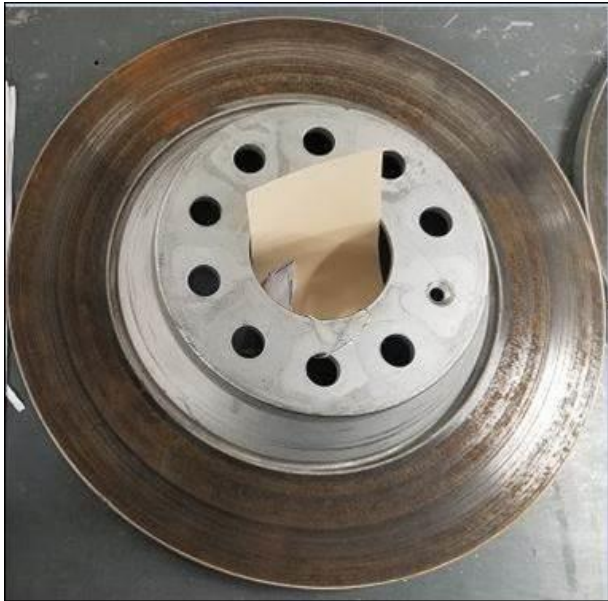
Figure 5: Corrosion.

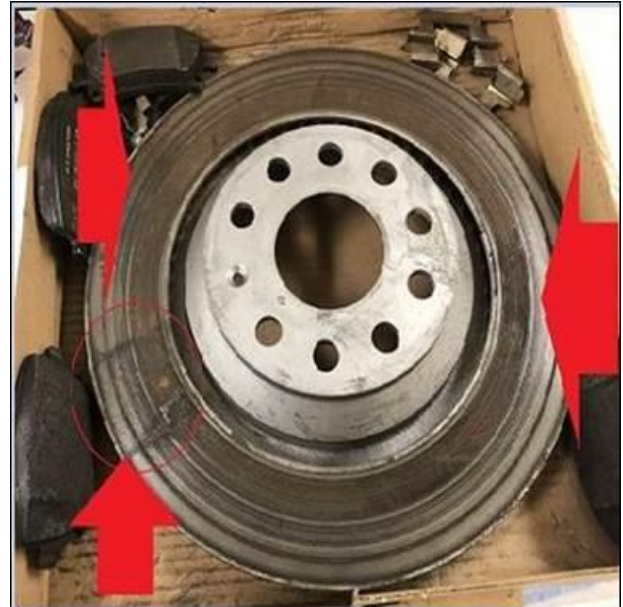
Figure 6: Corrosion, brake pad stuck to brake disc.

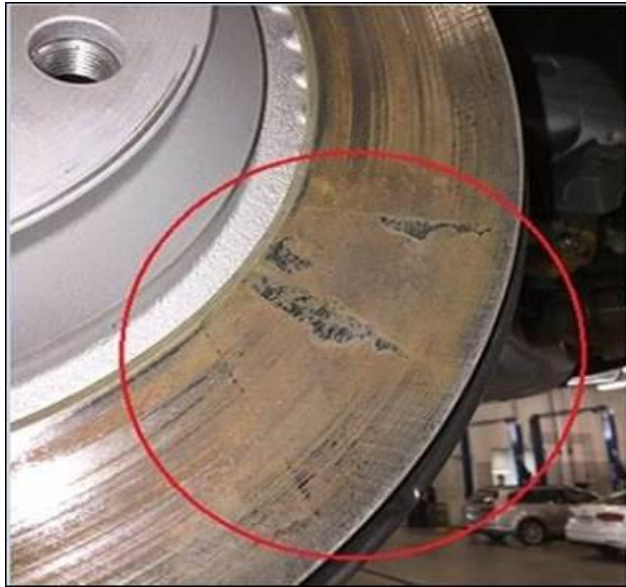
Figure 7: Corrosion, brake pad stuck to brake disc.

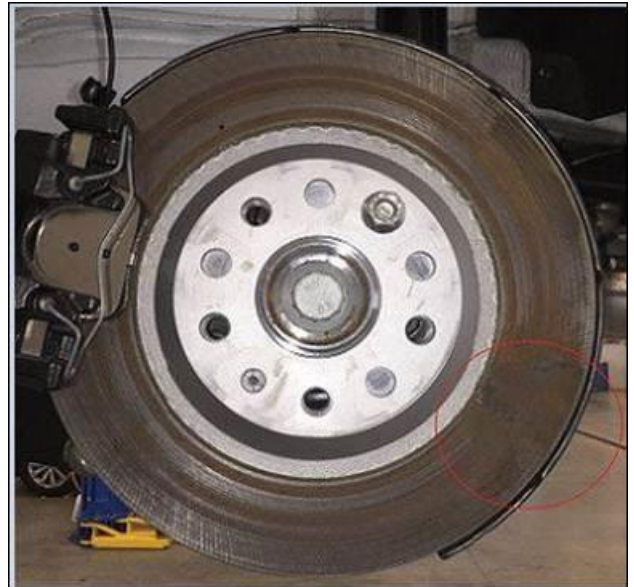
Figure 8: Corrosion, brake pad stuck to brake disc.

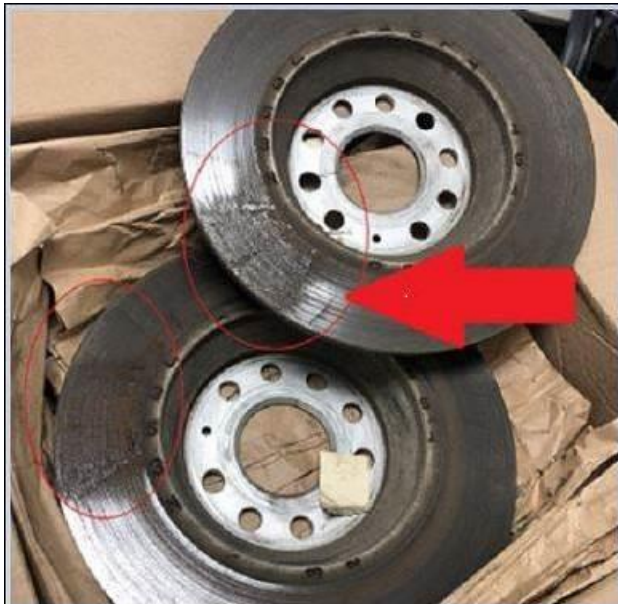
Figure 9: Brake Pad stuck to Brake Disc

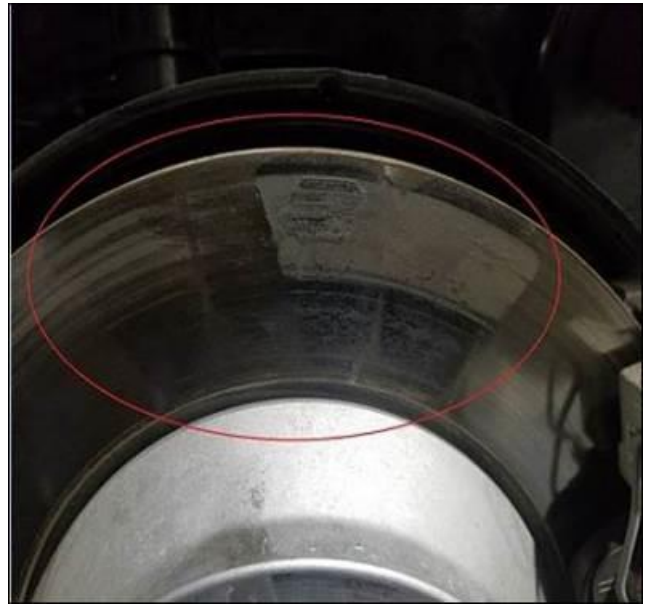
Figure 10: Brake Pad stuck to Brake Disc.

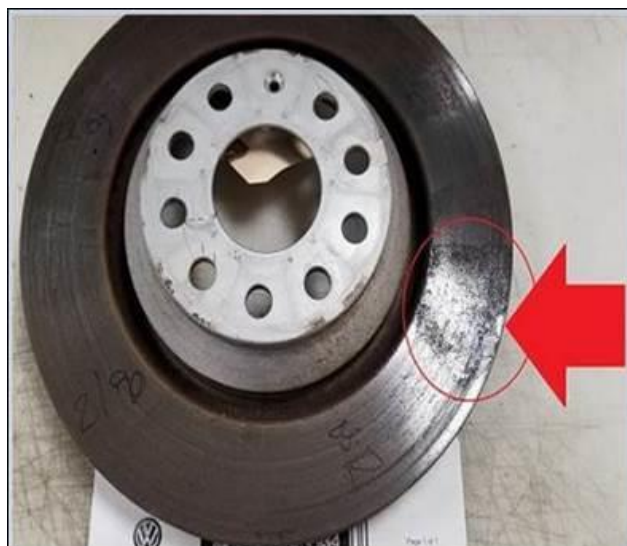
Figure 11: Brake pad imprint.
