# Service Action Code: 1903

**Coolant Bottle**

October 16, 2019

The coolant bottle may leak coolant into the electrical connector for the coolant level sensor.

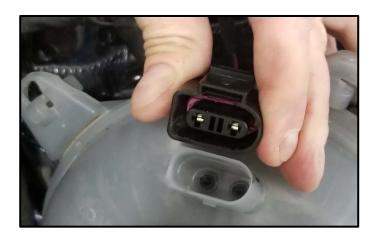
Check coolant bottle for coolant migration.

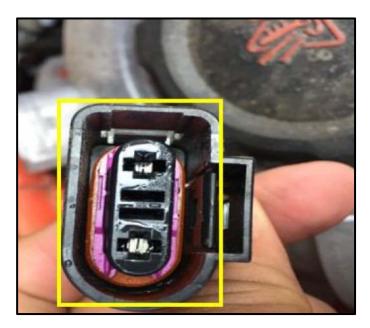
### Inspect coolant bottle connector:

- If corrosion is found on the connector pins:
  - o The connector pins must be replaced.
- If only liquid coolant is found at the connector pins:
  - The coolant bottle connector housing must be cleaned with a dry, lint free cloth.
  - The coolant bottle connector pins must be cleaned with compressed air.

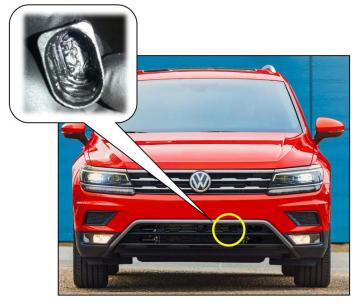
# <u>TIGUAN ONLY</u> - Inspect ambient temperature sensor for coolant migration:

- Connector and sensor will be inspected.
- If NO liquid coolant or corrosion is found:
  - o Reconnect connector to sensor.
- If corrosion is found on the connector or sensor pins:
  - Ambient temperature sensor must be replaced.
  - Corroded connector pins must be replaced.
- If only liquid coolant is found at the sensor, but there is NO corrosion:
  - Ambient temperature sensor connector and pins should be cleaned with a dry, lint free cloth.
  - Ambient temperature sensor connector and pins should also be cleaned with compressed air.

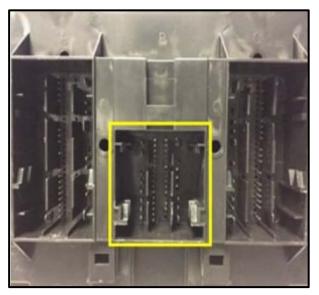
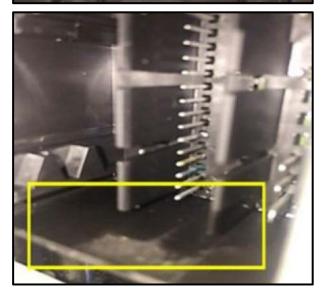
### Inspect -J519- for coolant migration:

- Connector T46b connector will be inspected.
- If NO liquid coolant or corrosion is found:
  - Reassemble vehicle in reverse order of removal.
  - o Proceed to Section E.
- If corrosion is found on the -J519- pins:
  - o -J519- must be replaced.
  - Corroded connector pins must be replaced.
- If only liquid coolant is found at the -J519-, but there is NO corrosion:
  - -J519- should be cleaned with a dry, lint free cloth.
  - The -J519- pins must be cleaned with compressed air.

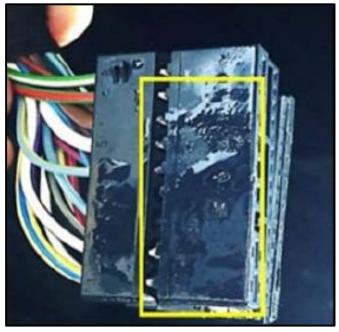
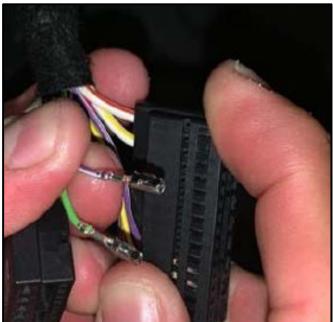
### **Check -J519- connector for coolant migration:**

- Separate the individual terminal housings and inspect for coolant migration or corrosion.
  - See Appendix A for detailed disassembly instructions for separating the individual pin terminal housings from the -J519- connector housing.
- If NO liquid coolant or corrosion is found:
  - Reassemble vehicle in reverse order of removal.
  - Proceed to Section E.
- If corrosion is found on the -J519- connector pins:
  - Corroded connector pins must be replaced.
- If only liquid coolant is found on the -J519-, but there is NO corrosion:
  - -J519- connector housing must be cleaned with a dry, lint free cloth.
  - The connector pins must be cleaned with compressed air.
- Once all necessary -J519- repairs have been performed, Proceed to Section E.
