October 15, 2019

Version 2

Engine Stalls In Reverse Shortly After Cold Start (On-Board Snapshot Required)

Supersedes 18-072, dated July 3, 2018. See Revision Summary.

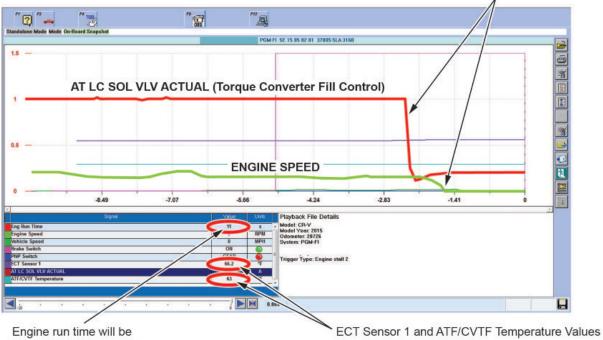
There is too much oil clearance between the input and stator shafts, which allows ATF to drain out of the torque converter during extend off periods. During a cold start, when the torque converter is refilled, air gets trapped in the torque converter. This applies the lock up clutch, which stalls the engine.

Engine stalls shortly after the torque converter fill control shuts off.

between 10-14 seconds.

should be almost the same.

- ECT Sensor 1 and ATF/CVTF Temperature should be almost the same and under 180°F.
- The transmission will be in gear.
- Eng Run Time should be between 10 and 14 seconds.
- Engine stall will happen right after the torque converter fill control shuts off.
- If your snapshot compares to the sample, send your snapshot to Tech Line using the RO number. Then, go to REPAIR PROCEDURE.
- If your snapshot does not compare, this service bulletin does not apply. Continue with normal system troubleshooting.

- 1. Replace the transmission. Refer to the service information.
- 2. Fill the transmission with Honda Genuine HCF-2 transmission fluid.
- 3. Do the Neutral Position Memorization procedure and the Steering Angle Sensor Neutral Position Clear procedure. Then, do a four wheel alignment on the vehicle.
