# FIELD SERVICE CAMPAIGN BULLETIN

Subject: **Field Service Campaign D19M1**  
**GHG17 Detroit™ DD16® Software Reprogramming**

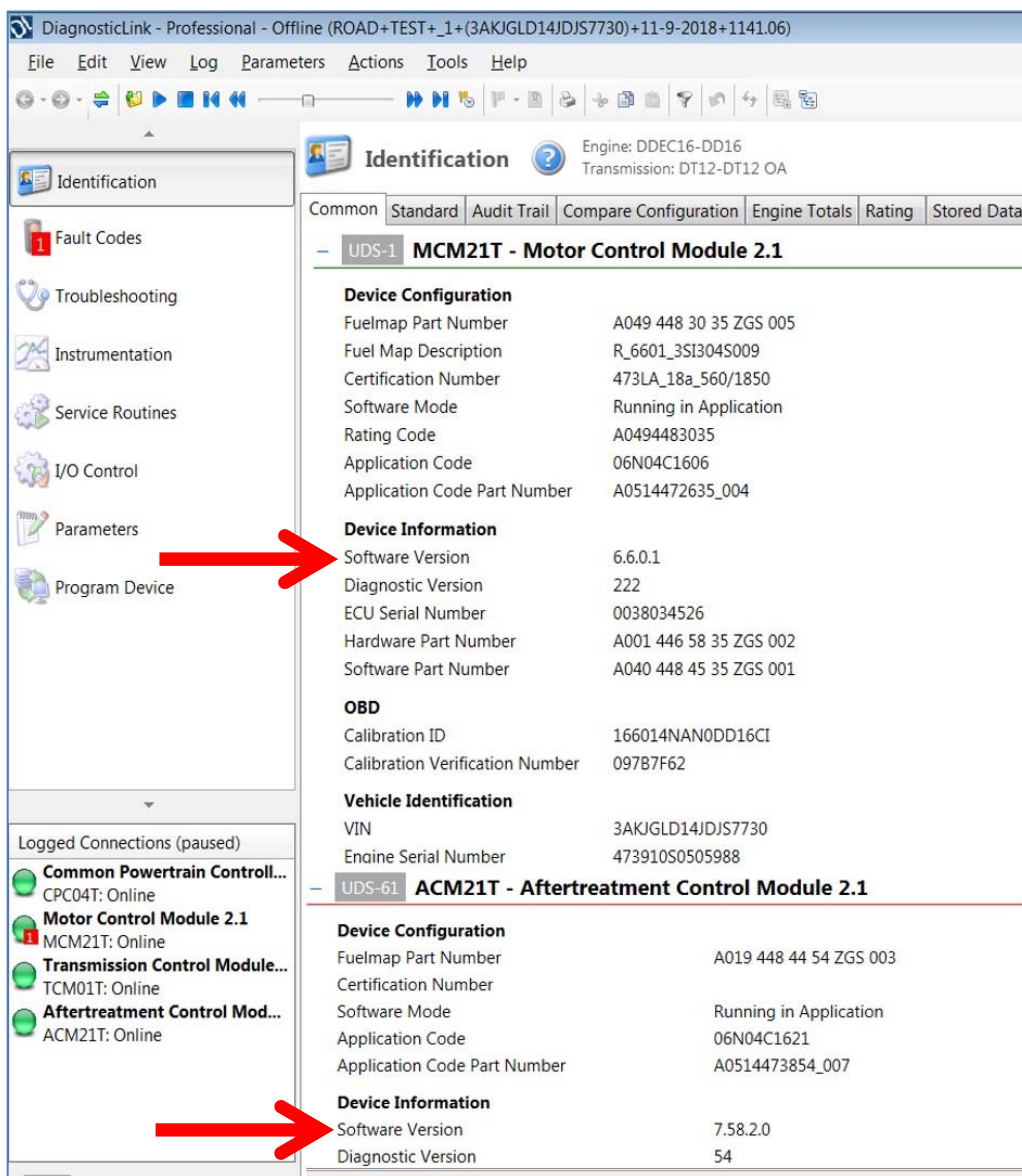
Figure 1 – DiagnosticLink® Identification Screen

6. Is the **software** level for all modules less than, equal to, or higher than the software levels listed in step 5? For example in Figure 1, MCM software 6.6.0.1 and ACM software 7.58.2.0 are both less than 6.7.0.2 and 7.59.2.0, and thus would require programming.
  - a. If less than the required software levels, proceed to step 7.
  - b. If equal to or higher than the required software levels, no programming is necessary. Proceed to step 13.
7. Select the “Program Device” option along the left side of the DiagnosticLink® screen.

5. On the Identification screen, check the current MCM, ACM, CPC, and if applicable the TCM, software. Listed below are the **MINIMUM** levels required. See Figure 1 for an example of the Identification screen.
  - a. MCM software **6.7.0.2**
  - b. ACM software **7.59.2.0**
  - c. For non-New Cascadia vehicles, CPC software **R42 00 000A**
  - d. For New Cascadia vehicles, CPC software **31.23.00**
  - e. For DT12 equipped vehicles, TCM software **NAMT150700**
