**Freightliner
Service Bulletin**

General Information

Powernet Distribution Box (PNDB) Replacement

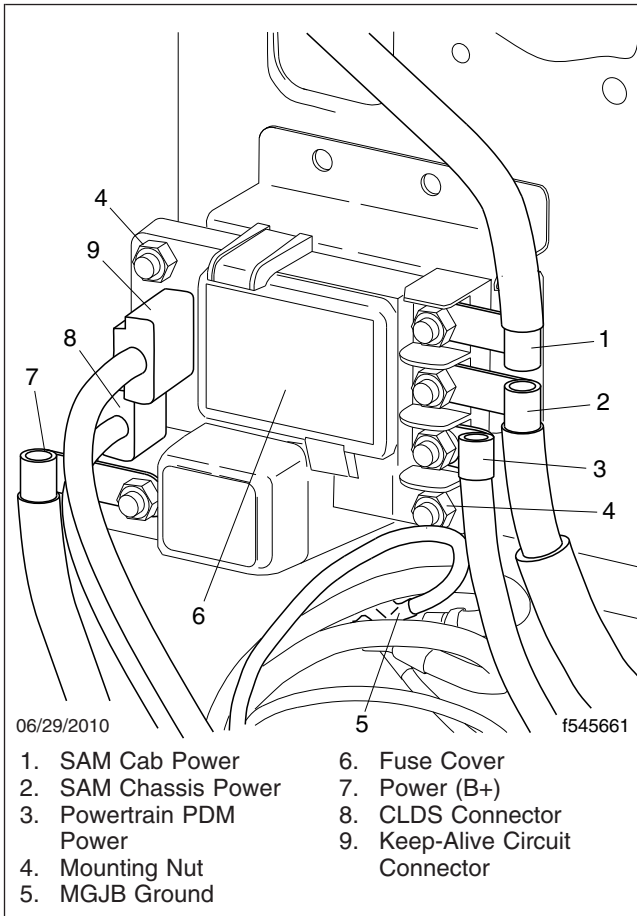
Fig. 1, Powernet Distribution Box (PNDB)

NOTE: The powernet distribution box (PNDB) is located on the cab frontwall, above the main ground junction block. See [Fig. 1](#).

If the fuses are not seating properly on the keep-alive circuits, or are falling out, use the instructions in this bulletin to replace the PNDB. The PNDBs have been updated with product improvements to both the fuse terminals and to the case fuse cavities to fix the fuse retention concern. In addition, the PNDB firmware has been updated to prevent unintended opening of the internal electrical contacts.
