Technical Service Bulletin

"AUTO LIGHT SYSTEM MALFUNCTION. TURN ON/OFF LIGHTS MANUALLY" WARNING MESSAGE AND DTC B10AD:09 STORED WHEN PARKED DURING HOT WEATHER CONDITIONS

Bulletin No.: 09-036/19

- 2019-2020 Mazda3 (Japan built) vehicles with VINs lower than JM1BP*****150083 (produced before July 27, 2019)
- 2019-2020 Mazda3 (Mexico built) vehicles with VINs starting with 3MZ

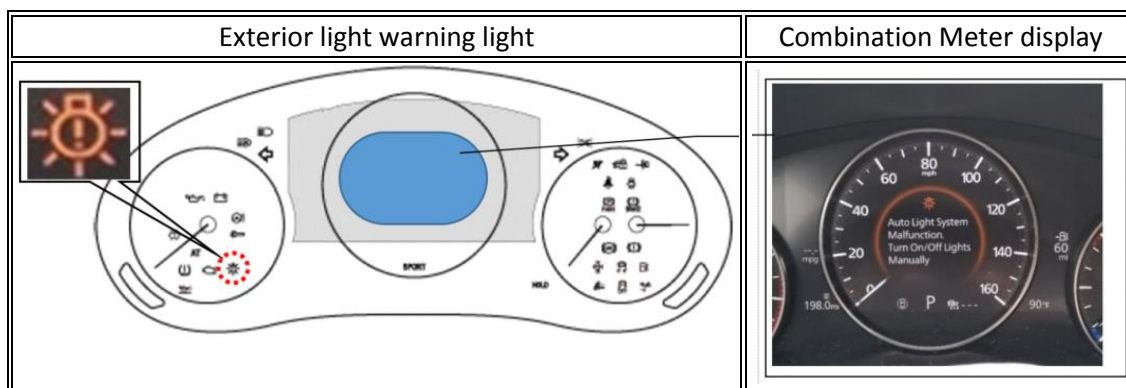
Some customers may complain about an instrument cluster warning message "Auto Light System Malfunction. Turn On/Off Lights Manually". DTC B10AD:09 (Humidity sensor/solar radiation sensor/auto light sensor/rain sensor malfunction) may also be stored with the exterior light warning indicator light ON.

This is caused by the rain sensor detecting a temperature higher than the operation range and temporarily stopping the auto light system. As a fail-safe, the low beam headlights are turned on. The auto light system will start to operate normally when the A/C is turned on and the interior temperature drops. To correct this concern, the heat resistance performance of the rain sensor has been enhanced.

1. Verify customer concern.
2. Replace the rain sensor with a modified one according to the instructions on MGSS (RAIN SENSOR

REMOVAL/INSTALLATION).
