# Technical Service Bulletin

<b>Subject:</b> <b>DTC B14F0:76 STORED AND i-ACTIVSENSE WARNING LIGHT (AMBER) ON AFTER BCM REPLACEMENT</b>	<b>Bulletin No.:</b> 15-003/19
	<b>Last Issued:</b> 10/30/2019

2019 Mazda3

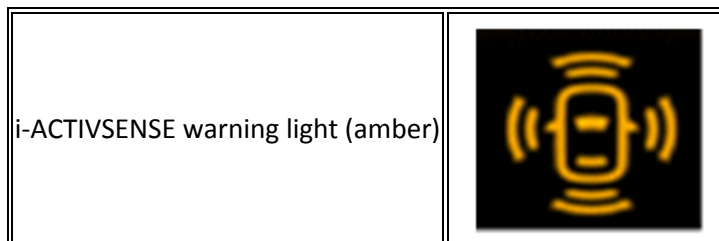
Some vehicles may exhibit DTC B14F0:76 [VCM] (Forward sensing camera (FSC) deviation) stored in memory and the i-ACTIVSENSE warning light (amber) on after BCM replacement.

This is caused by the learning value of the forward sensing camera (FSC) aiming being initialized after BCM replacement due to a software malfunction of the FSC. To correct this concern, the FSC software will be modified to not initialize the value of the FSC aiming after BCM replacement.

1. Verify customer concern.
2. Perform the FSC aiming according to the instructions on MGSS (FORWARD SENSING CAMERA (FSC) AIMING).  
**NOTE:** Either dynamic or static aiming is acceptable for this repair.
3. Verify repair.
