<b>Subject:</b>  DRW26 - 2020 MAZDA3 MAZDA CONNECT CONCERN	∴
	<b>Last Issued:</b> 10/1/2019

**Subject: Dealer Rework (DRW) 26 - Mazda Connect Concern 2020 Mazda3**

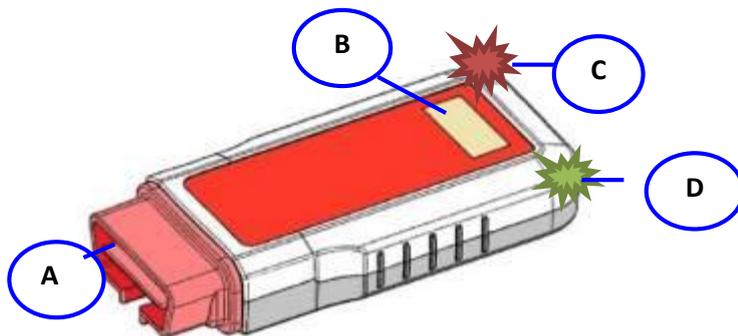
A	OBDII connector
B	Display
C	LED light (Red)
D	LED light (Green or Blue)

LED lights show the configuration status.

- \*There are two LED types for MDRT.
1. Green & Red (Serial number up to 02217)
  2. Blue & Red (Serial number after 02218)

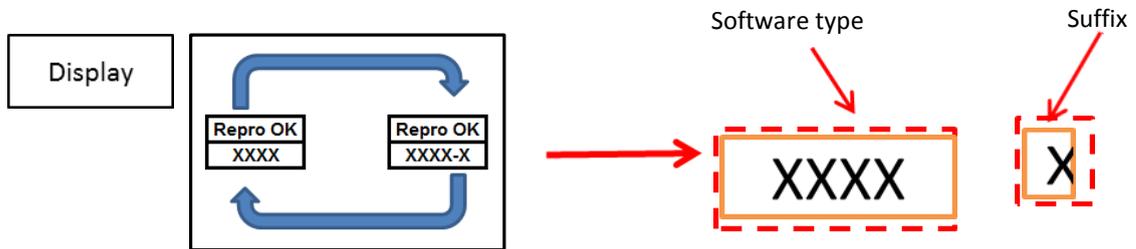
**How to verify the reprogramming results by display**

Confirm that the display shows a message as follows after completing reprogramming.

Lower message on the display indicates each of the software type & suffix. If a suffix becomes higher, Reprogramming is completed.
