INTRODUCTION:

This bulletin announces availability of a new combination meter with revised software.

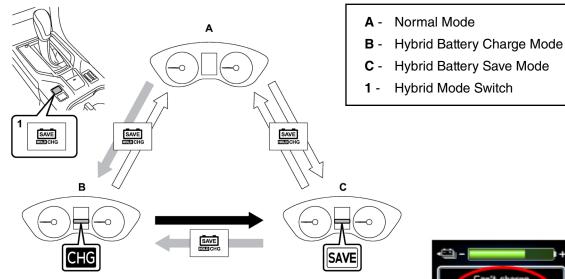
• On affected vehicles, when switching from Hybrid Battery Charge (CHG) mode (B) to Normal mode (A), SAVE is incorrectly displayed briefly in the combination meter center display.

The part number for the new combination meter is 85002FL701.

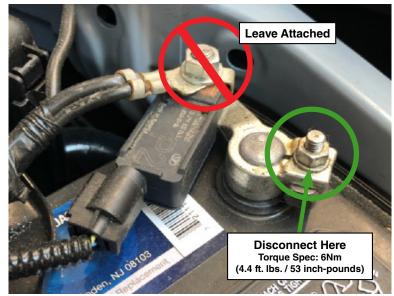
- The VARIANT WORK procedure (A or B) <u>MUST</u> be performed <u>BEFORE</u> proceeding with removal of the combination meter as outlined in the Service Manual.
- Follow the instruction below when disconnecting the battery ground on a PHEV vehicle: (Insert image snip from e-mail.)

VERY CRITICAL: Never over-tighten the 10mm hex nut at the battery terminal connection beyond the torque specification of 6 Nm (4.4 ft. lbs. / 53 inch-pounds).
