SERVICE BULLETIN

APPLICABILITY: 2019MY Forester

NUMBER: 12-262-19

SUBJECT: Hood Release Cable -Design Change

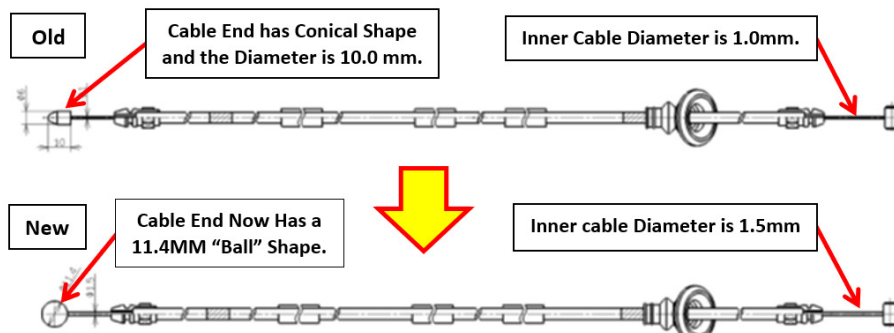
This bulletin announces availability of a new hood lock release cable to address concerns of the front hood lock not releasing when the release lever is pulled. The new inner cable diameter has been increased and the shape of the cable end has been changed to improve engagement between the release cable end and the lock release mechanism. Latching of the hood is not affected by this change.

- Comparison Illustrations between the New and Old-Style cables:

The part number for the new style CABLE-FRONT HOOD is **57330SJ011**.

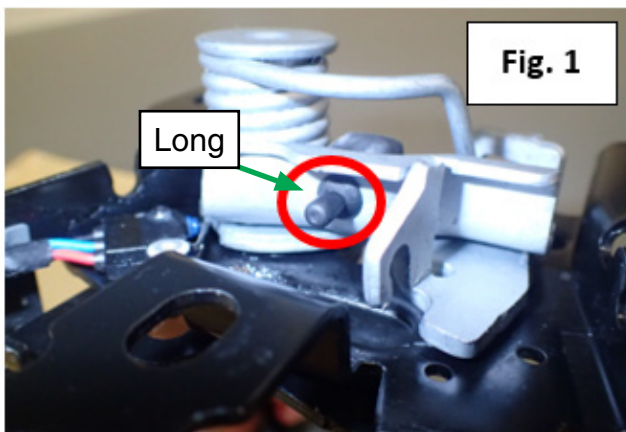
Step 2) Inspect the hood lock closely for the rubber buffer shown in the photos below. Fig. 1 shows a buffer with a long projection while the buffer's projection shown in Fig. 2 is very short.

- If inspection reveals a hood lock with a “long” projection buffer as shown in Fig. 1 above, 4mm from the end of the projection must be trimmed off using a small wire cutter or equivalent. Use the illustration below as a guideline.
