PRODUCT CAMPAIGN BULLETIN

APPLICABILITY: 2015-18MY Forester **NUMBER:** WUM-98R
SUBJECT: Occupant Detection Wiring Harness Inspection **NHTSA ID:** 19V-701
DATE: 10/14/19
REVISED: 10/22/19

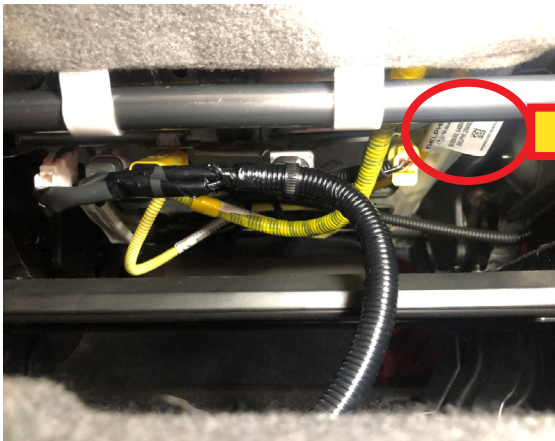
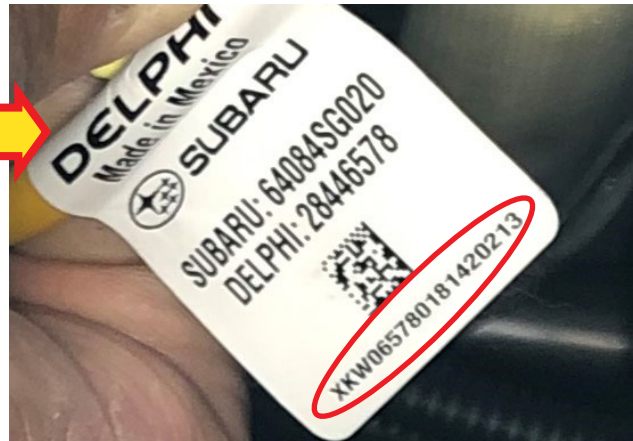
INSPECTION:

- There is enough room under the seat to access the harness label and perform the date / supplier code inspection without removing the seat assembly.
- Do not pull on the sensor mat harness with excessive force. There is enough flexibility and slack in the harness available to access the label for this inspection.

TIP: Take a photo of the label with a phone then review the image to get the necessary information.

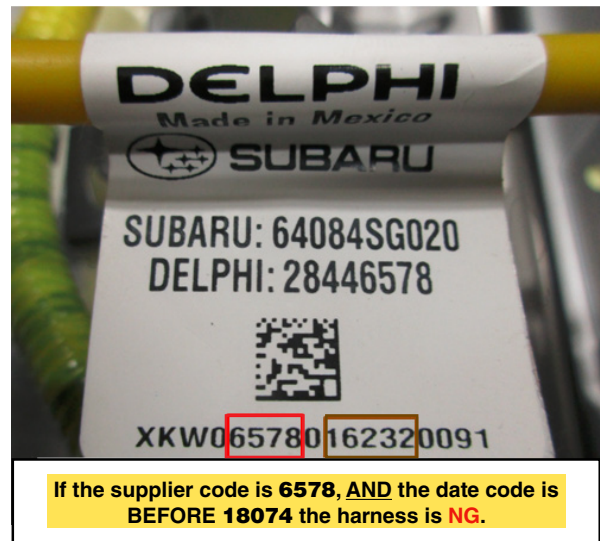
Step 1. If the date code (**BROWN** box in photo) on the label is **AFTER 18074** AND has a supplier code other than **6578** (**RED** box in photo) on it, harness is **OK**. See additional ****NOTE** below.

Step 2. If the date code is **18074** or **BEFORE** AND has the supplier code **6578** (**RED** box in photo) on it, the harness is **NG** and the seat cushion assembly must be replaced. Always order the most up-to-date part number seat cushion assembly for the VIN being repaired. Follow the Service Procedure in the applicable Service Manual for the repair.

- “6578” indicates the supplier where parts produced **prior to date code 18074** are considered **NG**. Parts produced **on or after date code 18074** by supplier “6578” are **OK** for use.
- “16” is the year (2016) and “232” is the 232nd day of the year: “16232”.
