05/19 ENU WKA5

WKA5 - Checking Fill Level Sensor for Water Spray System and Replacing it if Necessary (Workshop Campaign)

Vehicle type:	911 GT2 RS (991)
Model Year:	2018
Subject:	Fill level sensor for water spray system
Information:	There is a possibility that the float for the water spray system fill level sensor can stick at both the lowest and very top position due to unfavorable component tolerances on the affected vehicles.
	 If the float sticks at the lowest position, the warning message "Fill coolant reservoir for charge-air cooler - Visit workshop" will be displayed in the instrument cluster even though the reservoir for the water spray system is still sufficiently full. If the float sticks at the very top position, the reservoir will subsequently become empty and no warning message will be displayed. As a result, engine power will be reduced and the pump can be damaged.
Remedial Action:	Check the date of production on the water spray system reservoir and replace the fill level sensor if necessary.
Affected Vehicles:	Only the vehicles assigned to the campaign (see also PCSS Vehicle Information). There are 684 vehicles affected in the US and Canada

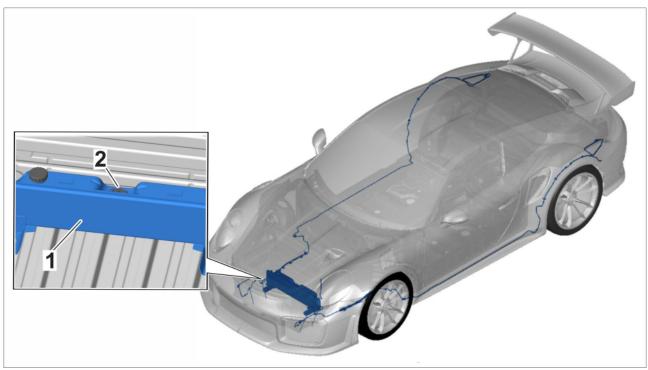
Installation position of water spray system

- 1 Water spray system reservoir
- 2 Fill level sensor
