# Product Upgrade Bulletin 190827REV

**YEAR(S)  
AFFECTED:**  
2020

**PRODUCT(S)  
AFFECTED:**  
2020 Fleetwood Flair  
2020 Holiday  
Rambler Admiral

**SUBJECT:**  
Correction of 12-  
Volt Patio Awning  
Circuitry and  
Wiring

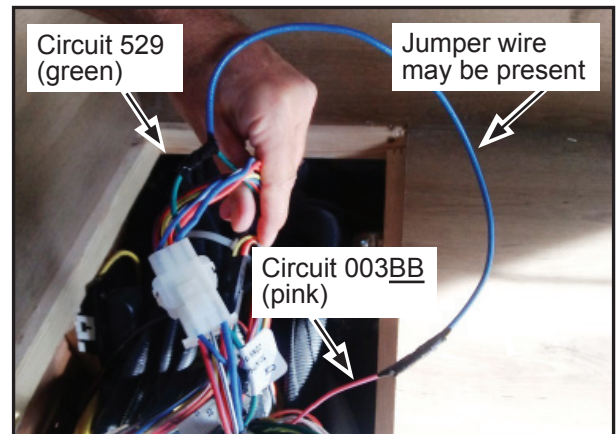
- a) The first scenario would be that the 003BB circuit (pink wire) has been cut and spliced into circuit 529 (green wire). Circuit 529 will be located in an adjacent harness connection labeled as "To Misc Harness Conn #1". Refer to the Figure 10 and the schematic in Figure 11 for this possible condition.

**NOTE:** A jumper wire may be present, as shown in Figure 10.

14. Based on the scenario found, circuit 003BB (pink wire) will either need to be disconnected from circuit 529 (green wire) or cut at the pinned connector.
  - a) If you disconnect the pink wire from a splice at circuit 529 (green wire), be sure that any exposed copper wiring is appropriately wrapped and covered with electrical tape to prevent arcing.
  - b) If you cut circuit 003BB (pink wire) off of the pinned connector, it can be left uncapped as there is no power feeding this circuit.

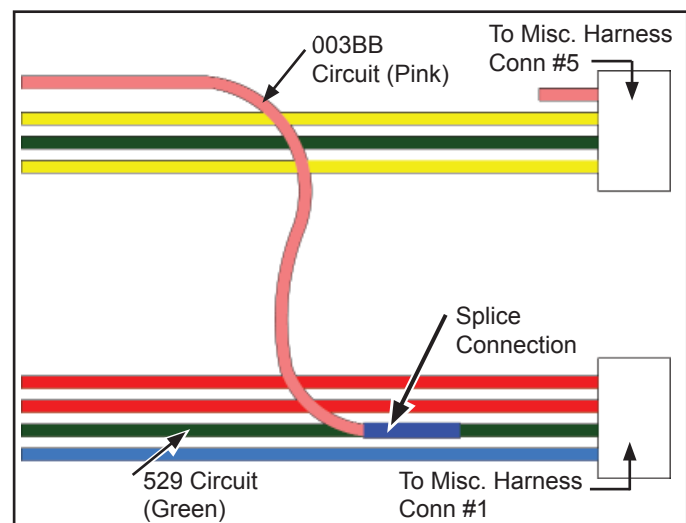
Figure 11  
(Example of possible miswired connection)

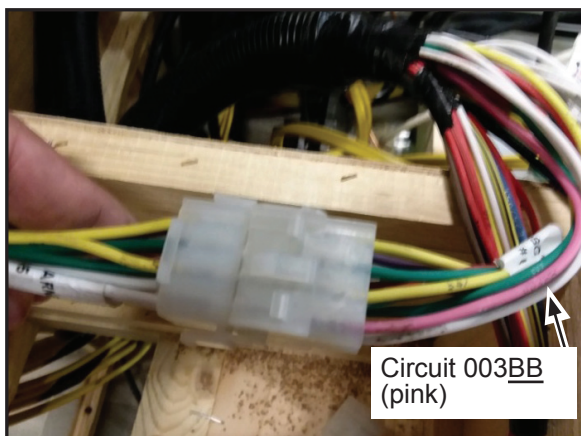
Figure 12

- b) The second scenario would be that the 003BB circuit (pink wire) is still intact and pinned into the original connection labeled "To Misc Harness Conn #5". See Figure 12.
