Service Bulletin

02-152

New faux door panel for fairing to replace old panel with insufficient weld.

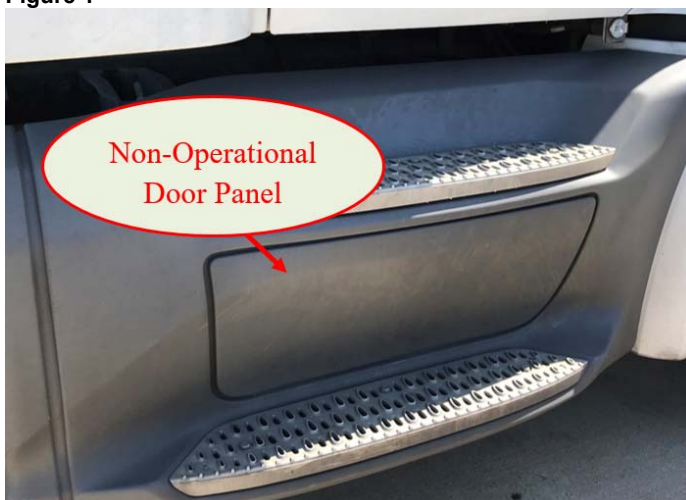
1. Locate the non-operational door panel.
Figure 1

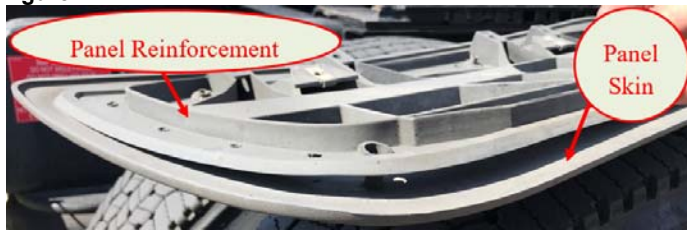
Figure 2

2. Visually inspect the panel for signs of being loose and lightly tap to listen for rattling.
3. If loose or rattling, remove panel assembly and inspect for separation as shown in Figure 2.
 - Locate the four mounting bolts behind the panel that are accessible from the underside of the fairing (see Figure 3).
 - Remove the four 10mm bolts holding the panel to brackets. If access to these bolts is difficult, the fairing may be removed by removing six 17mm step bolts.

Do not fully separate the panel skin from the reinforcement.

4. If the panel is part of a painted fairing, paint the panel to match the fairing in an onsite paint booth or outsource to a local paint shop.
5. Reinstall the fairing if it was removed and install the new panel. The bolts can be reused.
