Technical product information

Topic	Outer daytime running light/s not working - Warning message within the DIP
Market area	USA+CAN+MEX (4UCM),Hongkong-Macau (5HK),Russische Föderation (5RU),Australia E04 Bentley rest Asia and Australia (6E04),China 796 VW Import Comp. Ltd (Vico), Beijing (6796),Germany E02 Bentley rest Europe (6E02),Korea, (South) E08 Bentley South Korea (6E08),United Arab Emirates E06 Bentley Middle East and Africa (6E06),United Kingdom E01 Bentley UK (6E01)
Brand	Bentley
Transaction No.	2055589/2
Level	EH
Status	Approval
Release date

New Continental GT and New Continental GTC

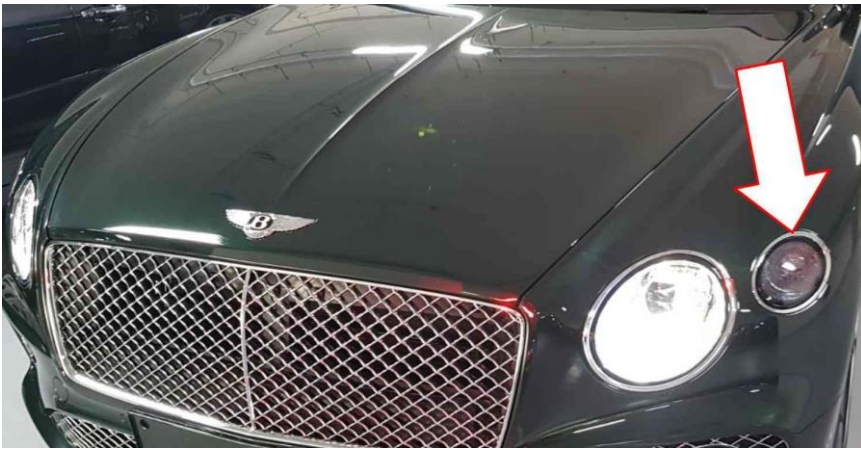
Figure 1

- Left and/or right outer daytime running light/s not working (Figure 1)

- DTC C10EF04 evident within Diagnostic address 29 Light control left and/or 39 Light control right

A software error in the headlight control modules can lead to malfunctions with the front Daytime Running Lights.

The software of address 29 – *Light control left* and address 39 – *Light control right* require reprogramming. This software reprogramming take place via two separate SVM codes.

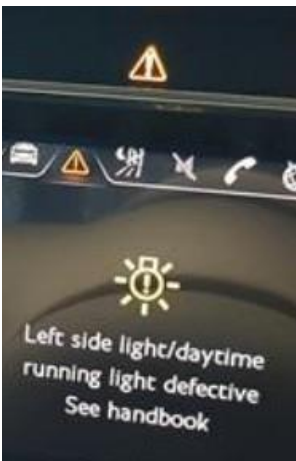
Figure 2

- Warning message also evident within the DIP (Figure 2)
