Technical Service Bulletin

37 Transmission malfunction, DTC P17F600, U008000, and/or U010100 stored in the TCM or ECM

37 19 89 2053878/5 October 22, 2019. Supersedes Technical Service Bulletin Group 37 number 19-88 dated August 14, 2019 for reasons listed below.

Model(s)	Year	VIN Range	Vehicle-Specific Equipment
A6, A7	2019	000001 - 121296	3.0TFSI

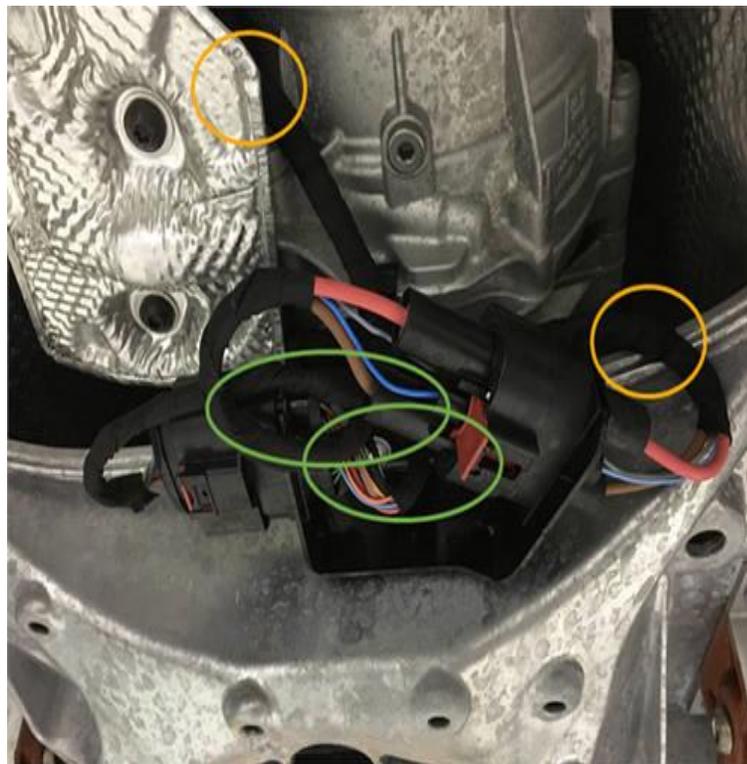
The transmission harness can come in contact with the transmission crossmember and could be damaged.

Figure 1. Common areas for harness damage. Also depicted is the original routing concept.

1. Inspect for damage to the transmission harness (Figures 1 - 4).
 - Thoroughly inspect the transmission wiring harness and routing to determine if the routing is the new or the original concept (Figures 1, 7, and 8).
 - Inspect the body harness and transmission harness for damage near the areas indicated in Figure 1.
 - Harness damage can be very subtle. Even a light chafing of the harness wrap can cause the DTCs.

If **transmission harness damage** is found and/or the original routing concept is in place, proceed to step 3.

If **body harness damage** is found regardless of the transmission harness routing, create a TAC case for further instruction. Include photos of the original harness routing, area of damage, close up of damage and a clear description of your findings.

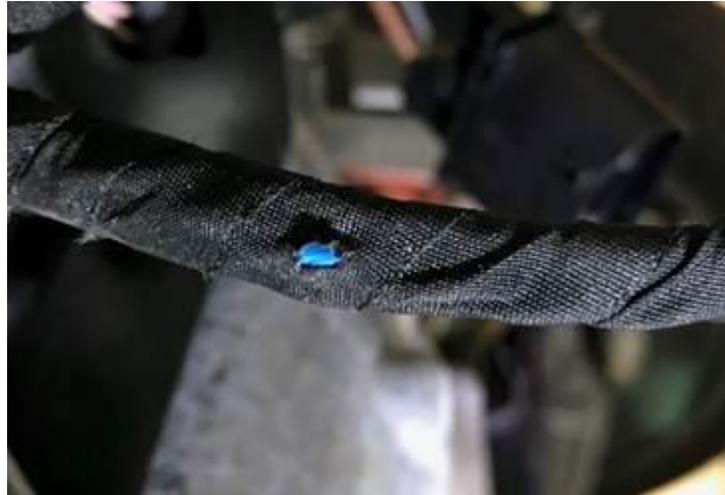
Figure 2. Example of a small rip in the protective tape.

3. Replace the original transmission harness with a new part and reroute the transmission harness. The transmission harness should not be repaired.
 - Remove the original transmission harness in the vehicle.
 - Wrap the exposed wires on the new transmission harness as shown in Figure 7.
 - Mount and route the new transmission harness as shown in Figure 8.

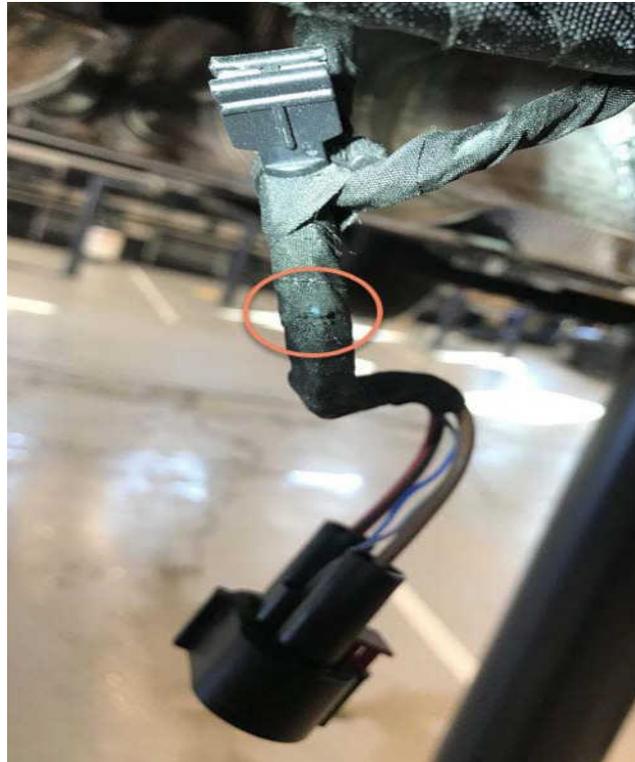
Figure 3. The damage on the original harness might be difficult to spot.

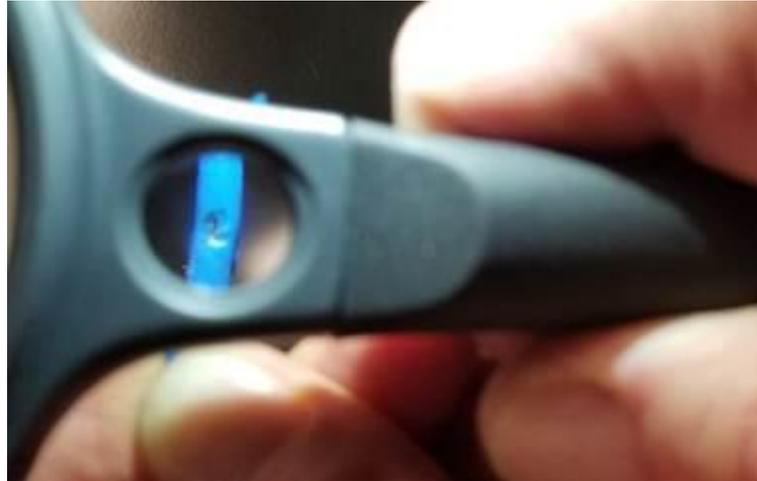
Figure 4. The cause of the DTC may be as small as a pinhole.

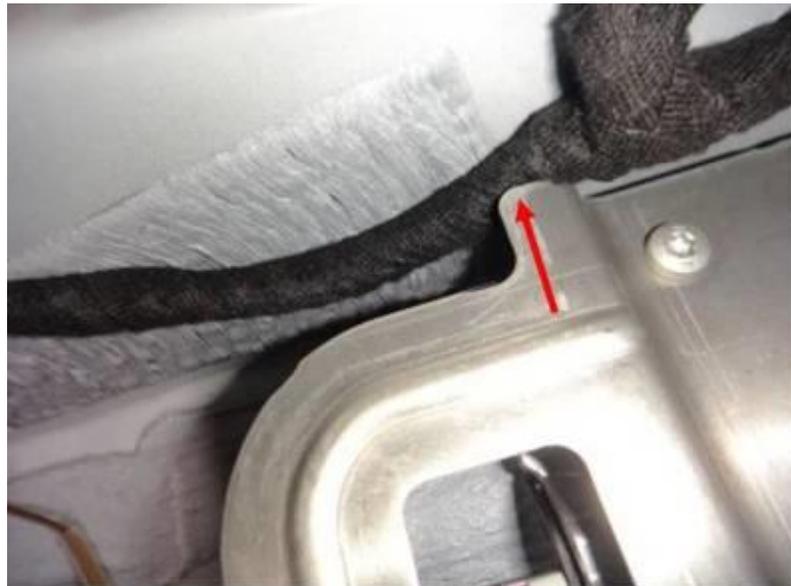
The body harness containing the FlexRay circuit to the transmission may rub against the mounting bracket of the driver assist systems control module, J1121 (address word 00A5).

If there is no damage found and DTC U11B000 (FlexRay data bus branch 2 faulty) is stored, inspect the area shown in Figure 5 and 6.

Figure 5. The area where the body harness may rub.

If damage is found in this area then create a TAC case, include photos, and a clear description of your findings.

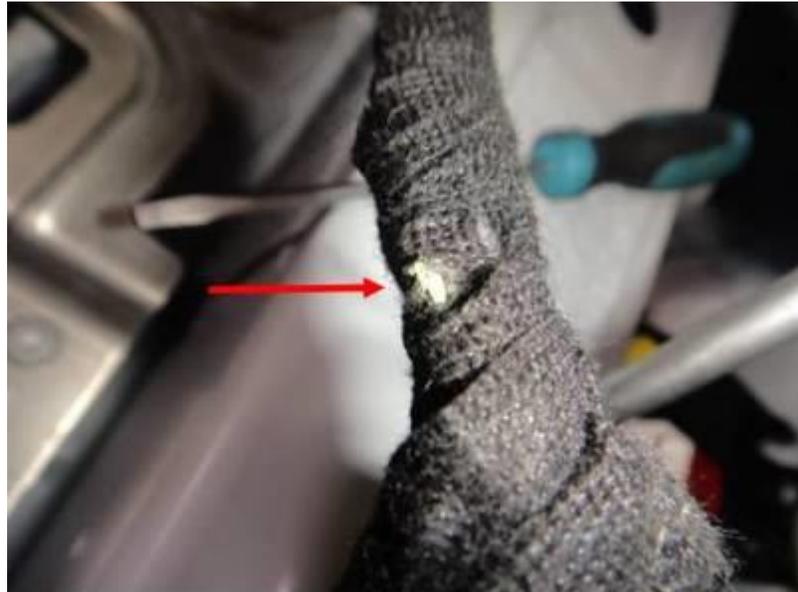
Figure 6. Shows the rub mark on the wiring harness.

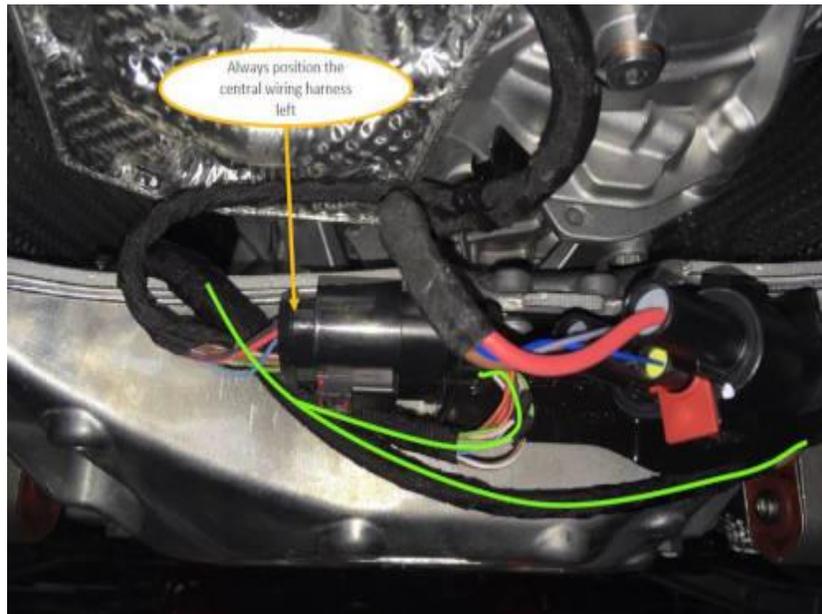
Figure 7. New routing and wrapping of the aft part of the transmission harness.

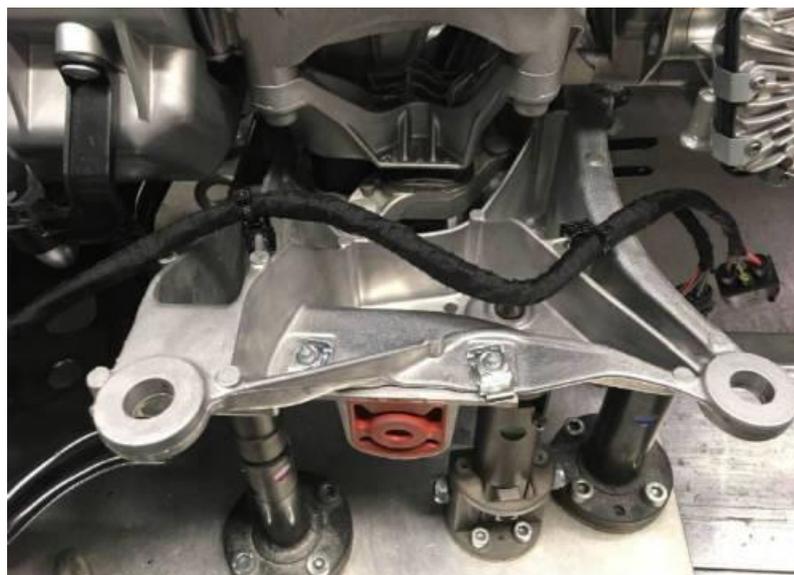
8. Routing and mounting of the transmission harness behind the crossmember.

4. The crossmember is shown dismounted in Figure 8 to show the new mounting points more clearly. For mounting and installation of the new transmission harness, the crossmember does not have to be disassembled.
