Technical Service Bulletin

90 Instrument cluster energy consumption defaults to the wrong units

90 19 30 2056041/1 October 28, 2019.

Model(s)	Year	VIN Range	Vehicle-Specific Equipment
Audi e-tron quattro	2019	000000 - 019602	Not Applicable

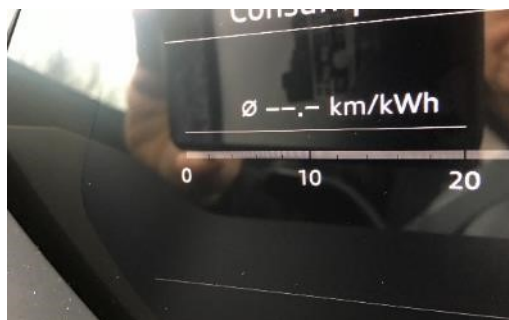
- After a MMI factory reset, the energy consumption unit defaults to km/kWh instead of mi/kWh.

Figure 1. Wrong units after a factory reset.

A wrong default value set at the factory causes some units to revert to metric.

New Target Data Container (ZDC) update in the instrument cluster control module, J285 (address word 0017) addressed the condition.

2. Update the instrument cluster control module, J285 (address word 0017) using the SVM action code as listed in the table below, if necessary:
