# Technical Service Bulletin

## 91 Navigation, Bluetooth, smartphone interface, voice recognition, drive select, ACC, or cruise control is not available

91 19 06 2042506/7 October 30, 2019. Supersedes Technical Service Bulletin Group 91 number 19-44 dated March 8, 2019 for reasons listed below.

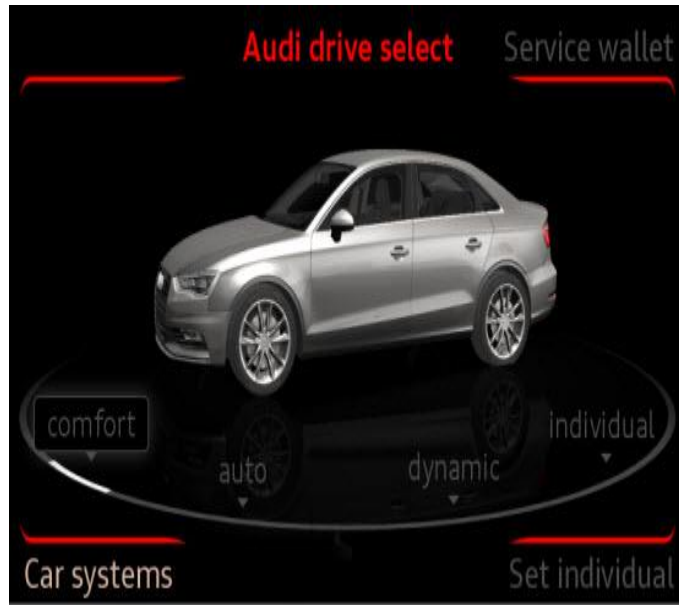
- Audi drive select functions cannot be selected (Figure 1).
- Cruise control does not work (except for A6 and A7) and **DTC P161200** (ECM incorrect coding) is stored in one or more of the control modules on the Powertrain CAN bus (address word 0003 (ABS)), (address word 0001 (ECM), etc.).
- Navigation is not activated (Figure 2 and Figure 3).
- Bluetooth is unavailable.
- Audi smartphone interface, including CarPlay or Android Auto, is not available.
- Voice recognition is unavailable (in all cars except A3 Cabriolet. For A3 Cabriolet, see TSB 2038136: 91 Voice recognition is not available or not enabled).

**Figure 1.** Audi drive select functions unavailable and greyed out.

1. There is a known issue with the activations keys stored in the MMI where they can become corrupt, thus the first step will be to delete the activation keys in the MMI. Delete the activations of the affected system using the ODIS test plan *DIAGNOSIS >> START DIAGNOSIS >> SPECIAL FUNCTIONS >> “SVM – Erase activations”* (Figure 5).

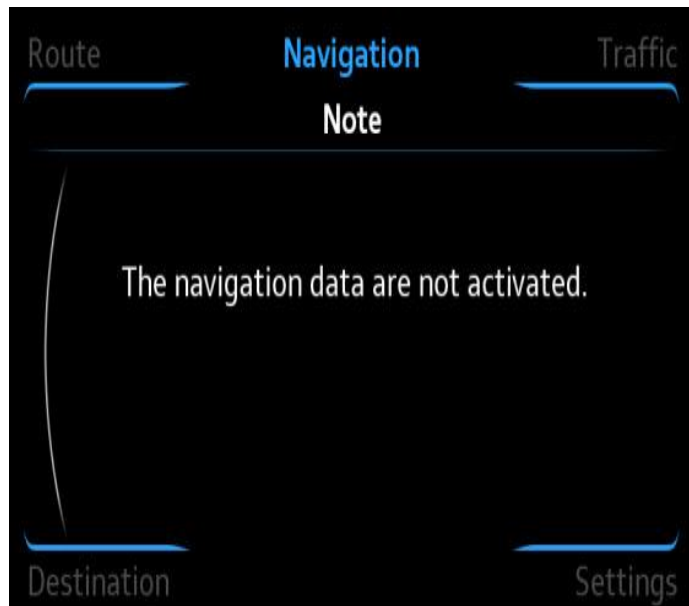
**Figure 2.** Navigation not activated message (Original MIB HMI).

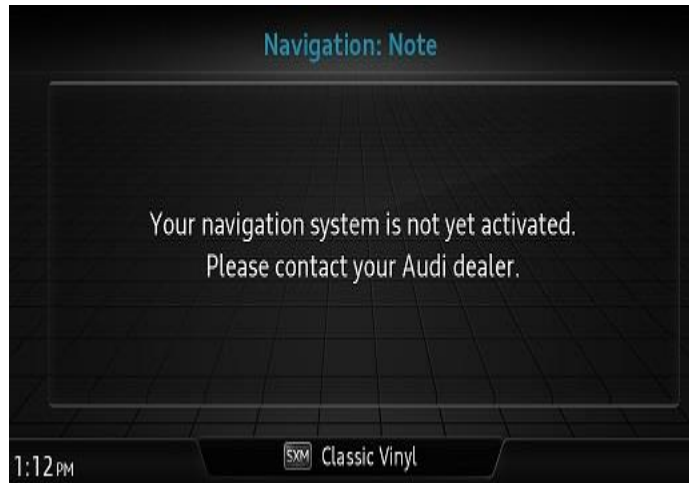
**Figure 3.** Navigation not activated message (New MIB2 HMI).

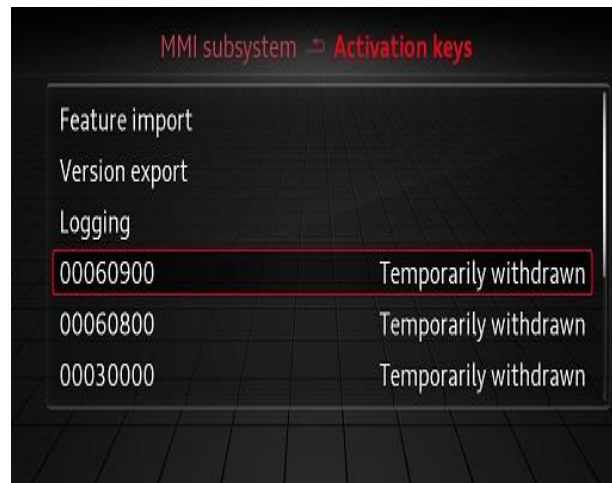
**Temporarily withdrawn or Temp illegal** = This indicates that the SVM activation test plan was not completed (Figure 4). This status is normal for all parts that have been swapped from a different vehicle. Perform the SVM Activations test plan as indicated below, under *Repair Procedure*.

**Figure 4.** Activation keys showing “Temporarily withdrawn”.
