Technical Service Bulletin

91 Audi connect myAudi pin not saved for stored online destinations

91 19 07 2047433/4 October 30, 2019. Supersedes Technical Service Bulletin Group 91 number 17-63 dated December 6, 2017 for reasons listed below.

Model(s)	Year	VIN Range	Vehicle-Specific Equipment
A6, A7	2016 – 2017	All	MIB2 High

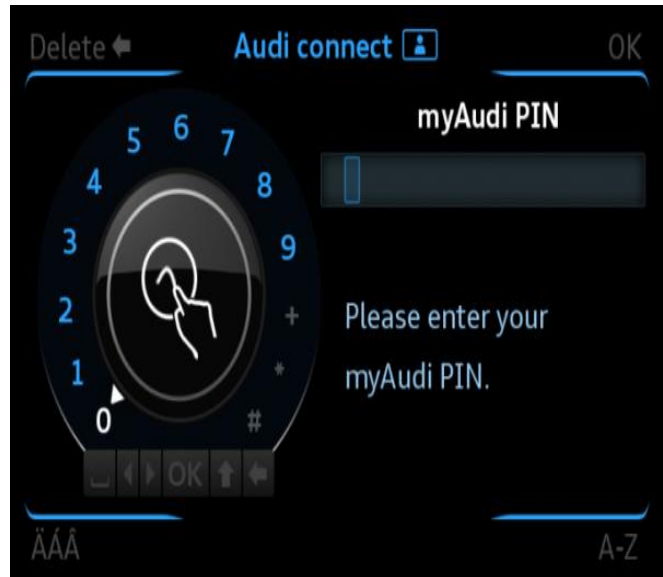
The vehicle is a MY2016 or MY2017 A6, A7, S6, S7, or RS7 and the customer states that when retrieving the stored myAudi online destinations, the myAudi PIN (Figure 1) is not saved and must be entered each time after the vehicle has been switched off for a long period of time. Additionally, the customer's vehicle is equipped with MMI Navigation plus (MIB2 High; PR code 7UG).

Figure 1. myAudi Pin entry screen.

The condition is the result of an MMI software bug and can be fixed by updating the MMI software. The software bug only prevents the myAudi PIN from being stored in the navigation area of the MMI menu. The myAudi pin is saved in the Audi connect menu for accessing custom news feeds.

The service solution is to update the MMI software to SW1062 for MY16 and SW0924 for MY17 to fix the myAudi PIN issue.

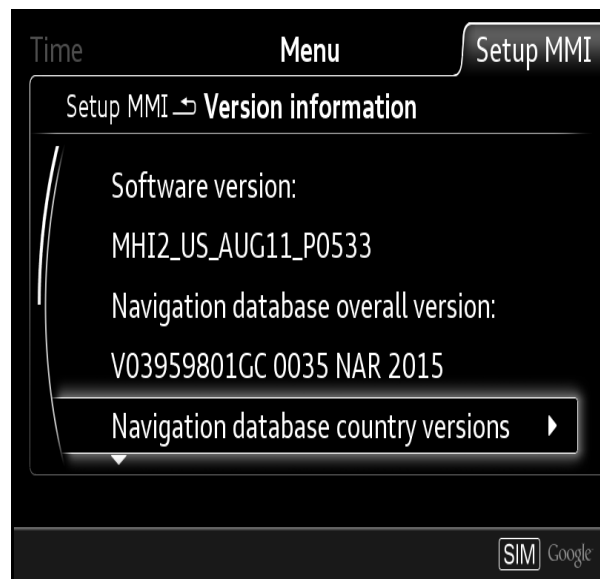
Figure 2. MMI Version Information.

1. Verify that the customer's MMI requires the software update by going to the *Main Menu* >> *Setup MMI* >> *Version Information* (Figure 2).
