91 MIB2 High: Navigation data read error/reboots, DTC B126CF0 stored in the information electronics control module

91 19 08 2057052/1 October 31, 2019.

Model(s)	Year	VIN Range	Vehicle-Specific Equipment
A5, Q5	2018 - 2019	All	MIB2 High
A3, A6, A7, and TT	2016 - 2019	All	MIB2 High
A4, Q7, and R8	2017 - 2019	All	MIB2 High

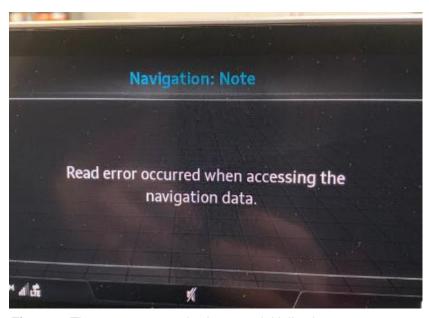
- The MMI shows the message "Read error occurred when accessing the navigation data" after initialization (Figure 1).
- The MMI reboots constantly.

Figure 1. The error message is shown on initialization.

If the navigation map database is corrupted during an online update, the message from Figure 1 is displayed and the navigation system is unavailable. The DTC B126CF0 is entered into the information electronics, J794 (address word 005F).
