# TECHNICAL SERVICE BULLETIN

Technical Service Bulletin: 80-1087

Forest River is alerting you to an issue involving certain 2020 – R. POD - RPT195-80 travel trailer recreational vehicles. Please see the information below which describes the issue and provides you with details on the steps you should take to have your vehicle repaired.

## R. POD - RPT195 A/C SHROUD – REMEDY INSTRUCTIONS

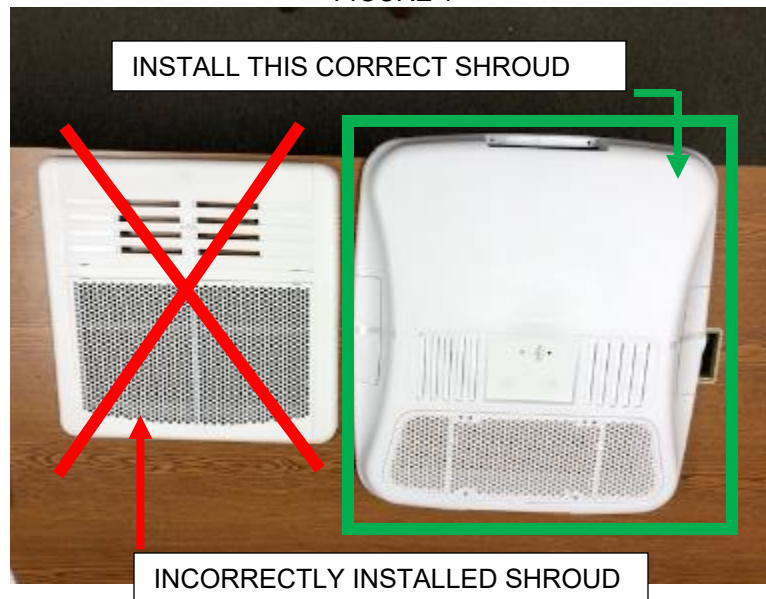
The manufacturing plant installed a ducted air conditioner shroud inside the vehicle while the vehicle manufactured with non-ducted air conditioning and requires the non-ducted air conditioning shroud.

STEP 1: REMOVE THE AIR CONDITIONER SHROUD DEPICTED IN FIGURE 1 AND PLATE (NOT PICTURED);

STEP 2: INSTALL THE KIT # 70A11314A (ORDERED FROM R. POD) PER THE INSTALLATION INSTRUCTIONS;

STEP 3: THERE IS NOT ANY WIRING THAT NEEDS TO CHANGE, TUCK ANY WIRING BACK INTO PLACE AND SECURE AS NEEDED;

STEP 4: DISCARD THE ORIGINAL AIR CONDITIONER SHROUD APPROPRIATELY.
