TECHNICAL SERVICE BULLETIN Glove Compartment Door Difficult To Latch Or Misaligned

19-2285 07 October 2019

Ford
2015-2019 F-150

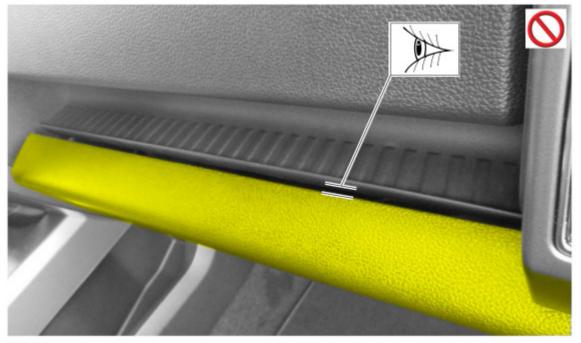
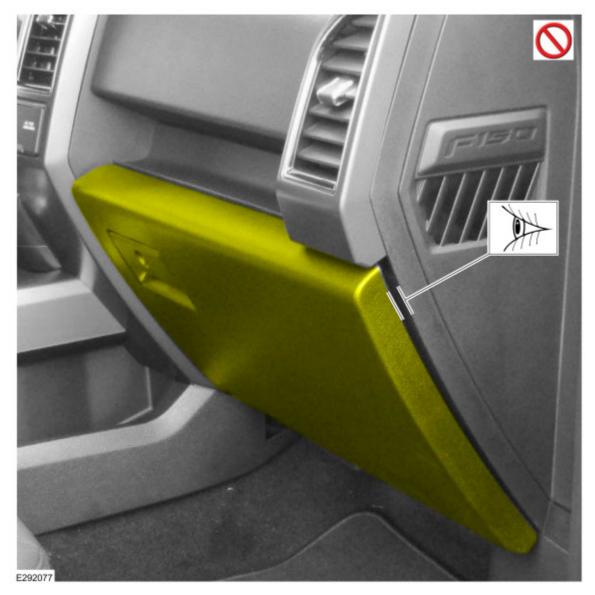
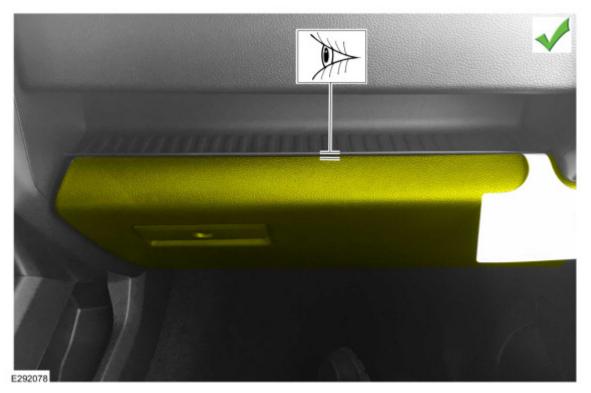
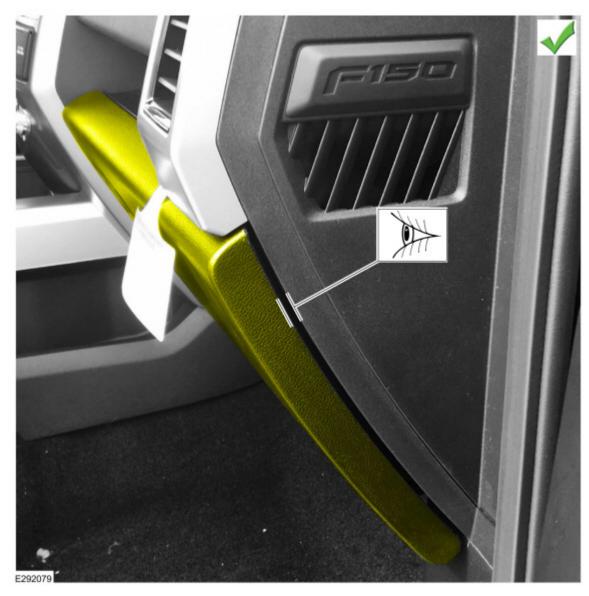
Figure 1

- Open and close the glove compartment door and inspect the glove compartment door in the closed position. Is the glove compartment door difficult to latch on one or both sides or does it exhibit a misalignment at the storage tray and/or right side instrument panel with no other visible defect? (Figures 1-4)
 - (1). Yes proceed to Step 2.

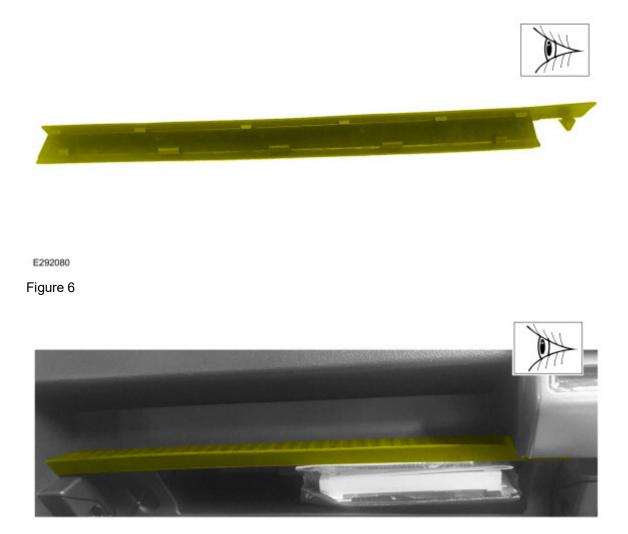
- **2.** Inspect the glove compartment storage tray rubber mat. Is the mat properly seated and flush on both ends of the instrument panel? (Figures 5-6)
 - (1). Yes proceed to Step 4.
 - (2). No proceed to Step 3.

3. Remove the rubber mat and close the glove compartment door. Refer to WSM, Section 501-12. Does the glove compartment door close properly?

(1). Yes - The rubber mat was installed incorrectly. Install the rubber mat making sure the right hand side is properly tucked and seated to the instrument panel. Refer to WSM, Section 501-12. Proceed to Step 4.

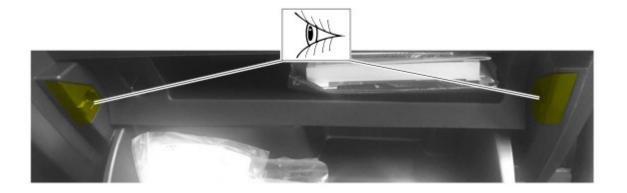
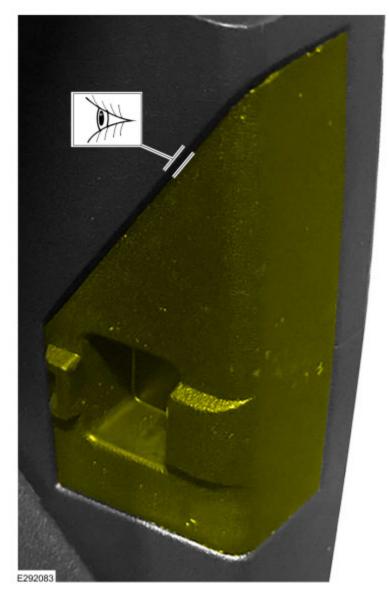
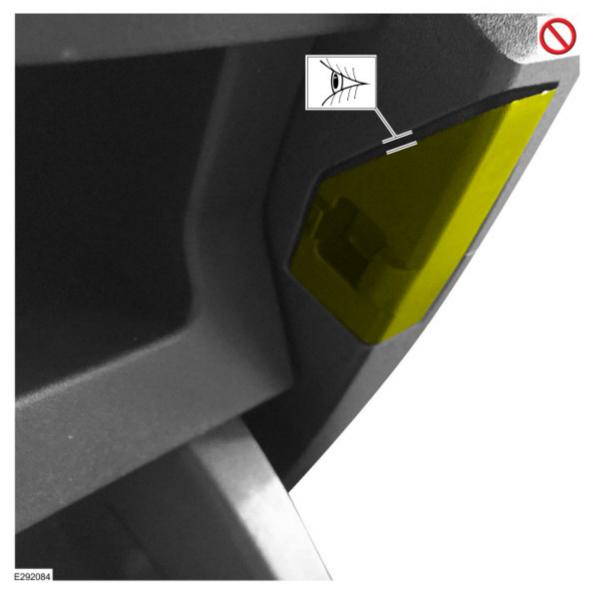
Figure 8

- (2). No install the rubber mat and proceed to Step 4. Refer to WSM, Section 501-12.
- **4.** Inspect the glove compartment door left and right hand strikers. Are the strikers fully seated? (Figures 7-9)
 - (1). Yes proceed to Step 6.
 - (2). No proceed to Step 5.

- **5.** Remove the improperly installed striker using a non-marring pry tool and reinstall. Make sure the striker is fully seated.
- 6. Inspect the glove compartment door hinge pins. Are both pins fully seated? (Figure 10)
