FIELD SERVICE CAMPAIGN – 19112

Rerouting and Clipping of Aftertreatment Harness.

International® MV™ Series

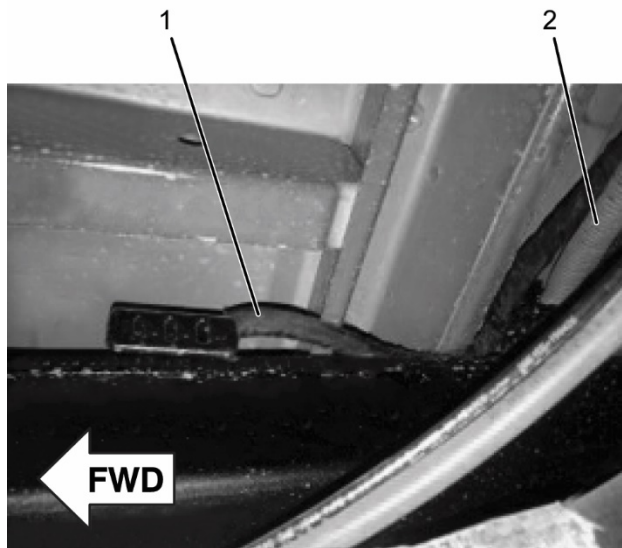
Figure 1. Aftertreatment Wiring Harness

1. Aftertreatment wiring harness
 2. Diesel Exhaust Fluid (DEF) lines
5. Locate and access aftertreatment wiring harness (Figure 1, Item 1) positioned with DEF lines (Figure 1, Item 2) on passenger-side of vehicle frame.

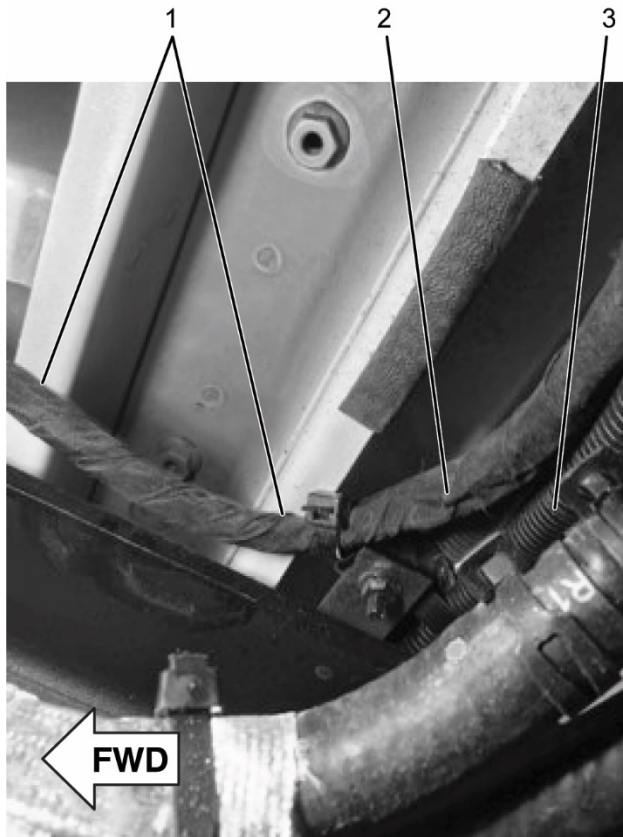
Figure 2. Incorrect Harness Routing

1. Harness-to-cab contact points
2. Harness
3. DEF line

NOTE: Figure 2 depicts incorrect routing of Aftertreatment harness. Harness (Figure 2, Item 2) contacts underside of cab (Figure 2, Item 1).

6. Verify routing of wiring harness is correct.
 - a. If harness routing is incorrect (Figure 2, Item 2), proceed to Step 7.
 - b. If harness routing is correct (Figure 3, Item 2), proceed to Step 12.

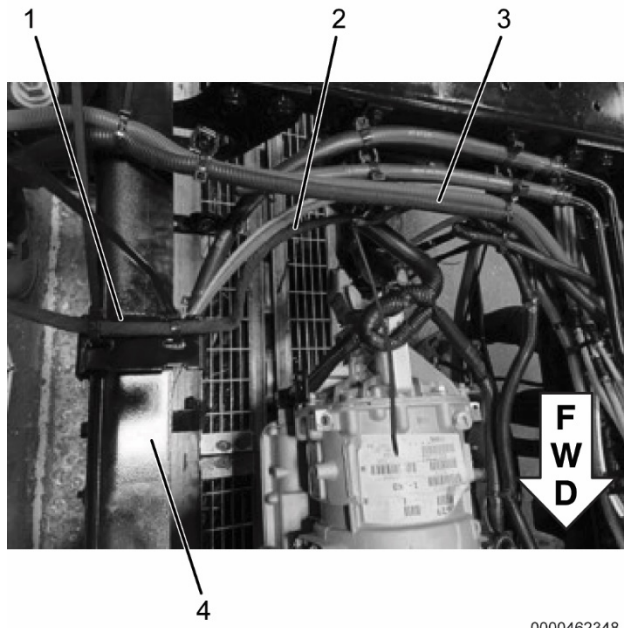
Figure 3. Correct Harness Routing

1. Support bracket
2. Harness routing
3. DEF line
4. Frame rail

NOTE: Figure 3 depicts correct routing of Aftertreatment harness. Harness (Figure 3, Item 2) is aligned with and mounted to support bracket (Figure 3, Item 1) and does not contact underside of cab.
