Applicable Vehicles					
Model(s)	Year	Eng. Code	Trans. Code	VIN Range From	VIN Range To
Tiguan LWB	2018	All	All	AX_JM000001	AX_JM158351

B-Pillar noise due to part production process.

## 51-19-01 - B-Pillar Noise while Driving

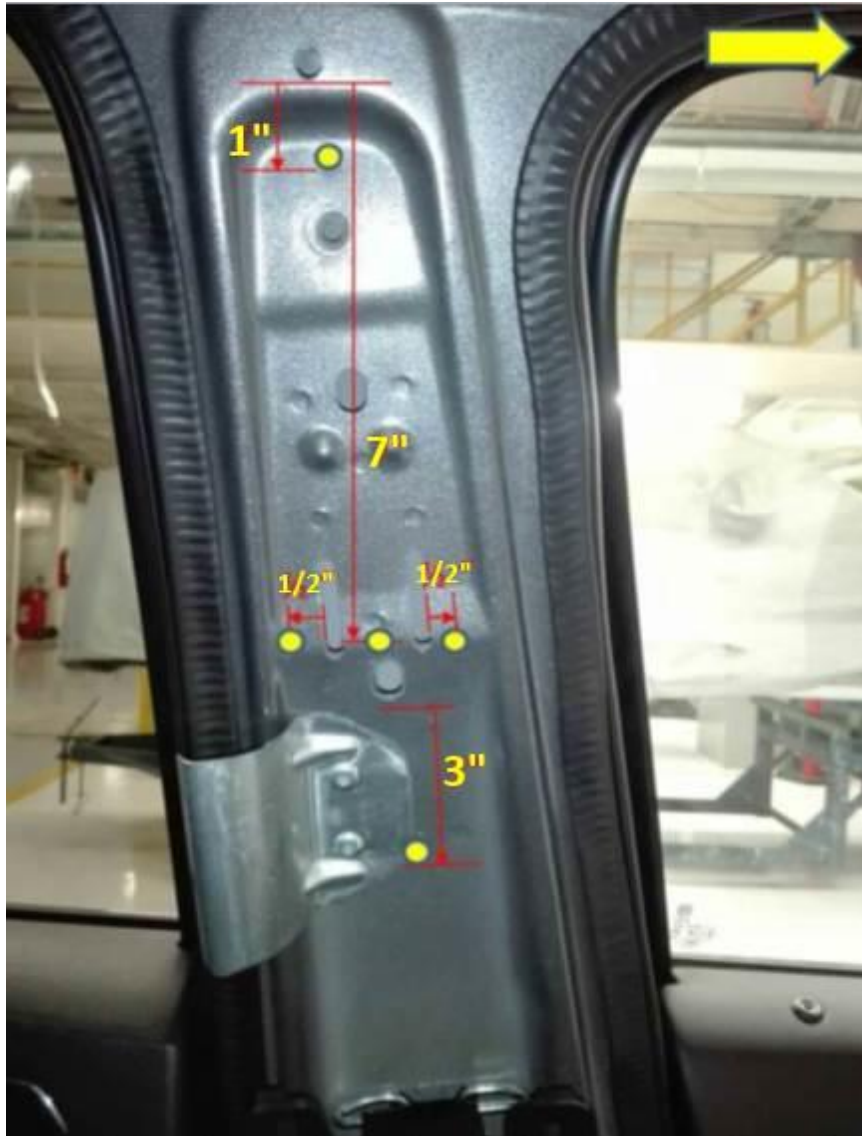
**Figure 2:** Striking points on the B-Pillar.

- 1.1 Using a conical punch  $\frac{1}{2}$ " and metal 16 oz. hammer strike once moderately in the reference points indicated on B-Pillar below, see Figure 2.

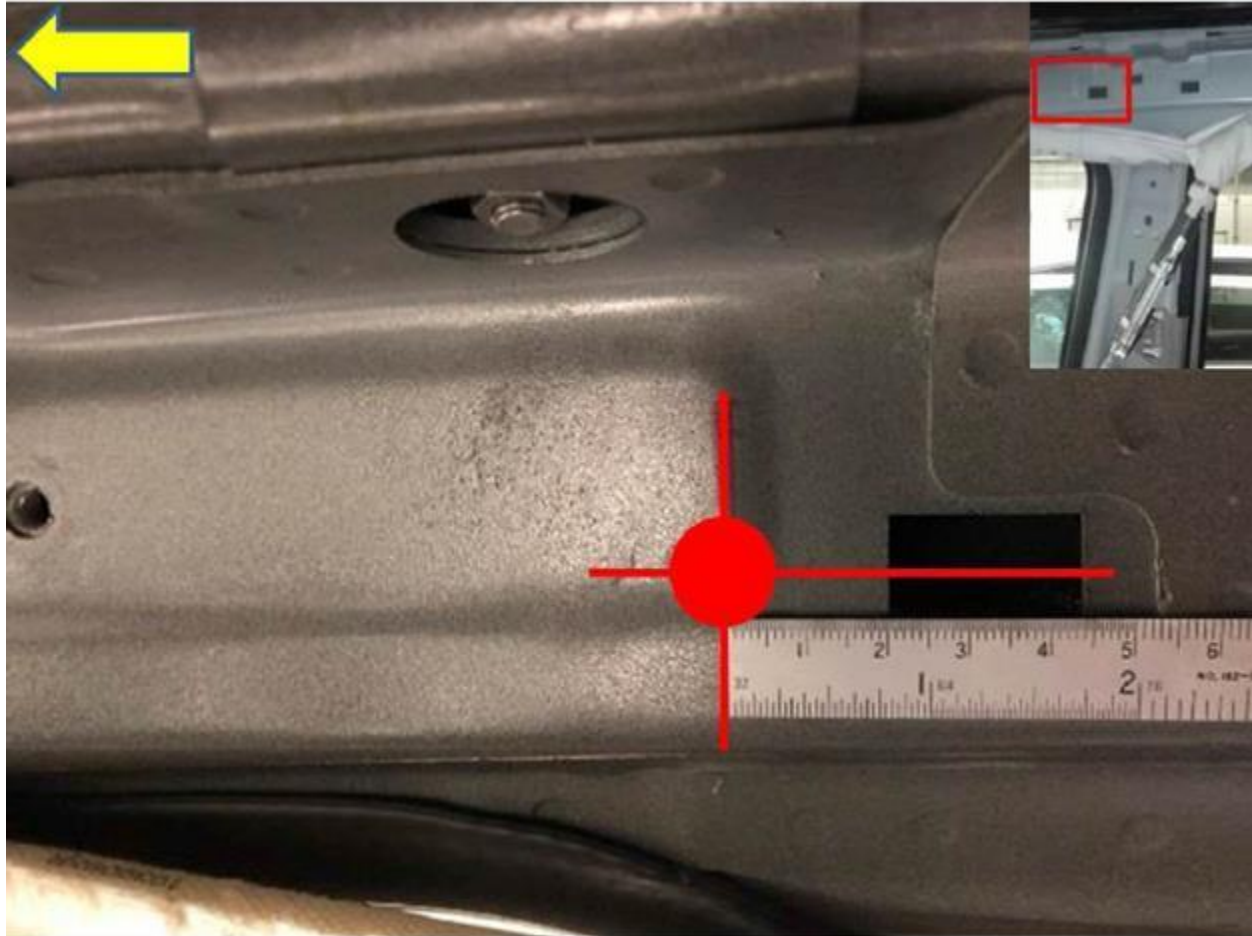
**Figure 3:** Reference point, front area.

- 2.1 Using a plastic 16 oz. hammer strike twice in the upper zone of the B-Pillar according to the reference points described, see Figures 3 and 4. The end result is to create a gap approximately 3 mm between the internal bracket and cover sheet metal. See Figure 5.

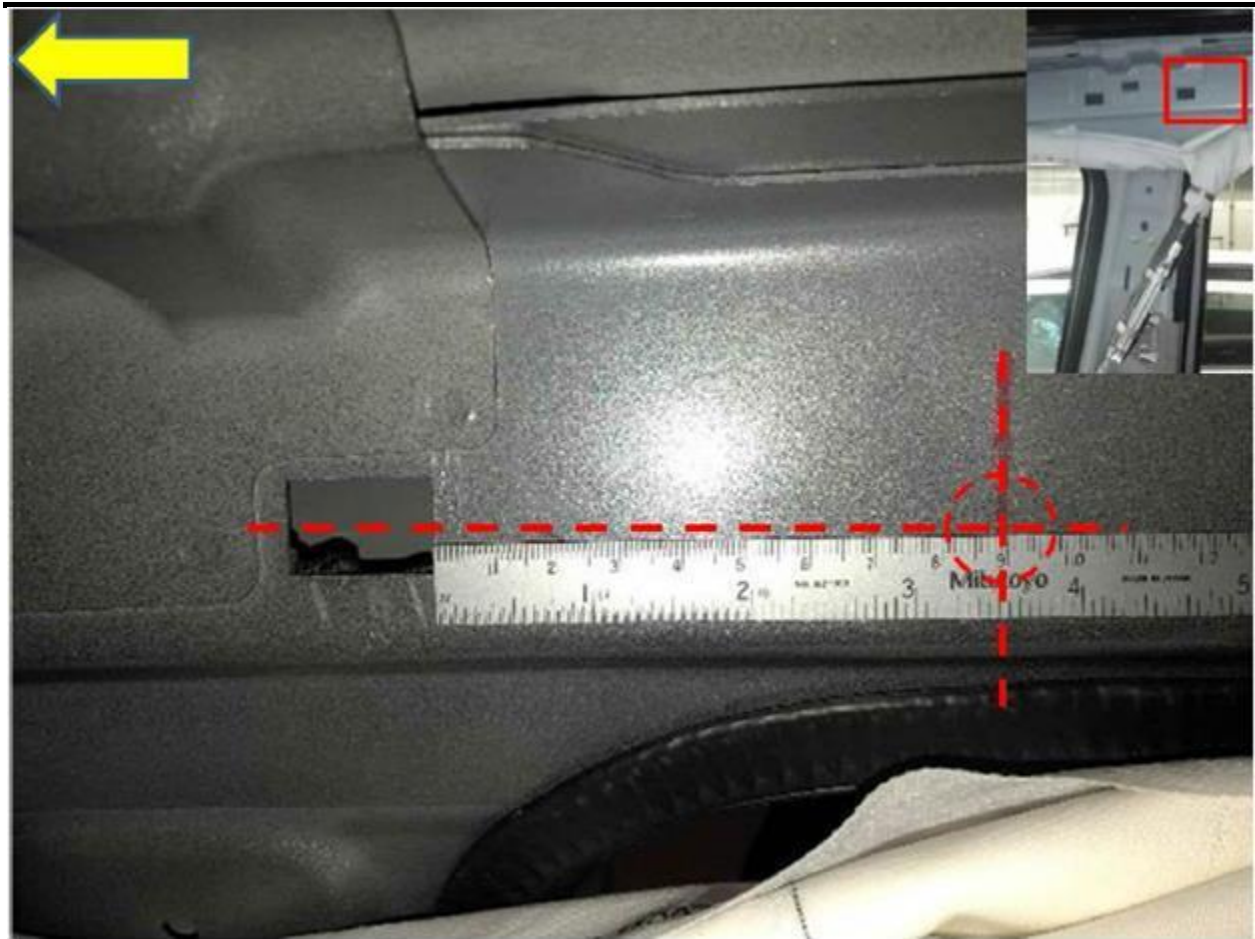
Figure 4: Reference point, rear area.

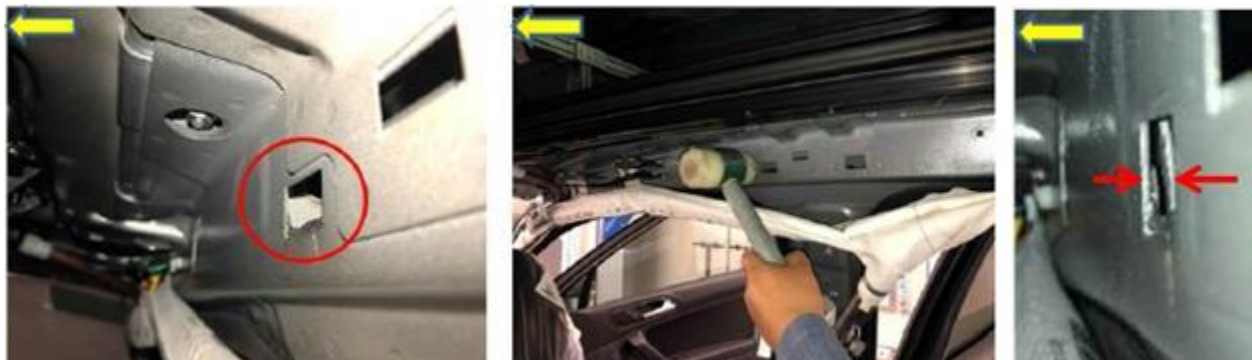
Figure 5: No gap

Striking action

Gap 3 mm

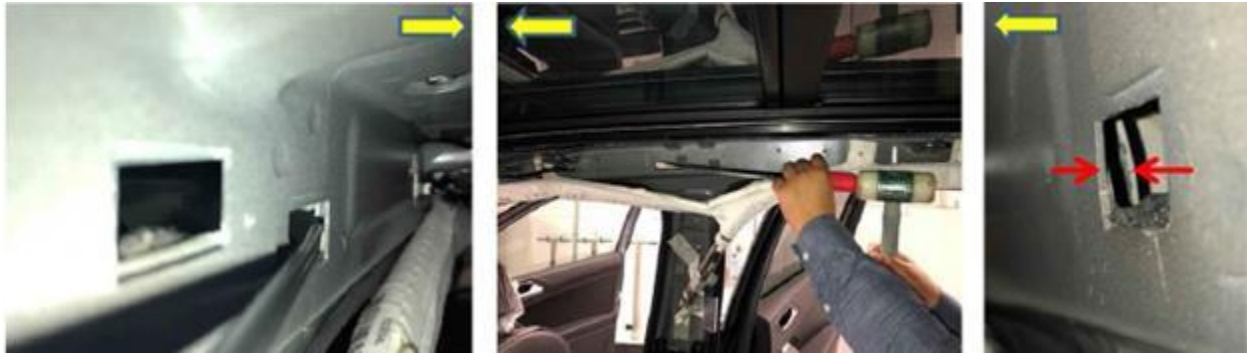
Figure 6: Insert screwdriver

Strike moderately upper/lower

Gap 3 mm

- 2.2 To ensure a uniform gap of 3 mm, insert a flat screwdriver (recommended 3/8"x16") through the indicated window and strike moderately using a plastic 16 oz. until reaching a gap of 3 mm. See Figure 6.

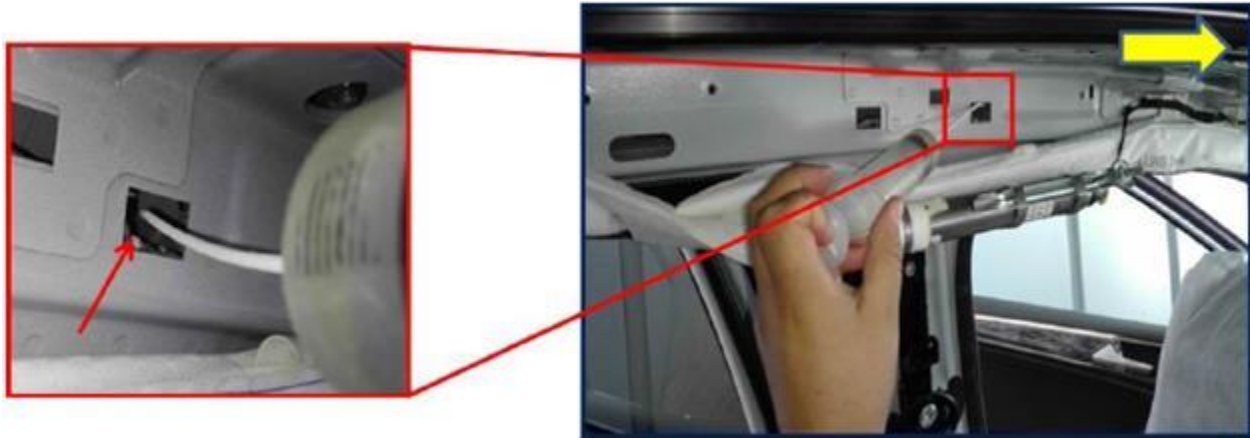
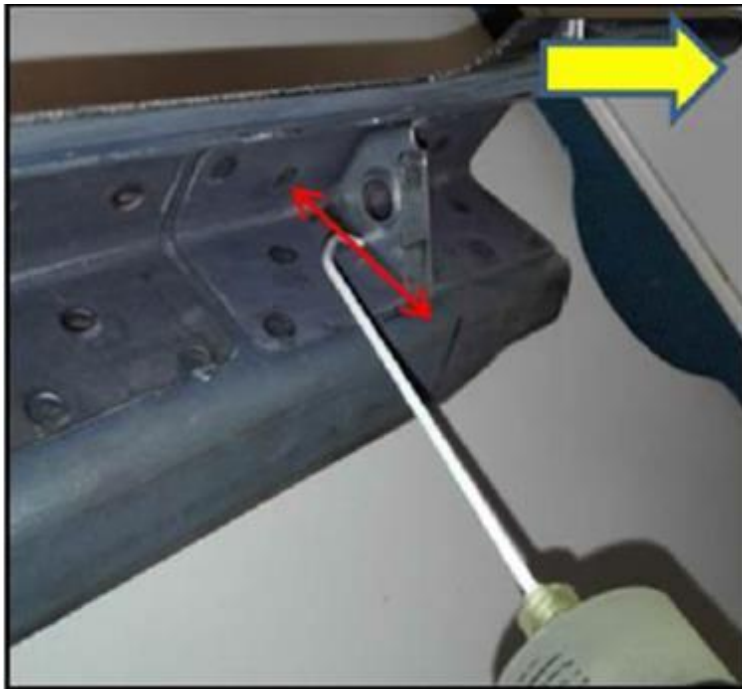
Figure 7: Front bracket

Figure 7a: Cut-away illustration of the internal area for the Krytox™ application on front bracket.

- 3.1 Apply approximately 5 ml of Teflon (Krytox™) between the lower part of the bracket and cover sheet metal, apply in a uniform application on the entire contact zone of the bracket. See Figures 7 and 8.

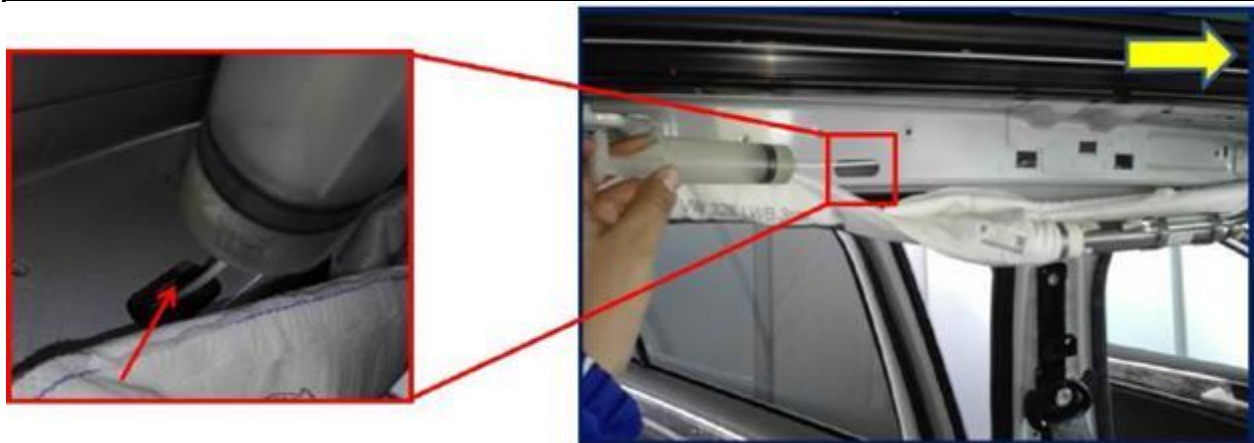
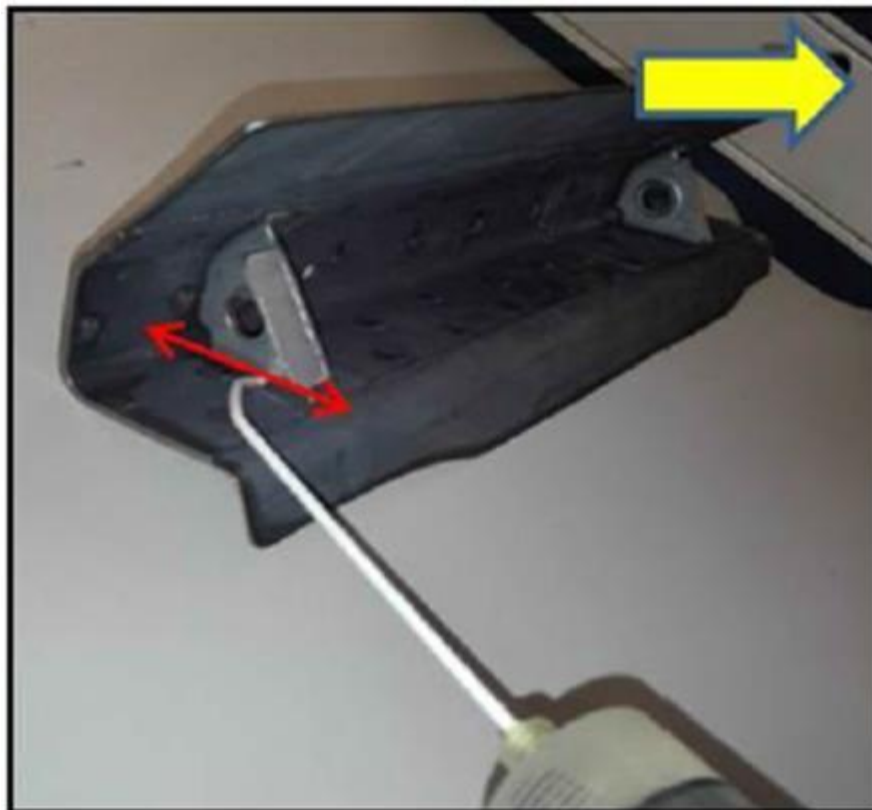
Figure 8: Rear bracket

Figure 8a: Cut-away illustration of the internal area of the Krytox™ application on rear bracket.

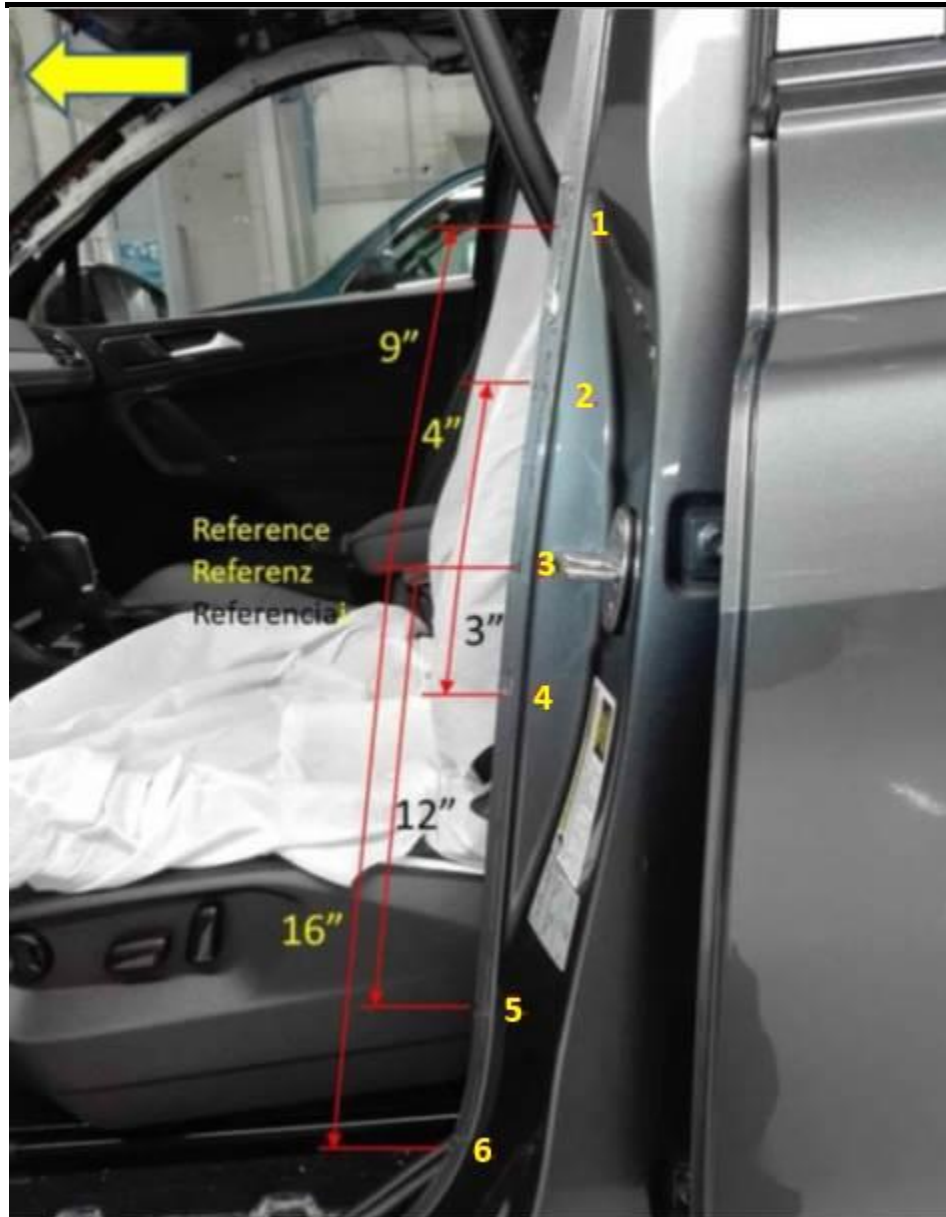
**Figure 9:** Sequence, bend back and forth on the metal panel of the front door frame, use the striker as the reference point.

- Remove the B-pillar trim panel and partially remove the door seal according to the Repair Manual.
- 4.1 Using vice grips or equivalent, clamp in the (6) areas indicated, bend back and forth the metal panel of the front door frame. Following the sequence described, see Figure 9.
