Document ID: IK0800444

Title: Driver Information Display won't boot up

Applies To: ProStar, LoneStar, LT, RH, HX

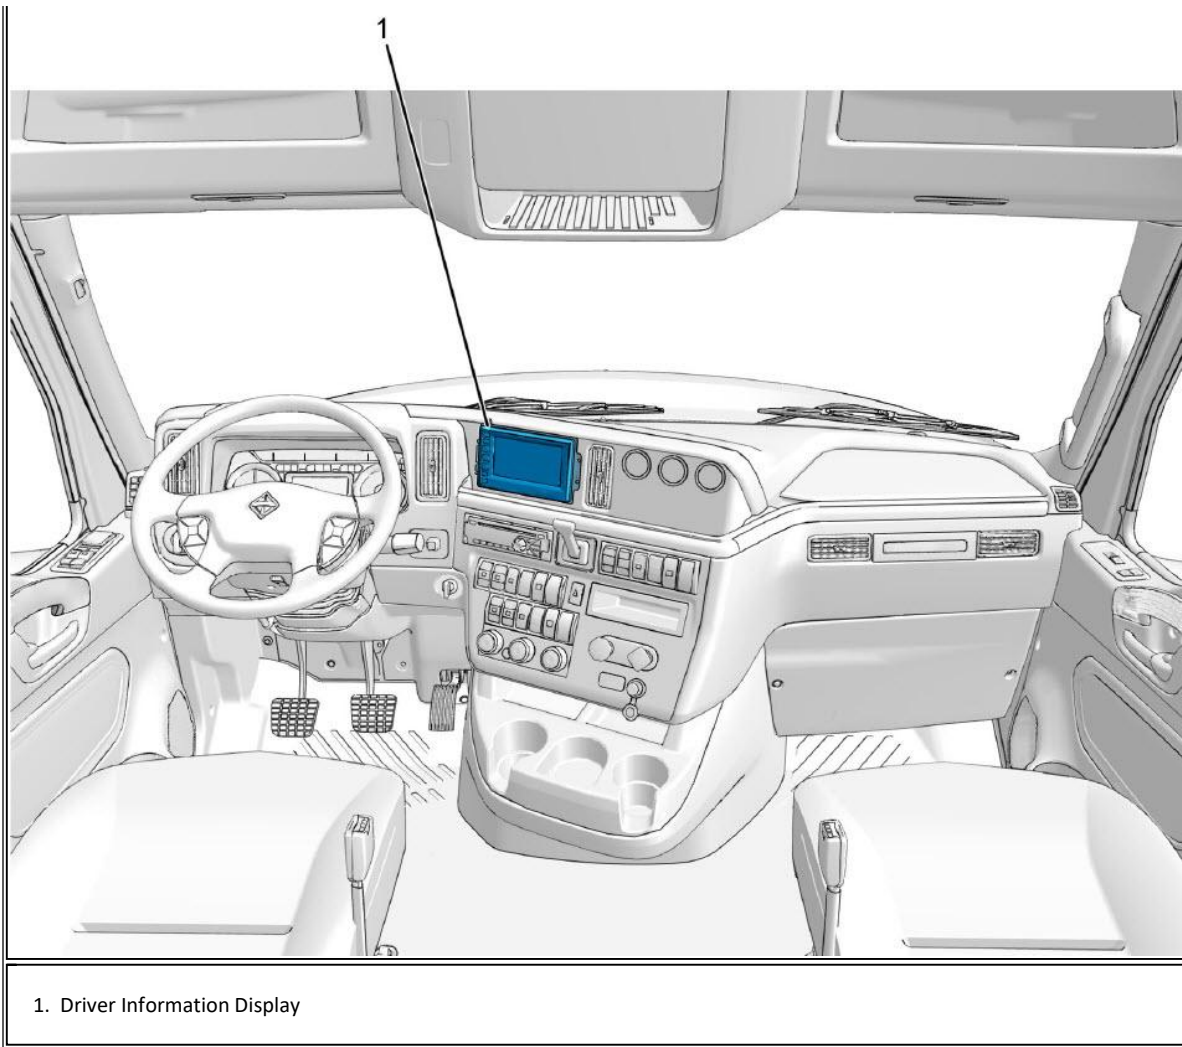
1. Driver Information Display

The customer will report the Driver Information Display (VIS/DID) screen fails to boot up. It might show the international logo and appear to be in a boot up loop. A corrupt SD card will cause this issue. This article will outline how to identify the correct replacement SD Card as well as the procedure for replacing the SD Card.
