GROUP  
Engine

MODEL  
2016-2020MY  
Optima (JF, JFa,  
JF P/HEV)

NUMBER  
PS616

**SUBJECT:** LOWER ENGINE SERVICE COVER BOLT LOCATIONS

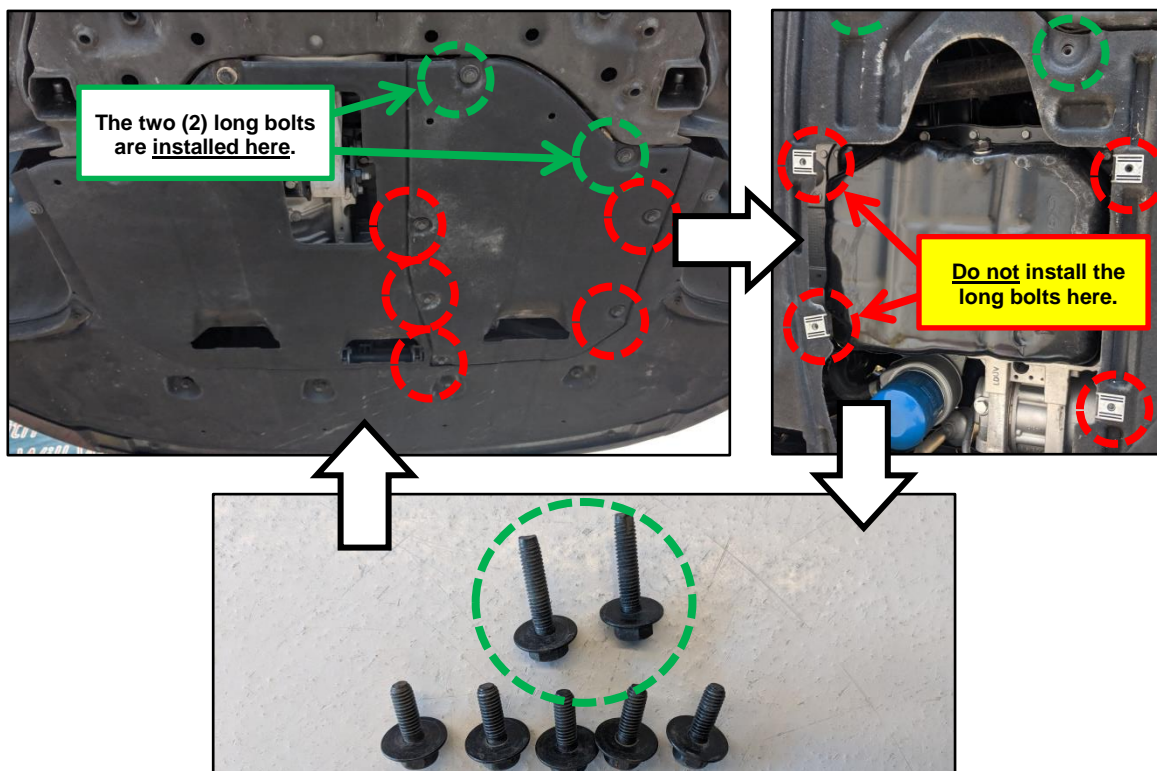
This Pitstop provides information on the correct bolt location of the lower engine service cover on 2016-2020MY Optima 2.4L and 2.0L equipped vehicles. The lower engine service cover is secured by seven (7) retaining bolts. Installation of the two (2) long bolts in the incorrect location may cause puncture or damage to the oil pan in the event that the vehicle is bottomed out while driving. If the oil pan is damaged or punctured, the engine oil may leak, possibly causing engine damage.

Failure to install the lower engine service cover bolts in the correct location may cause damage to the oil pan, which may result in an oil leak and potentially affect engine operation.

When installing the lower engine service cover, ensure that the two (2) long bolts, circled in green, are installed in the correct location. The remaining five (5) lower engine service cover retaining bolt locations are circled in red.
