Title: Identifying the Source of Oil Seen at the Lower Flywheel Housing Area

Applies To: All low mileage A26 and Cummins engines equipped with an Allison Transmission

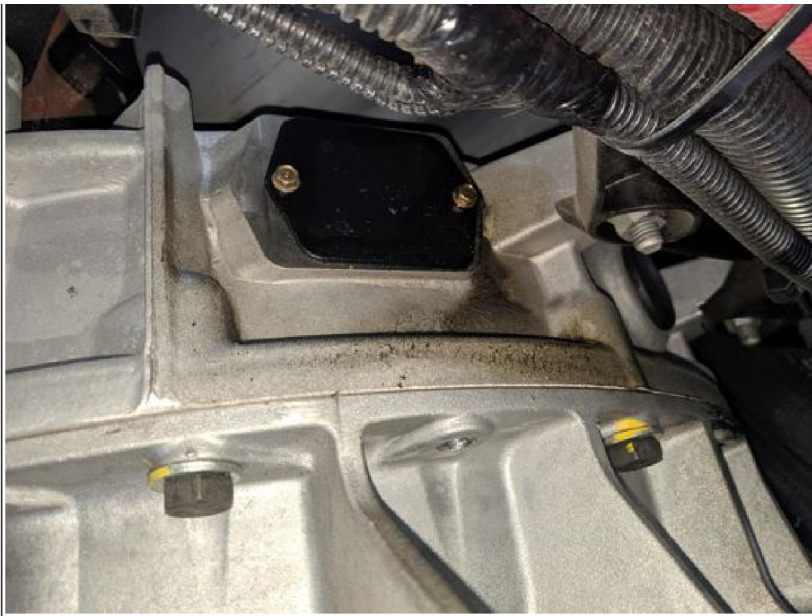
Figure #1: A26 Light Oil Film Present at Lower Flywheel Housing

- For A26 engines new enough to have the original factory fill oil in them, perform the following steps while using the UV light from the ZTSE4618 Leak Detection Kit
 - Shine the light up through the lower flywheel housing inspection opening, and on the oil seen externally on the housing
 - If any fluorescent green color is seen in the oil anywhere (**Example Figure #6**), proceed with necessary engine repairs per the [Engine Service Manual](#) to correct the leak
- If no fluorescent green is seen anywhere, then the visible oil seen is not from the engine and no engine repair is needed.

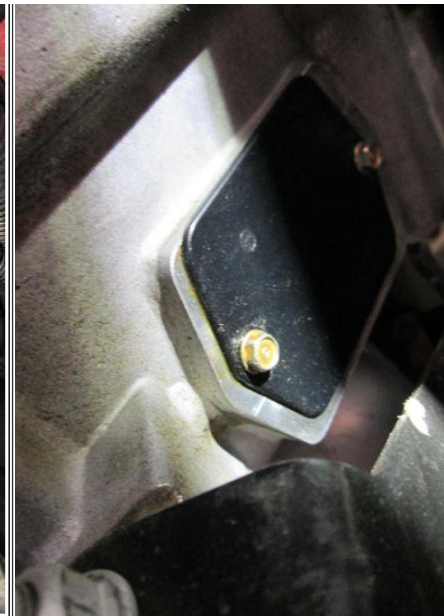
Figure #2: A26 Light Oil Present at Inspection Cover

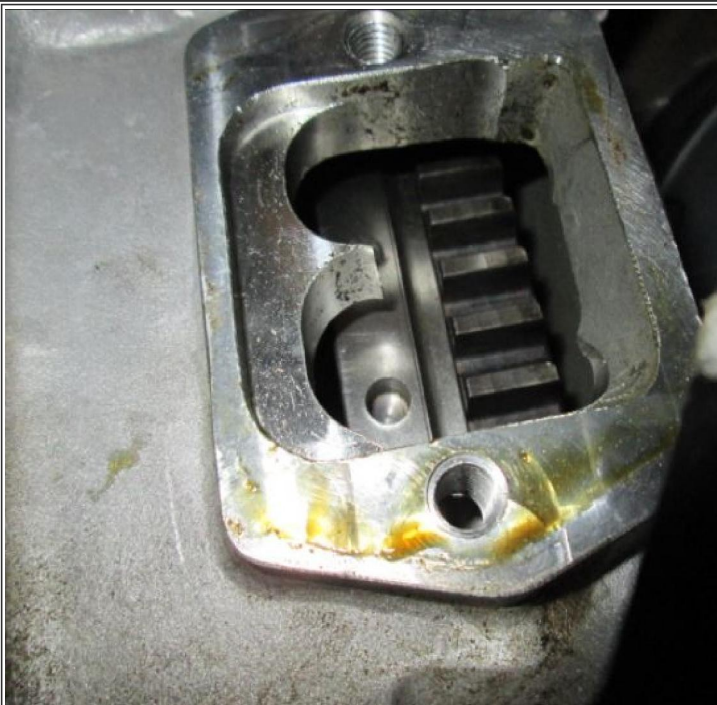
Figure #3: A26 Light Oil Seen with Inspection Cover Removed

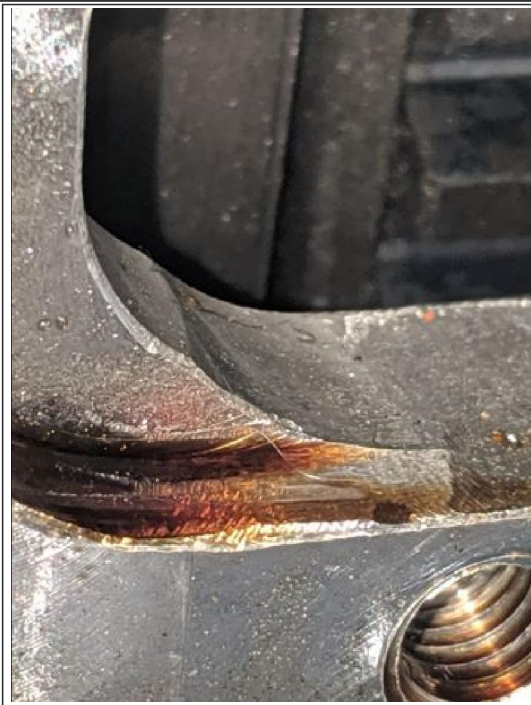
Figure #4: A26 Light Oil Collected under Inspection Cover

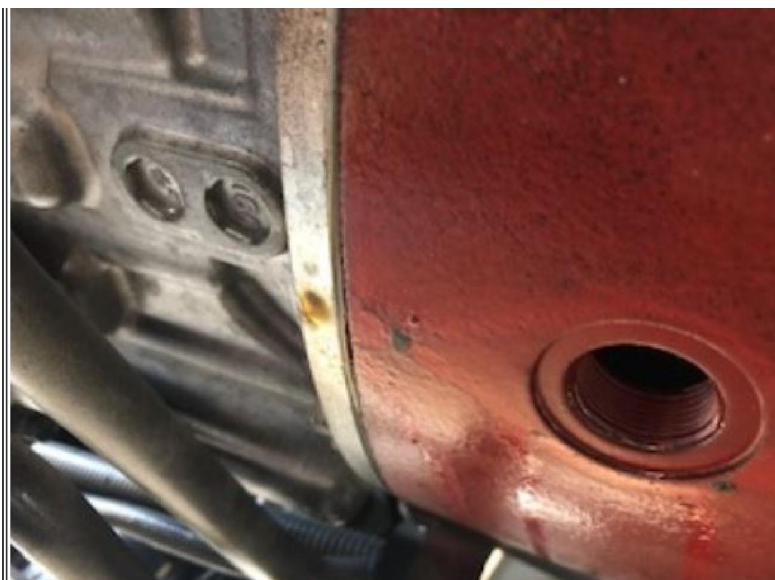
Figure #5: Low Mileage Cummins L9

3. For new or very low mileage Cummins engines with this complaint, and no dye was detected on the previous steps for A26 then it is recommended to do the following.
 - Verify the leak is not transmission fluid
 - Clean the oil from the housing and all area's as best as possible
 - Return the truck to service and instruct the owner / operator to monitor the area for approximately 10,000 miles
 - Return to the dealer for service if the leak returns

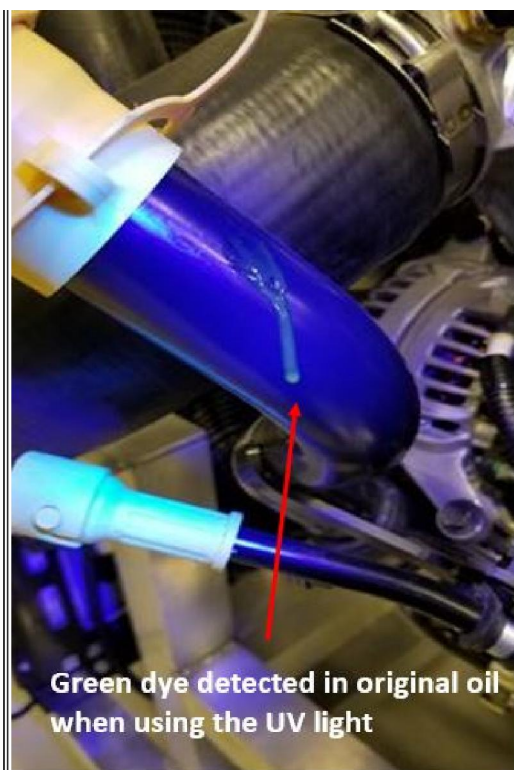
Green dye detected in original oil
when using the UV light

Figure #6: Example of dye's reaction to the UV light
