Title: LT Fuller Advantage Series Transmission Power and Ground

Applies To: LT w/ A26 & X15

This document will provide the user with Fuller Advantage Series (FAS) Automated Transmission power and ground circuit information.

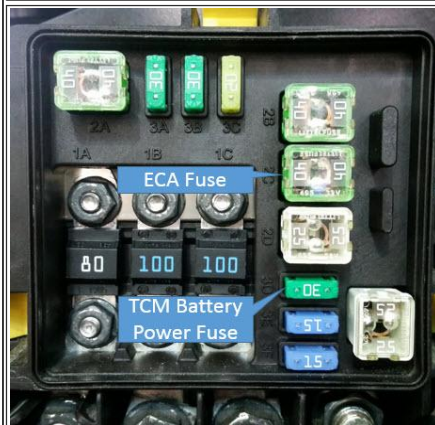
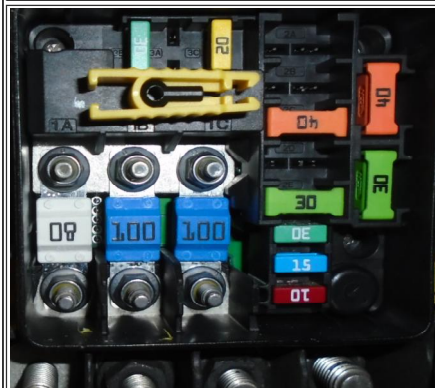
**Figure #2: Under Hood PDM**

**Note PDM Torque Specs:**

- M5 MIDIFUSE Tightening Torque 4.5 +/- 0.5 Nm (40 +/- 4 in•lb)
- M8 Torque 15 +/- 1.5 Nm (11 +/- 1 ft•lb)
- M10 Chassis / Feed Torque 28.5 +/- 1.5 Nm (21 +/- 1 ft•lb)

1. While performing Eaton diagnostic steps be sure to inspect the power and ground connections at the Underhood PDM and the Ground Stud located by the engine starter.
  2. Ensure the connections are clean (free of corrosion) and tight, Ground Stud Torque 43 N-m (31.7 ft-lb).
-

1. Clean and tighten any loose connections.
  2. Clearly document in RO, with Road Ranger, and or Navistar tech service if loose connection was found.
  3. Clear DTC's in all modules.
-
